# Failure of a steel boiler chimney caused by corrosion of the structural shell plate

**Abstract.** The article presents issues concerning the corrosion of sheets of the guyed steel chimney with boiler house in an industrial plant. The subject of considerations is a steel chimney with a height of 46.5 m and a diameter of 1.25 m. The chimney was used for seventeen years and did not show any significant corrosion losses. After the change of the way of usage and the fuel used for feeding boilers, the corrosion rate has dramatically increased. The paper presents issues concerning corrosion types and mechanisms of corrosion degradation of the steel. The reasons for the increase of corrosion velocity within the chimney base were given. The method of chimney renovation and the results of this renovation, detailing the order of works is presented too. Attention was also paid to the proper maintenance of construction works, as periodic inspections themselves may be insufficient to ensure safe operation.

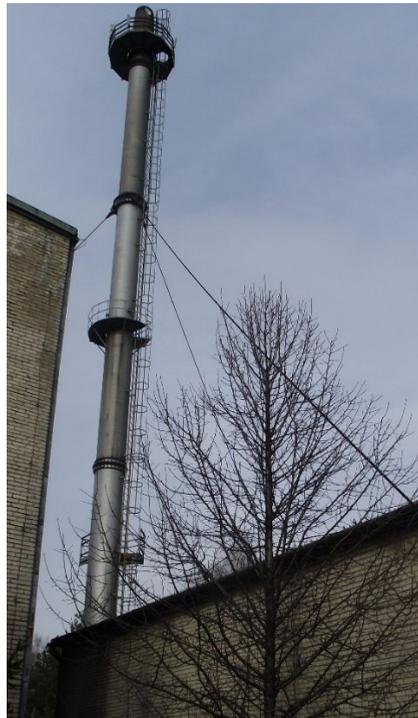
**Fig. 1.** General view of the chimney.

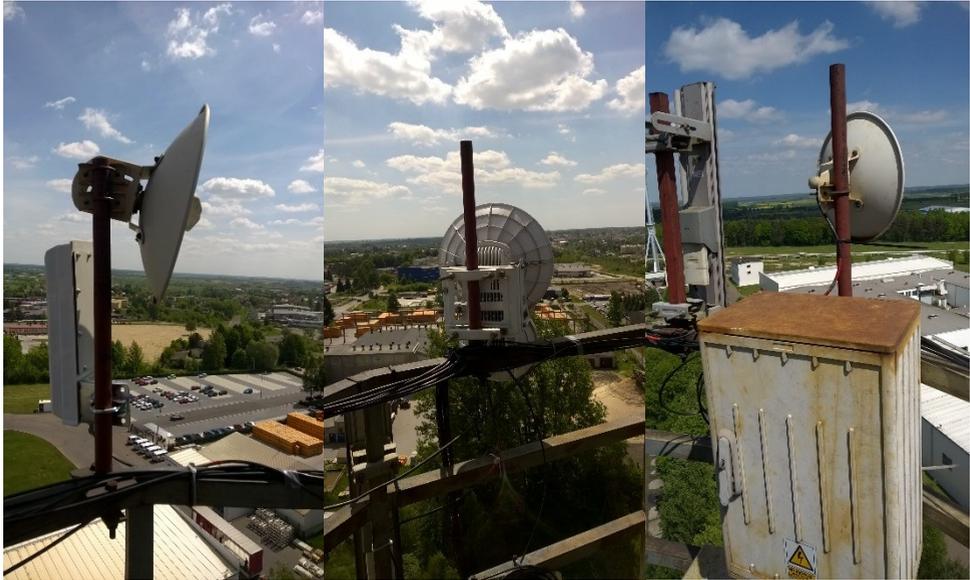
In 2010, antennas of mobile telephony were added to the gallery of the upper chimney (Fig. 2). The chimney supports three coal-fired boilers and is used continuously, with only one boiler operating outside the heating period.

**Fig. 2.** Mobile telephony antennas on the upper chimney gallery - additional load.

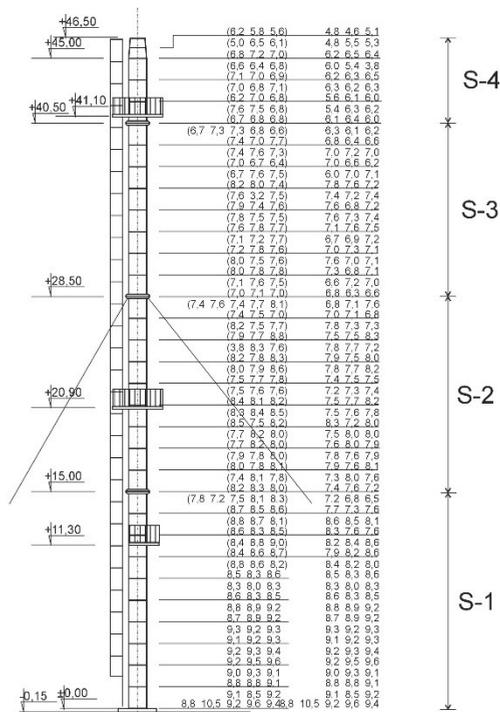
i.e. in frontal joints connecting individual sheets of chimney shaft elements, on average every 1.5 m, at the contact points of assembly segments, and near the chimney shaft support area and at the chimney support on the foundation. The measurement results from 2006 and 2009 are shown in Fig. 3.

**Fig. 3.** Inventory drawing of the chimney.

the chimney height depending on the segment. The maximum corrosion rate occurred in the S-4 segment. This is in line with the assumptions, because the upper segments are usually the most corrosive because of the condensation of the cooled gases. In the S-3 segment, the thickness of the 3.2 mm sheet was scored. Perhaps it was only a measurement error, but you should pay attention to this place during the next measurements.

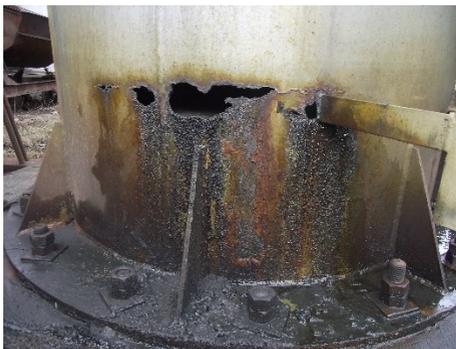
During the inspection of the chimney after the winter period in 2014, the perforation of the chimney structural shell plates was noticed. The damage took place about 40 cm above the foundation of the chimney (Fig. 4). The damage was from the south side on the opposite side in relation to the anchorage of the guy. In the place of damage, it was noticed that the water was present with dust, soot and slag falling off the exhaust waste gases (Fig. 5). The stagnation of water and condensation was caused by clogging of the drainage conduit that was in the foundation.

**Fig. 4.** Corrosion perforation of chimney sheets.

The reasons for the increase in the corrosion rate should be seen in the local change of the working conditions of the roof sheath. Under typical conditions, condensation of exhaust fumes contaminated with sulphur compounds in a high concentration caused general corrosion of the upper chimney segment. Due to the lack of condensate, the lower segments were not exposed to chemical corrosion. The change of fuel containing harmful substances and forming dust accelerated the corrosion process. Among the ash-forming substances,

The precipitation water diluted the sulfuric acid concentration, which also caused acceleration of corrosion (Fig. 7), as well as reduced the access of air, which also increased the speed of corrosion (Fig.8) [4]. In addition, the prevailing tensile stresses from wind forces in this part of the chimney, initiated stress corrosion.

To protect the chimney against further devastation, it was ordered to immediately repair the damaged part of the bottom of the chimney shaft. Repair of the resulting damage consisted of using an additional steel sheets on the perimeter of the chimney, which will take over the role of a heavily corroded part at the foundation. Due to ribbing and access door existing here, as well as the necessity of the best connection with the existing construction of additional sheets, it was recommended to reinforce the entire circumference of the chimney. The reinforcement was designed from a 10 mm thick and 1500 mm high sheets (Fig. 9). The width of each belt was taken so that it did not exceed 350 mm. In each sheet before welding, holes for existing elements (stem ribs and cleanout) were cut out. Only after cutting the holes, the sheet was put on the chimney stem. After fitting, each sheet was welded to the chimney shaft and neighboring sheets in stages. In the first stage, the sheets were welded on lengths of 20 cm, with a 20 cm break. In the next stage, the welds were refilled. A drain hole was left in the chimney wall (Fig.10).

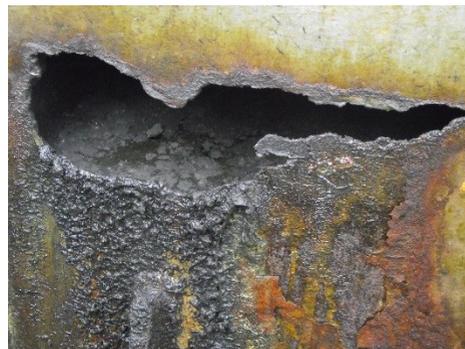
**Fig. 5.** Water in the interior of the chimney.

The phenomenon of soot deposition did not occur in previous periods. After an interview with the user, it turned out that the heating fuel supplier has recently changed. During combustion, this coal produced much more slag and dust transferred from the exhaust. The way of servicing boilers has also changed. Due to interruptions in the plant's operation, the boilers were turned off and the chimney was cooled down. This resulted in water coming from the precipitation in the chimney. Despite these unfavorable conditions, it was difficult to assume that the progress of corrosion would be so great. The measurements of the chimney

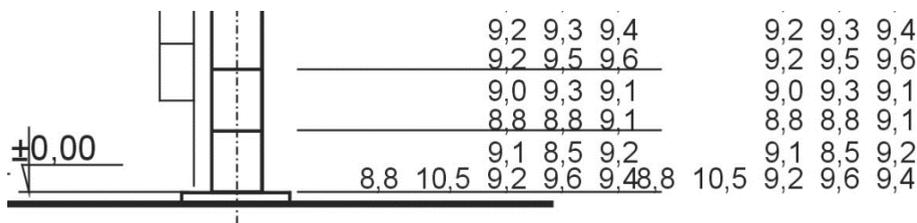
structural shell plate thickness (Fig. 6) showed an adequate corrosion reserve at a specified corrosion rate of 0.103 mm / year.

Fig. 6. The measurements of the chimney structural shell plate thickness.

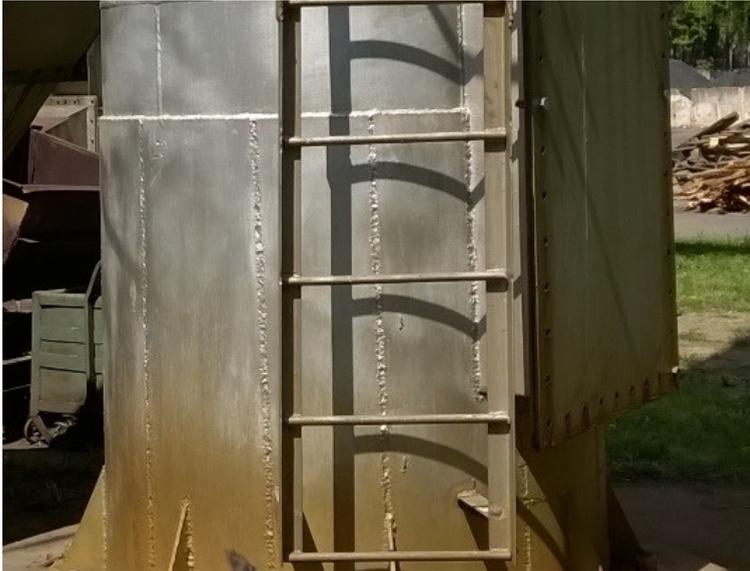
**Fig. 9.** Repair of the bottom part of the chimney.

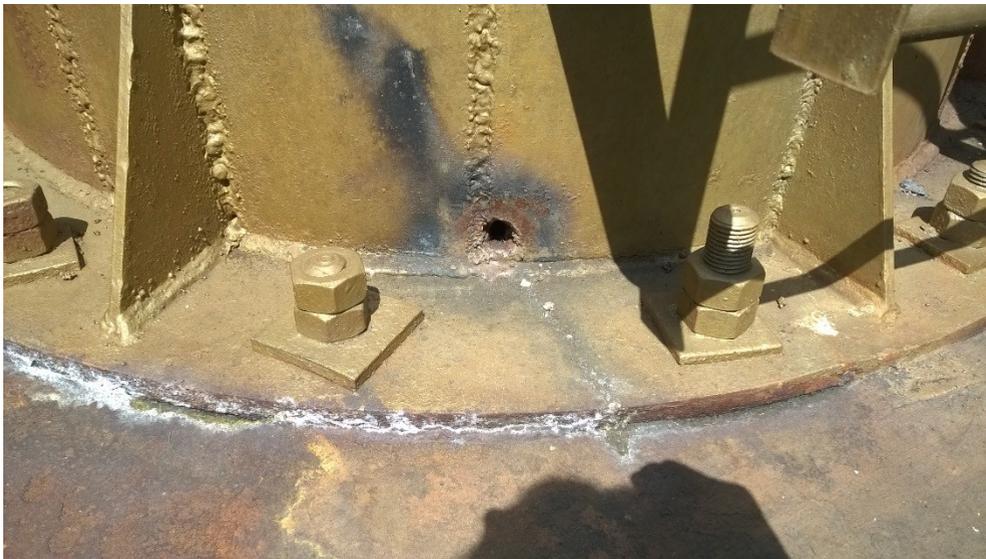
**Fig. 10.** The drain hole in the chimney wall.
