Results on the long-term performance and effectiveness of a galvanic CP system applied on a lightweight concrete bridge with prestressed steel as determined by depolarisation values and current densities

A.J. (Hans) van den Hondel MSc

Vogel Cathodic Protection, Zwijndrecht, The Netherlands

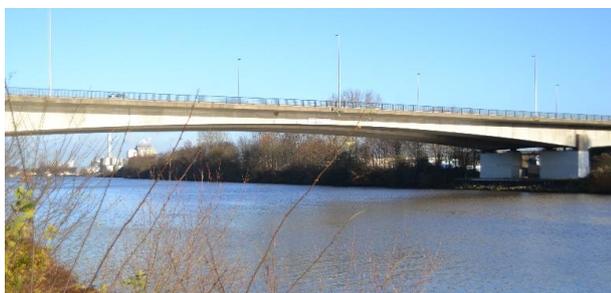
Fig. 1. The Neerbosche Bridge over the Maas-Waal canal.

The bridge is a post tensioned double box girder bridge from 1982, of which the structure above the canal is constructed with light-weight concrete (1650 kg/m^3). The in-situ cast concrete segments have a length of about 3.4 meters. For each box girder, the part of the bridge located between the piers comprises 33 segments of which the 2 segments above the piers are constructed with conventional normal weight concrete. So each box girder is comprised of 31 light-weight concrete segments above the canal. The soffit of the light-weight concrete sections of the southern box girder showed serious

damage and consequently maintenance was required in the short term in view of structural safety as well as possible danger for the shipping underneath the bridge due to falling lumps of concrete.

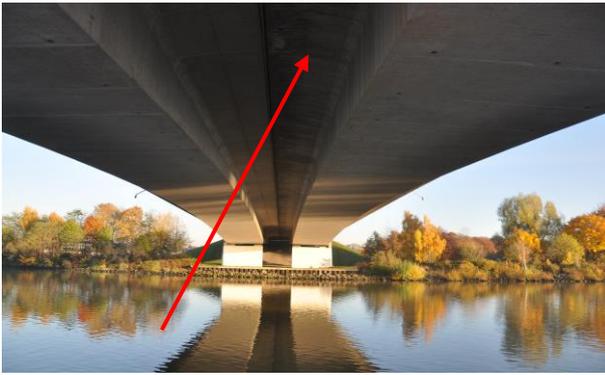
The damage in the bridge was extensively investigated and reported [1] in a preliminary phase and it was concluded that the damage was limited to the concrete surface at the soffit of the northern cantilever of the span of the southern bridge (see Figure 2). Due to long-term leakage in the longitudinal joint between the northern and southern bridge, chlorides originating from the frequent application of de-icing salt during winter periods had penetrated into the concrete up to the level of the reinforcement and beyond. As a consequence, the mild steel reinforcement had started to corrode which eventually resulted in the development of significant tensile stresses in the concrete, leading to cracks, delaminations and spalling at multiple locations.

The corrosion induced damage amounted to approximately 44 m^2 , which was about 22% of the total surface of the soffit. At other locations, the likelihood of corrosion was demonstrated by corrosion potential measurements which showed values down to -450 mV (Cu/CuSO_4) and -350 mV (Ag/AgCl ; see Figure 3).

Fig. 2. Location of the damaged cantilever (southern bridge).

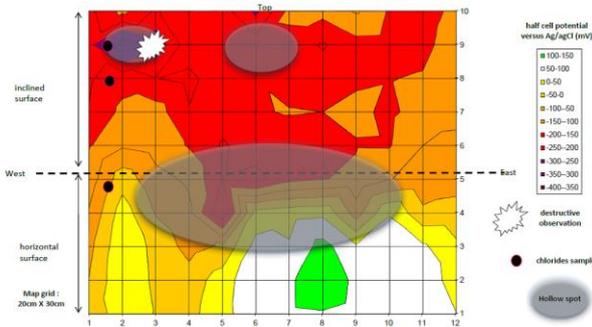
Fig. 3. Corrosion potential measurements at the cantilever in the southern bridge. The grey areas denote hollow spots and the white flash a destructive investigation point.

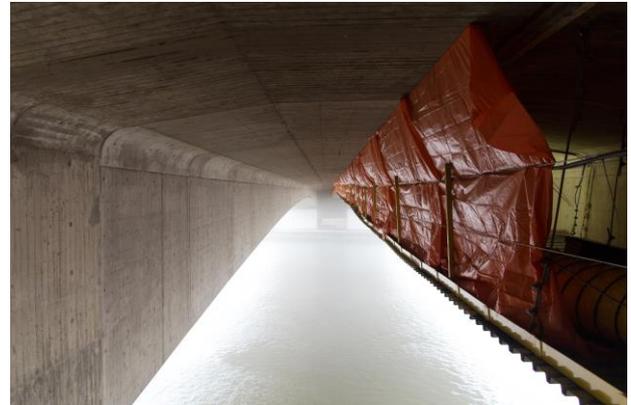
Fig. 4. Access to the soffit at the damaged cantilever.

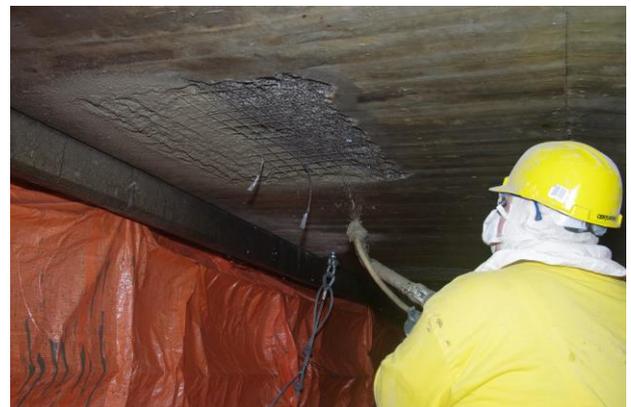
Fig. 5. Repair of the damaged locations with shotcrete.

level, the application of shotcrete using a light-weight mortar with a high cement content and no additives for the concrete repairs and the application of the GCP system (Figure 4-6).

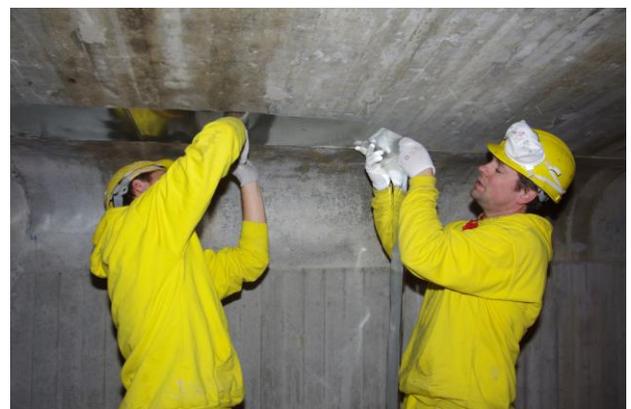
Fig. 6. Application of the zinc anode in 25 cm strips.

The anode material used for the protection of the steel reinforcement was a surface mounted zinc anode. This so-called Zinc Layer Anode (ZLA) is applied as a foil on the surface and consists of a 250 μm thick zinc sheet provided with a 750 μm thick ion-conductive adhesive.

The complete zinc surface, including the edges, was covered with a 2 mm waterproof cement-based coating in order to prevent the zinc from direct contact with

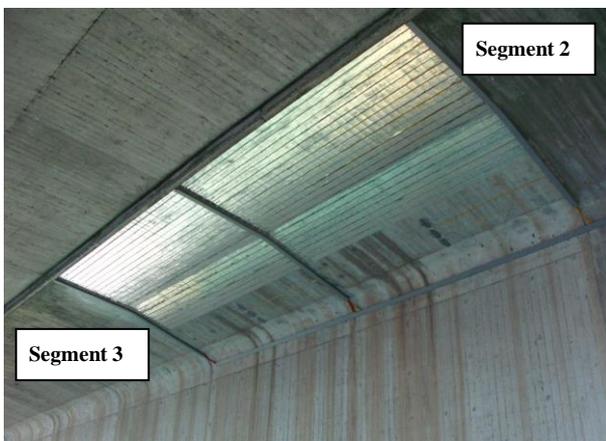
Fig. 7. Test locations with the zinc anode material.

The CP system at the test segments was applied on the horizontal part of the cantilever and the adjacent 50 cm of the inclined segment (thus over a total width of 2 meters). Each test segment was in this way covered with 6.2 m² of ZLA (see Figure 7).

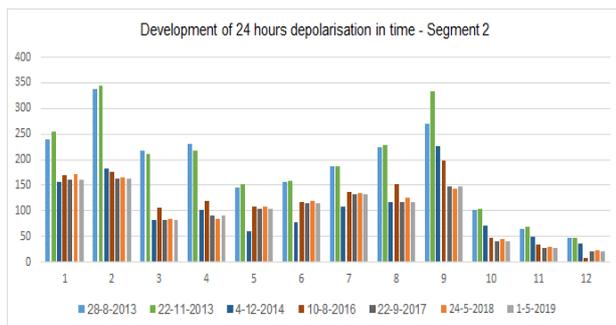
The measured values of the depolarisation in the protected area decreased over time (Figures 10 and 11). At the start in 2013 the measurements showed higher values indicating that the applied GCP system complied with the code-based ISO-EN12696 criteria ([3]) at almost all locations where RE's are installed, resulting in sufficient protection of the reinforcement.

After 17 months (in December 2014) 4 out of 5 RE's (80%) at the 1st layer of reinforcement in segment 2 still met the code-based protection criteria (compared to 100% compliance in 2013). In October 2015, more than 2 years after the installation of the GCP system, this is reduced to 3 out of 5 RE's (60%) at the 1st layer. Since then the results at different measuring moments (up to 6 years after the installation) are stabilized and 60% to 100% of the RE's still meet the protection criteria.

Fig. 10. 24 hours depolarisation values of segment 2.

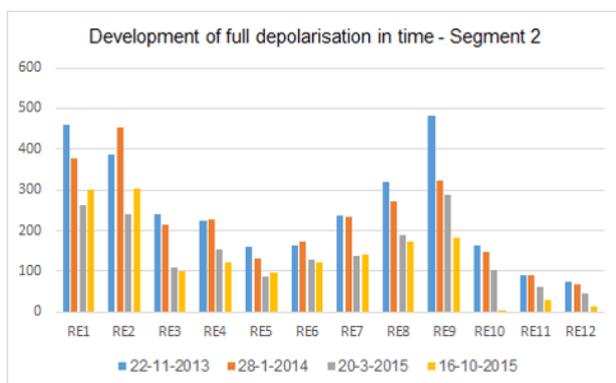
The RE's placed at the 2nd layer of reinforcement in segment 2 have behaved more or less in the same way. After 17 months, 2 out of 4 RE's (50%) still met the code based protection criteria (compared to 100% compliance in 2013). In October 2015 this was further reduced to 25%, but since then the measurement results are back to 100% compliance.

Fig. 11. Full depolarisation values of segment 2.

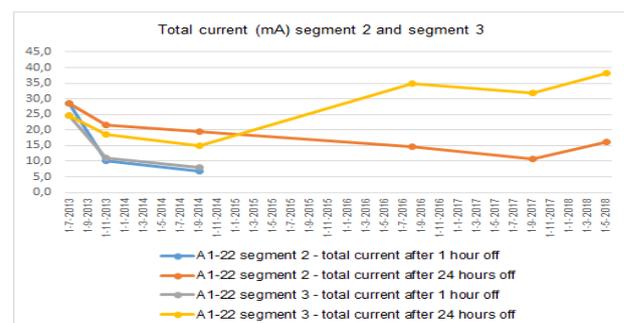
Fig. 12. Development of the total current output in time for segments 2 and 3.

The measured current outputs decreased over time (see Figures 12-14), with a strong accent in the first months. However, in 2018 the current outputs increased again.

At the start in 2013 the total current output amounted to 28.6 mA (equal to 4.6 mA/m²_{anode} and roughly 7.7 mA/m²_{steel}) and 24.8 mA (equal to 4.0 mA/m²_{anode} and roughly 6.7 mA/m²_{steel}) for segment 2 and 3, respectively. After 14 months the total current output was reduced (measured 1 hour after switching off the GCP system) to 6.8 mA (equal to 1.1 mA/m²_{anode}, roughly 1.8 mA/m²_{steel} and 76% reduction) and 8.1 mA (1.3 mA/m²_{anode}, roughly 2.2 mA/m²_{steel} and 67% reduction). After 3, 4 and 5 years the current output was measured after switching off the system for 24 hours. In segment 2 a total current output of 14.6 mA was measured in 2016, 10.8 mA in 2017 and 16.3 mA in 2018 (equal to 2.4, 1.7 and 2.6 mA/m²_{anode} respectively and roughly 4, 2.8 and 4.3 mA/m²_{steel}).

After replacement of parts of the zinc anode in segment 3 in December 2014, the current output increased. After switching off the system for 24 hours 35 mA was measured in 2016, 32 mA in 2017 and 38 in 2018 (equal to 5.7, 5.2 and 6.2 mA/m²_{anode} respectively and roughly 9.4, 8.6 and 10.2 mA/m²_{steel}).

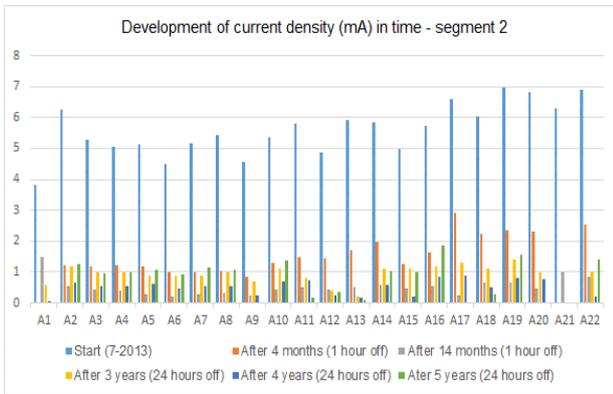
Fig. 13. Development of current output in time for segment 2.

The zinc strips applied in segment 2, which has less patched areas, showed more equally distributed current outputs from the start: varying from 3.8 - 7.0 mA/strip in July 2013 to 0.1 - 0.9 mA/strip in September 2017 and 0.0 - 1.9 mA/strip in May 2018; see Figure 13).

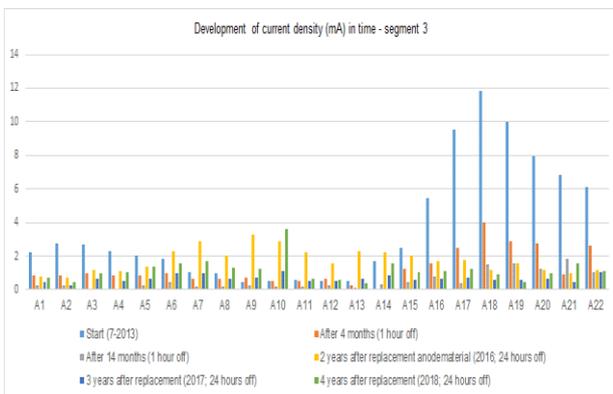
Fig. 14. Development of current output in time for segment 3.

During the first year the current output for the separate zinc foils (22 strips per segment) varied strongly in segment 3 (from 0.5 - 11.8 mA/strip; see Figure 14). The parts of segment 3 with patched areas (from zinc strip A5 to A16 and with the larger patched areas from A9 to A13; see Figures 15-16; [5]) showed much lower current outputs compared to the zinc strips in non-patched areas. The disbanded repair mortar caused a higher resistance and subsequent lower current densities at these locations.

As mentioned above, the current output in segment 3 increased significantly after having the disbanded areas from the test phase repaired and the majority of the zinc anodes replaced in December 2014. At the same time the current distribution over the zinc strips became more equally spread (varying from 0.3 - 1.2 mA/strip in September 2017 ($\approx 0.28 \text{ m}^2$ for each strip) and 0.3 - 3.6 mA/strip in May 2018; see Figure 14).

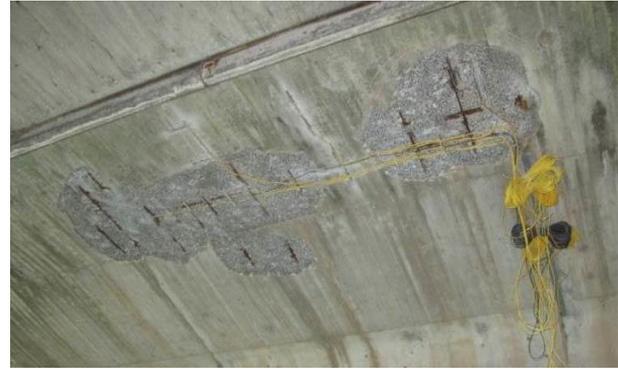
Fig. 15. Repair locations and RE's in segment 3.

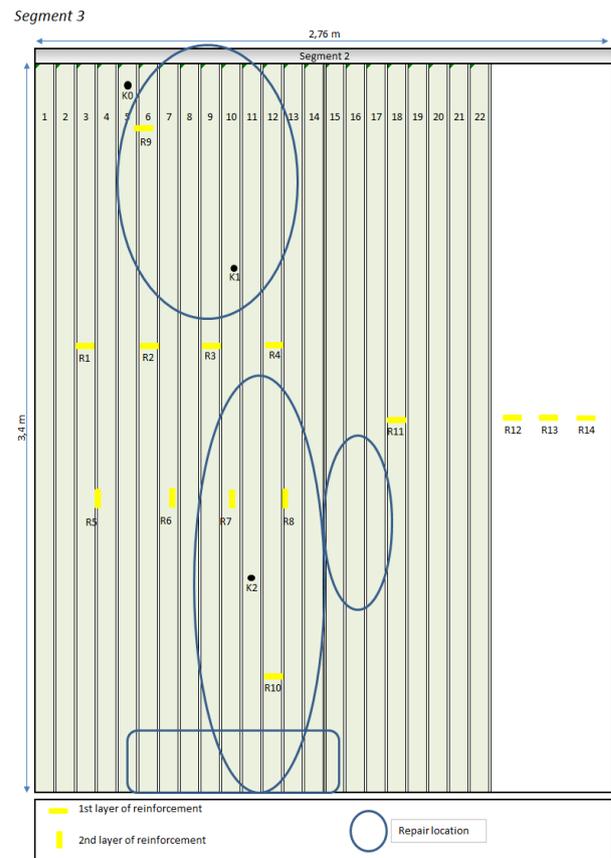
Fig. 16. Anode strips, RE's and repair locations in segment 3.
