A novel approach to in-depth façade assessments: Improved corrosion test methods for embedded steel framing in historic masonry clad buildings

Gina Crevello¹, Irene Matteini¹, and Paul Noyce¹

¹Echem Consultants LLC, 4 Jefferson Plaza, Ste 500, Poughkeepsie, NY, USA

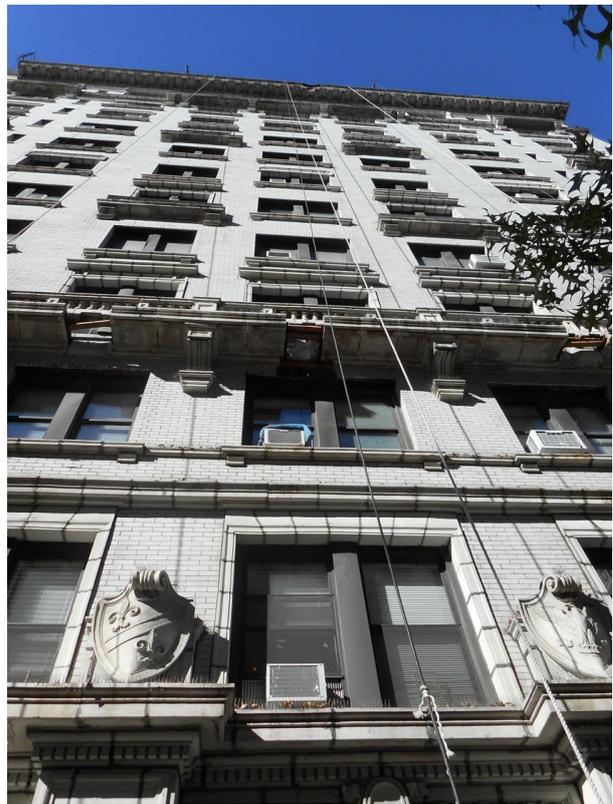
Fig. 1: Projecting Terra Cotta Façade Elements.

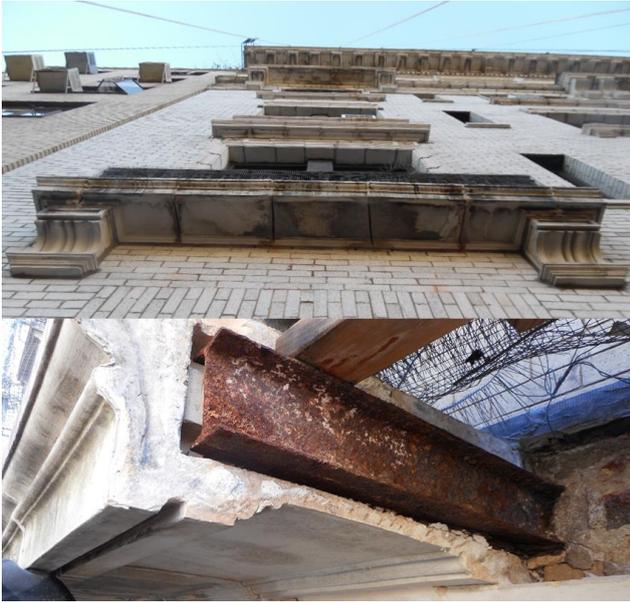
limited inspections. The associated costs with this work was approximately \$2 million USD. Prior repair work had been carried out on some of the balconettes, where a cementitious parge was applied over damaged terra cotta. This and the noted ingress of moisture from leaking air conditioning units was causing deterioration of the steel outriggers which support the terra cotta balconette tiles.

Fig. 2. (Top) Terra Cotta Balconettes. **Fig. 3.** (Bottom) Exposed Corroding Outrigger.
