Condition assessment and service life prediction of a marine concrete structure: an interesting case study

Joost Gulikers*

*Ministry of Infrastructure and Water Management, Rijkswaterstaat GPO, P.O. Box 2232, 3500 GE Utrecht, Netherlands

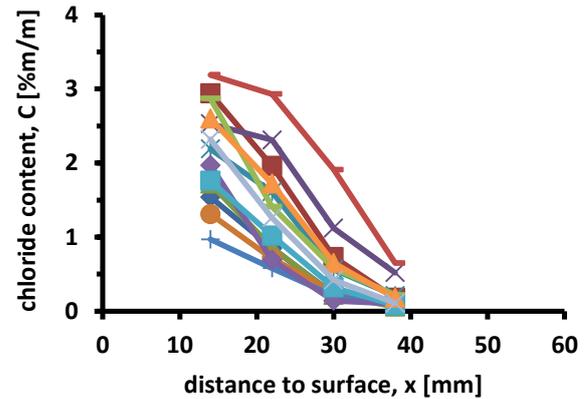
Fig. 2. Measured chloride profiles (2002) in the walls of the box girder bridge after 18 years of exposure (windward side).

It can clearly be seen that the scatter in chloride ingress is significant, despite the uniform concrete quality and exposure conditions, even at the level of the reinforcing steel ($c = 40\text{mm}$), with chloride contents ranging from 0.05% to 0.80% (m/m cement). Generally, for chloride levels in excess of 0.7% the probability of depassivation of reinforcing steel is considered high, see Fig. 7 [3]. This conclusion resulted in great concern of the local asset owner on both the actual and future condition of the box girder bridge in view of timely and effective interventions to be considered.

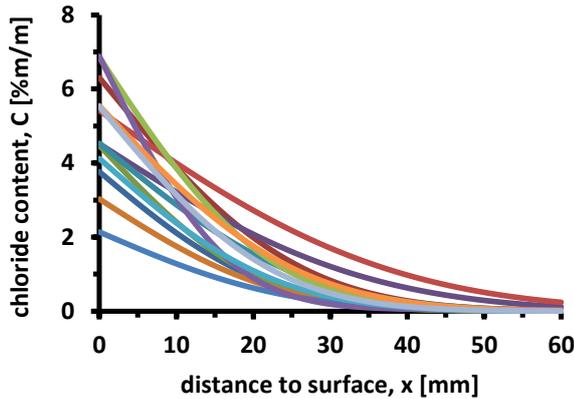
Fig. 3. Fitted chloride profiles (2002) in the walls of the box girder bridge after 18 years of exposure (windward side).

The values of the fitted surface chloride contents, $C_{s,fit}$, ranged from 2.1 to 6.9% (%m/m cement), whereas the values for the initial chloride content, $C_{i,fit}$, generally amounted to 0% and incidentally up to 0.06%. This level of C_i was as expected as no chlorides were allowed to be mixed in during concrete production. If significant levels for the chloride content at depths $>50\text{mm}$ had been found then this could hint at a systematic bias in the chloride measurements. The apparent chloride diffusion coefficient, $D_{a,fit}$, was found to range between 4.7 to $24.7\text{mm}^2/\text{yr}$, corresponding to $0.15 \cdot 10^{-12}\text{m}^2/\text{s}$ and $0.78 \cdot 10^{-12}\text{m}^2/\text{s}$, respectively, with an average of $11.2\text{mm}^2/\text{s}$ ($0.35 \cdot 10^{-12}\text{m}^2/\text{s}$). These values for $D_{a,fit}$, as determined by regression analysis, for a concrete age of 18 years are indicative for a very dense concrete cover zone. This qualification is supported by other visual and microscopic observations on the concrete cores.

Adopting a conservative approach by assuming that the diffusion coefficient D_a remains constant over time and $C_{crit} = 0.5\%$ for individual concrete cores onset of reinforcement corrosion would occur within -7 to $+38$ years.

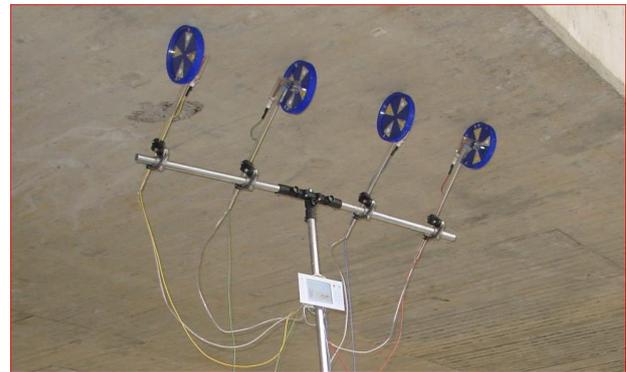
Fig. 4. Potential mapping executed on the floor of a bridge element using 4 potential wheels in parallel.

Generally, the potential values recorded were less negative than -200mV (vs Cu/CuSO_4) whereas resistivity measurements performed at the concrete surface generally demonstrated values well in excess of $500\Omega\text{m}$ (equal to $50\text{k}\Omega\text{cm}$). Consequently, none of these investigations indicated locations clearly suspect of reinforcement corrosion. This interpretation was also supported by the absence of any damage on the concrete surfaces investigated.

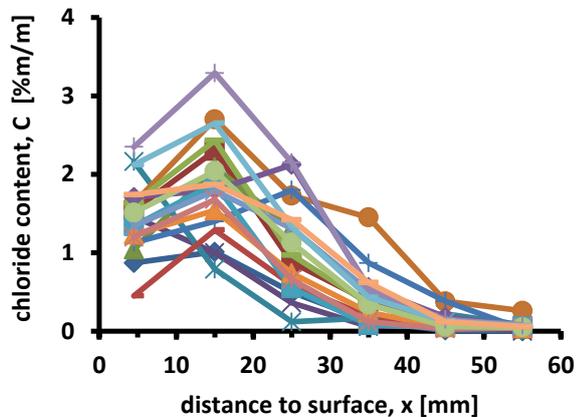
Fig. 5. Measured chloride profiles (2016) in the walls of the box girder bridge after 32 years of exposure (windward side).

With respect to onset of corrosion the chloride contents found at the level of the reinforcing steel, $x = c$, are relevant. According to the results of the regression analysis the chloride content at $x = 40\text{mm}$ range from 0.05% to 0.84% with an average of 0.29%. However, these values achieved through regression analysis are generally higher than was actually measured at depths between 35 and 55mm.

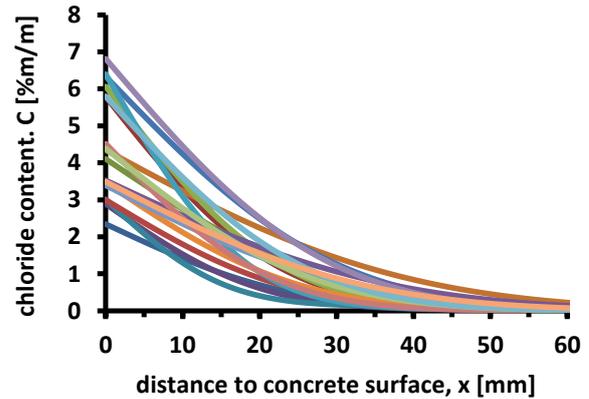
Fig. 6. Fitted chloride profiles (2016) in the walls of the box girder bridge after 18 years of exposure (windward side).

The values obtained through regression analysis for $C_{s,fit}$ ranged from 2.3 to 6.8% with an average of 4.4% (m/m cement), whereas the magnitude of $C_{i,fit}$ was almost 0. For $D_{a,fit}$ a minimum value of $2.3\text{mm}^2/\text{yr}$ ($0.07 \cdot 10^{-12}\text{m}^2/\text{s}$) and a maximum value of $14.8\text{mm}^2/\text{yr}$ ($0.47 \cdot 10^{-12}\text{m}^2/\text{s}$) were derived, whereas the average value amounted to $7.1\text{mm}^2/\text{yr}$ ($0.23 \cdot 10^{-12}\text{m}^2/\text{s}$).

Comparing the average values obtained for $D_{a,fit}$ at $t_{insp1} = 18\text{yr}$ and at $t_{insp2} = 32\text{yr}$ the magnitude of the ageing factor was calculated to be $n \approx 0.78$. This value is much higher than $n = 0.45$ which is reported in [3] as an average value for concrete produced with CEM III/B exposed to a marine environment.

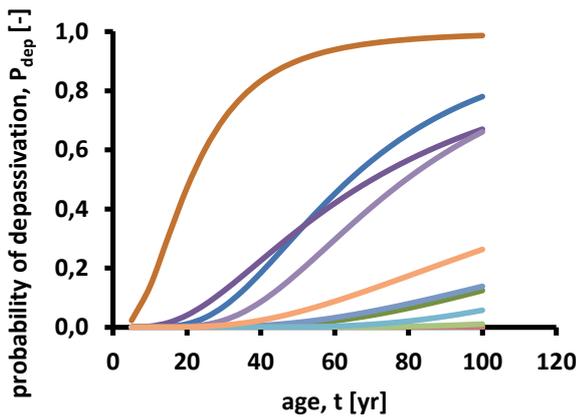
Fig. 8. Development of probability of depassivation for individual chloride profiles according to input values adopted for the “realistic scenario”.

However, even for the results according to the “realistic scenario”, the conclusion of these predictive calculations is that localised onset of corrosion may start within less than a decade after the second inspection in 2016. On the other hand, in the area of the worst chloride profile found in the 2016 inspections no evidence of active reinforcement corrosion was found, although the

probabilistic calculations resulted in a 78% probability of depassivation being present.

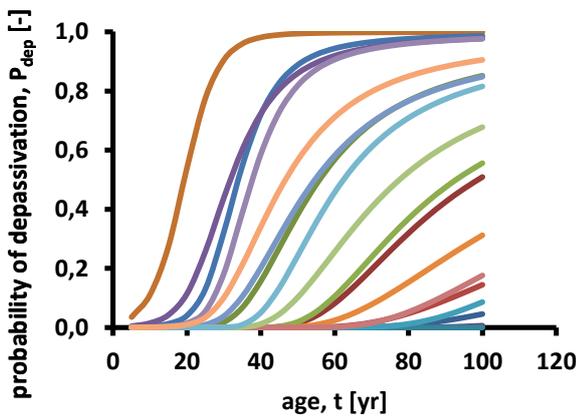
Fig. 9. Development of probability of depassivation for individual chloride profiles according to input values for the “fib 34 scenario”.
