ASR: Practical investigative techniques and field monitoring systems used to assess ASR for service life modeling.

Irene Matteini^{1,*}, Paul Noyce², Gina Crevello³

¹ Echem Consultants, Technical Operation Manager, New York, USA

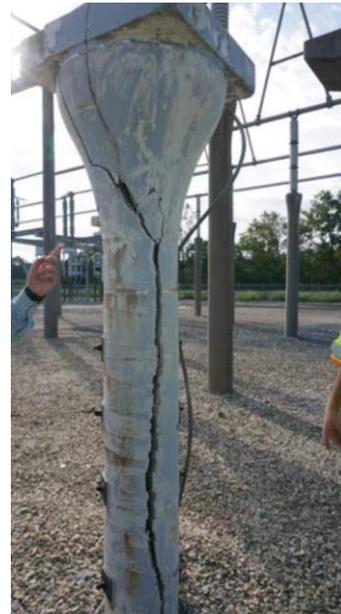
The poles, originally installed with a projected service life of 100 years, represent a critical support structure for the power plants. The structures, while still erected, have been suffering from several modes of concrete and material failure overtime as shown in Fig. 6.

Fig. 6 Image of one pole used for this investigation. Courtesy of Echem Consultants.

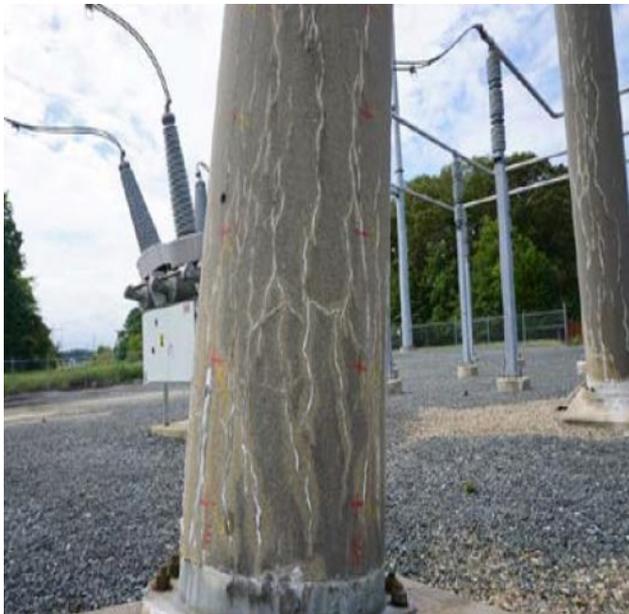
The structures appeared in poor condition showing parallel hairline cracks and map cracking along their entire elevation. In addition, gel exudation was visible on the surface as shown in Fig. 8.

Fig. 8 Image showing ASR mapping cracking and whitish gel leaching at the bottom of one of the pole. Courtesy of Echem Consultants.

As a result of the petrographic analysis, it was determined that Alkali-Silica Reaction was the root cause of the concrete deterioration of these structures.

Multiple aggregate types utilized in the original mix design are known to be unstable in alkaline environments such as opal, and chert. Visible micro-cracking appeared in several of the aggregates showing gel exudation. In addition, a sufficient level of moisture was also detected due to a high water table on site.

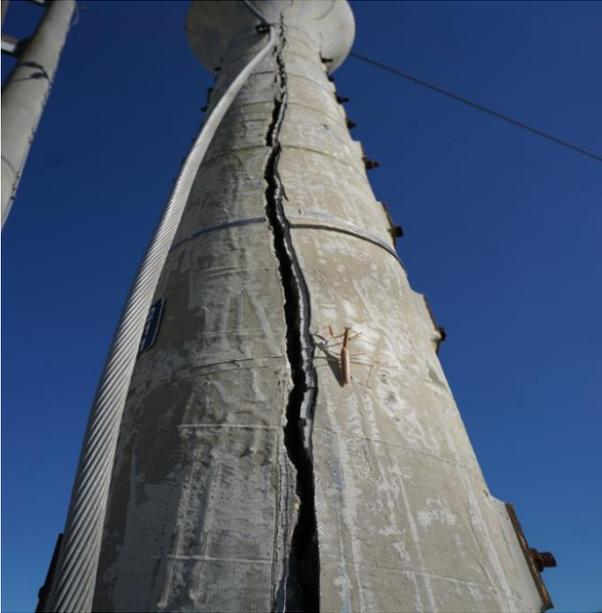
Another unanswered question in regard to this case study is related to the location of the ground wire and its role in the ASR Reaction. As described before, each pole has a ground wire for lightning protection and ground fault dissipation. This ground wire is bonded to the substation grounding system and runs for the entire height of the structure which is discontinuous to the main steel reinforcement. The ground wire has the potential to generate an electromagnetic field which could have played a role in the degree of this reaction given the size of the cracks that appear on the pole. In many of the poles, it was noted that the largest cracks, which developed for the entire height of these structures, occurred close to a ground wire as shown in Fig. 9.

Fig. 9 Image showing a detail of one of the poles where the ground wire is located close to a large crack which extended for the entire height of the pole. Courtesy of Echem Consultants.

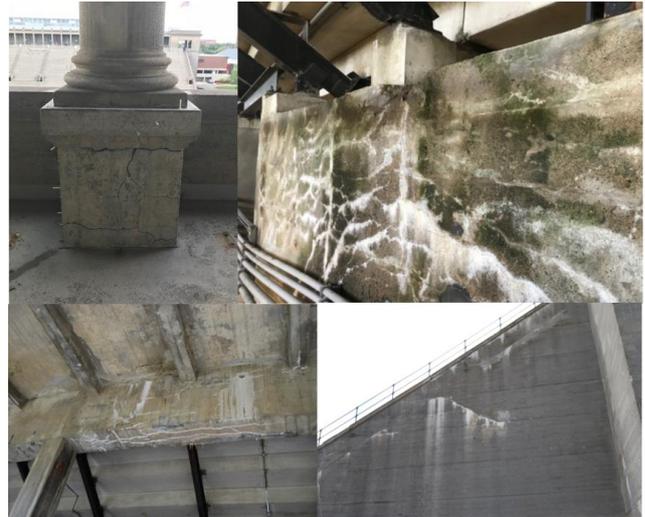
This structure has been suffering from ASR for decades with numerous consultants and engineers working on it overtime. Multiple petrographic examinations have reported the presence of reactive aggregates in the cement paste, attributing the main cause of deterioration to ASR. Several components of the structure have been suffering from it including columns, beams, and the main exterior arches as shown in Fig. 11.

Fig. 11 ASR problem visible in structural component of the stadium. Echem Consultants.

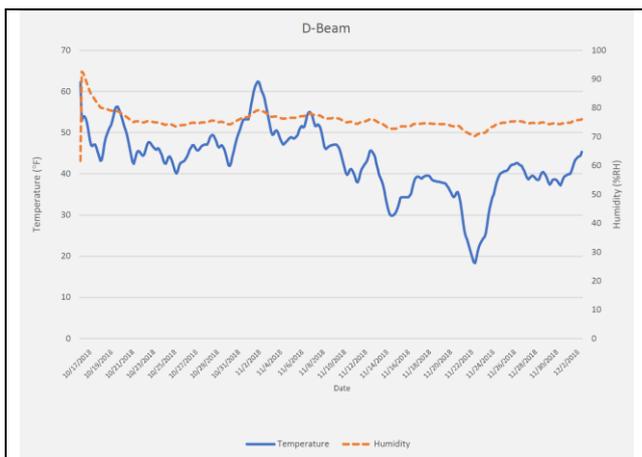
At this time, the data collected so far shows high constant level of moisture within the concrete as shown in Fig. 13. In addition, the humidity level recorded was not influenced by the atmospheric condition as it remained reasonably constant inside the concrete. This also supports the visible sign of ASR on the surface.

The majority of the structure is exposed to the elements with limited water-proofing. As moisture plays a fundamental role within the ASR, this demonstrates a long-term issue.

Fig. 13 Graph of Temperature/Humidity sensor at beam location. Courtesy of Echem Consultants.
