# Structural condition assessment of a reinforced concrete driveway

**Abstract.** The reinforced concrete structure of a driveway built in the eighties of the 20<sup>th</sup> century is under consideration. It is a single-storey structure with a length of approx. 66.00 m, made in the form of a reinforced concrete skeletal structure, consisting of 7 frames with cantilevers, spaced at 9.00 m: 3 frames in the horizontal part of the driveway are three-span ones, and 4 in the sloping part are single-span frames. The driveway frame main beams have a rectangular cross-section and are based on pillars that have been placed on the spread footing - these elements form a monolithic structure. Prefabricated reinforced concrete hollow floor plates were laid on them in the central part of the driveway, and in the outer parts the driveway floor was made of hollow clay slab blocks (Ackerman type). At the time of investigation, the upper layers of the driveway consisted of a surface waterproofing layer, a concrete slab of approx. 10 cm thickness made on a 1 cm sand layer. However, no internal waterproofing layer was found as was in the original design. The paper describes the process of determinin

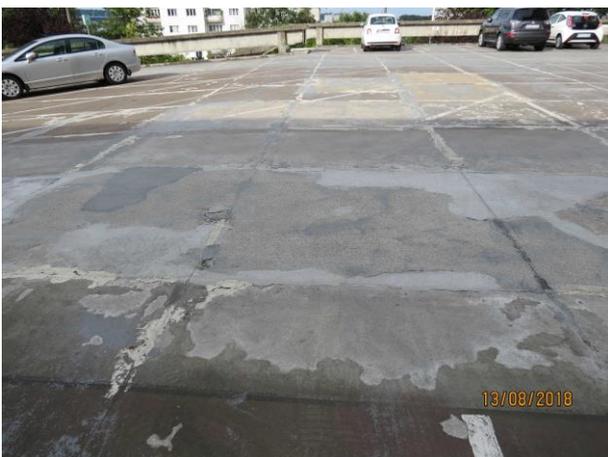
At the time of conducting the assessment, the upper pavement layer at the whole surface of the driveway was protected with different kinds of waterproofing materials as the owner tried to find out the best solution to prevent the continuous leakage of rainwater and melted snow in order to stop concrete destruction (Fig. 10).

**Fig. 10.** Different protection layers on driveway surface.

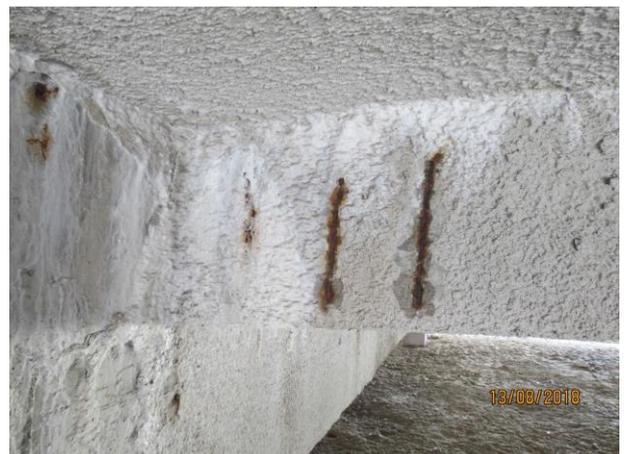
1. Spalling on the surfaces of reinforced concrete elements (Fig. 11).
2. Local surface destruction and material losses due to corrosion of bars and reinforcement due to insufficient thickness of concrete cover, especially for stirrups (Fig. 11).

**Fig. 11.** Spalling and lack of proper rebar cover.

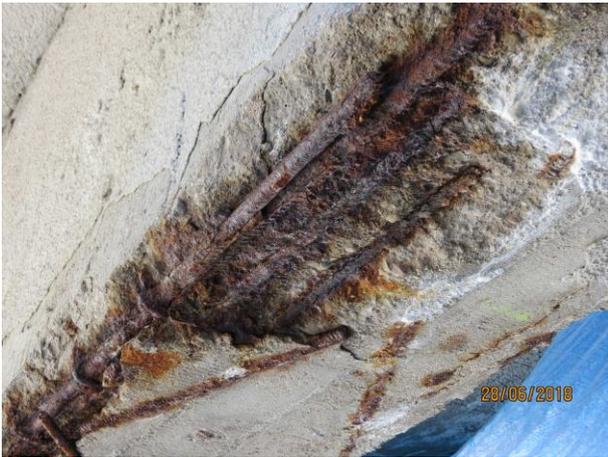
3. Local corrosion damage (defects in material) of the exposed main reinforcement bars connected with the exposure of the reinforcement cover (Fig. 12).

**Fig. 12.** Reinforcement corrosion.

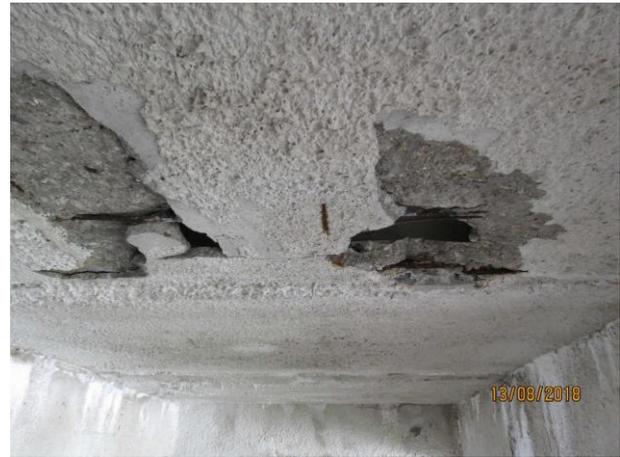
5. Local damage of hollow-core slabs (dropping of lower plate fragments) and corrosion damage of exposed reinforcement (delamination and loosening of concrete lagging as a result of freezing water penetrating through the leaky surface) (Fig. 14).

**Fig. 14.** Destruction of prefabricated hollow slabs.

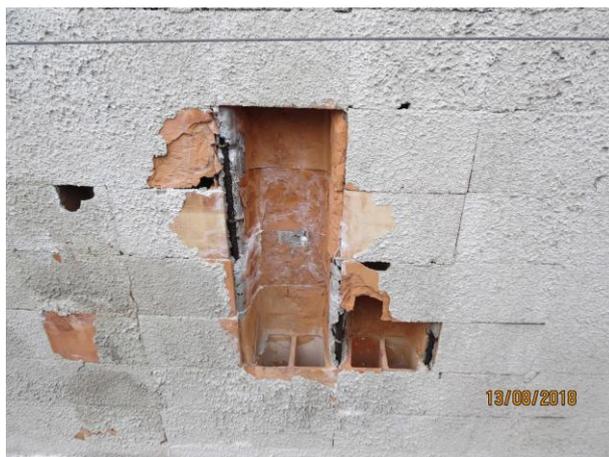
4. Local losses of the material of the Ackerman blocks (dropping of the lower parts of blocks) and corrosion damage (destruction and loss) of the exposed reinforcement (delamination and cracking of the ceramic as a result of freezing water penetrating the leaky surface) (Fig. 13).

**Fig. 13.** Destruction of Ackerman hollow clay blocks slab.

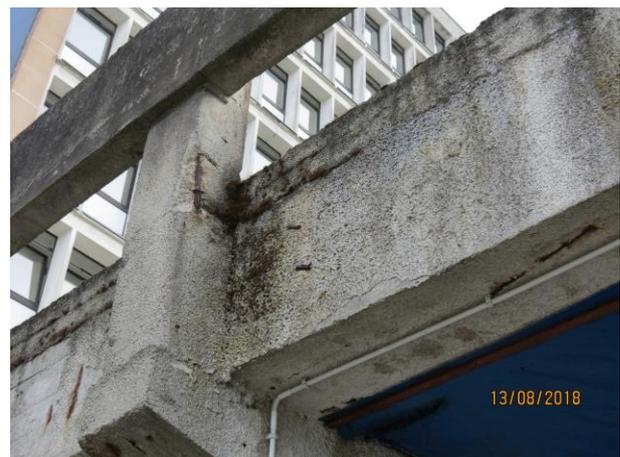
**Fig. 15.** Destruction due to organic contamination.

6. Local cavities and delamination of concrete, corrosive damage (destruction and defects of material) of reinforcement bars in balustrades.
7. Delamination (de-bonding) at the edge contact of the end ribs and the curb of the driveway plate.
8. Organic contamination (overgrowing with mosses), resulting in the destruction of plaster and surface concrete (Fig. 15).
9. Freeze-thaw destruction of the driveway surface and material losses and delamination of the pavement surface (Fig. 16).
10. Prolonged leaching of concrete material components as a result of water penetration – water stains and stalactites on the lower surfaces of plates as well on frames and ribs surfaces (Fig. 17).

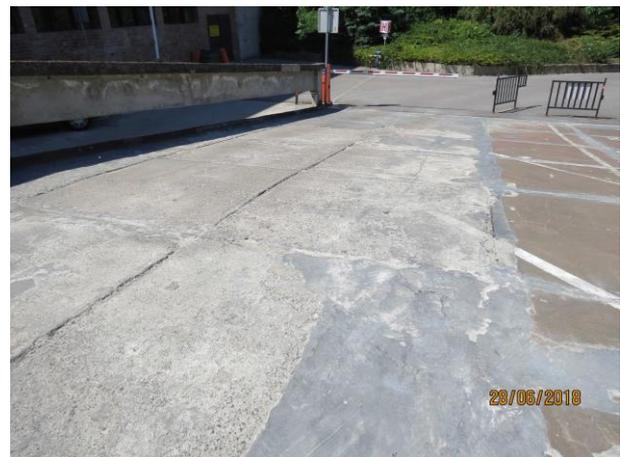
**Fig. 16.** Destruction of driveway pavement surface.

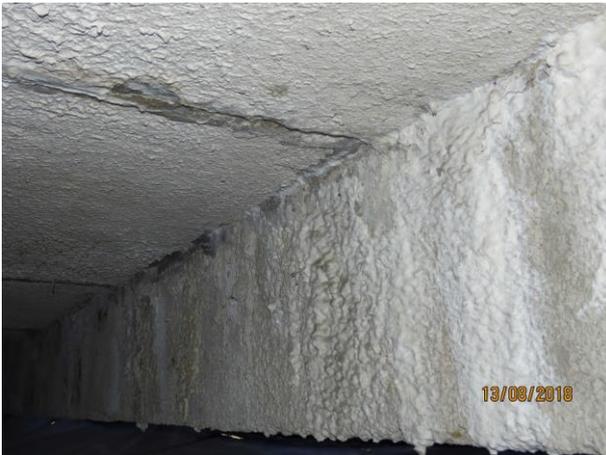
Fig. 17. Salt infiltrations on the surface of structural elements.

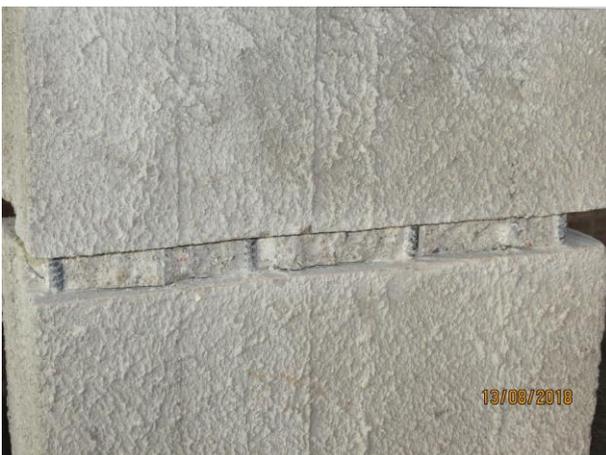
In order to verify the structural reinforcement, its identification was carried out at 16 points: in 5 new pits and in 11 places with damaged concrete cover where the reinforcement was exposed. A PMD10 Bosch metal detector was used to determine the reinforcement situation and a YATO YT-7201 electronic caliper was used to measure reinforcement diameters. Generally, in all the examination points, the reinforcement was as designed. Moreover, in new reinforcement openings no corrosion of the reinforcement was revealed (Fig. 18). However, in previously made openings and in the places where the reinforcement was exposed due to damage of concrete cover, corrosion of the reinforcement was found, with varying intensity (Fig. 19).

Fig. 18. Reinforcement checking opening in column.

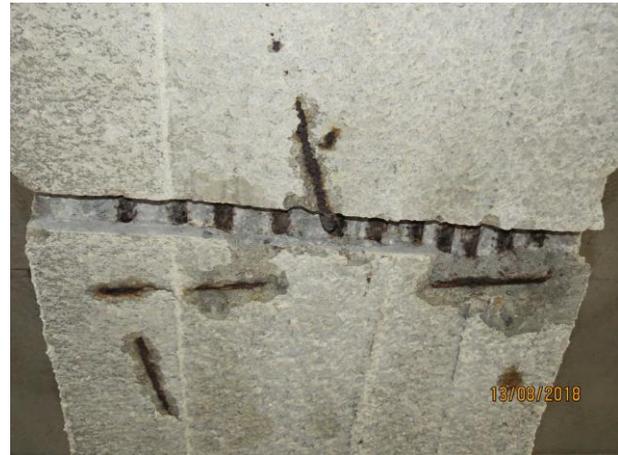
Fig. 19. Reinforcement checking opening in frame girder.

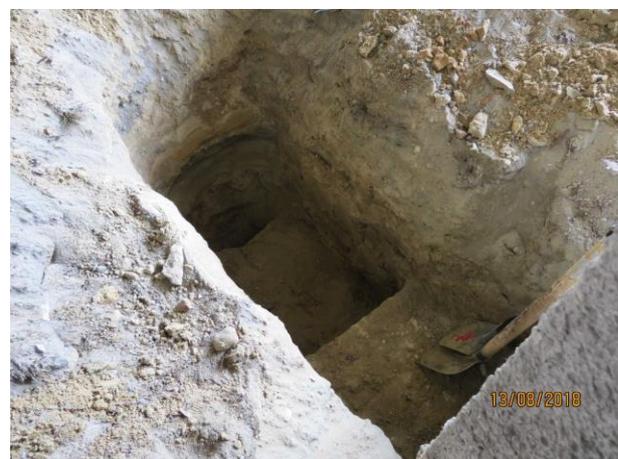
In order to verify the geometry of the foundations of the main columns of the supporting frames, a trench was made (Fig. 20). Measurements showed that the foundation had different dimensions than those assumed in the project [3]. In view of the above, the dimensions from the inventory were used to calculate the bearing capacity of the foundations.

Fig. 20. Foundation inventory.
