Concrete repair challenges in the Middle East

Rene Brueckner*

Mott MacDonald, 10 Temple Back, Bristol, BS1 6FL, UK

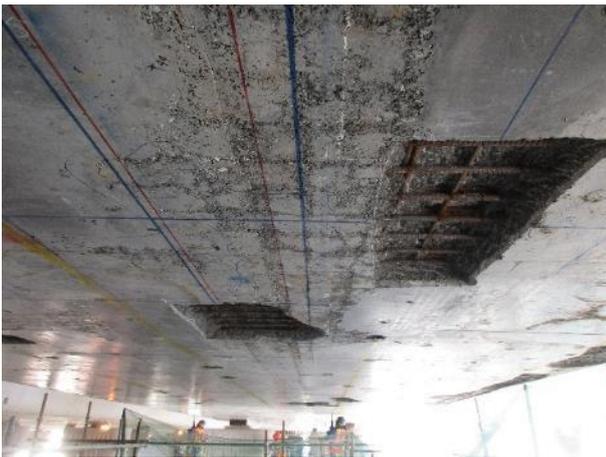
The defects were mainly located below the five void formers of the voided post-tensioned widening slabs. Figure 2 shows a general view of the most-affected area of one span where the lines of the five. void formers are marked on the soffit (yellow line).

Fig.2. General condition of soffit

Honeycombing was identified over a large area but the extent of the honeycombing into the slab varied significantly. Near-surface honeycombing defects were observed on the majority of the soffit whereas honeycombing extending beyond the lowest reinforcement layer was mainly observed below the void formers (Figure 2 to Figure 4). The maximum extent of honeycombing into the slab was found to be approx. 180mm, i.e. up to the bottom of the void formers. The honeycombing resulted locally in a lack of bond around the reinforcement but there was no honeycombing below the post-tensioning ducts away from the void formers. The soffit also suffered from an excessive amount of debris that was not cleaned before the concrete pour and

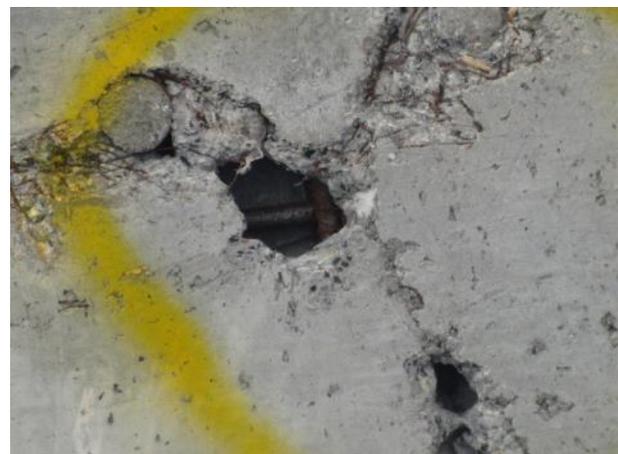
Fig. 3. Honeycombing with visible reinforcement

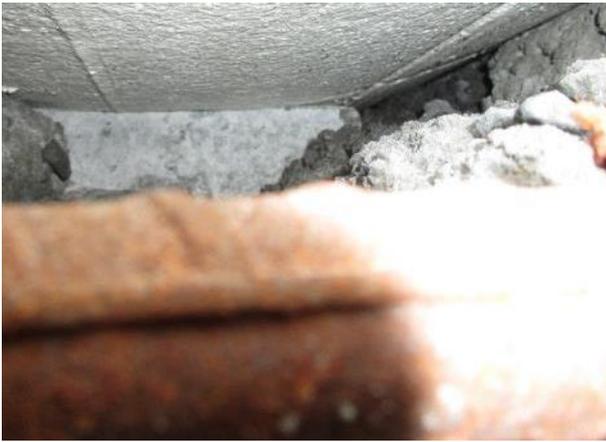
Cold joints were found between the 1st and 2nd pour layer which is located approximately between the two lower layers of transverse reinforcement or between bottom reinforcement and void former. A gap was observed between the void formers and the lowest reinforcement in several locations, reducing the internal concrete cover to the lowest reinforcement. The gap was mainly encountered where the bottom spacers for the void former (concrete blocks: 200x200x55mm³) were located at a distance of 100mm from the joints of void formers.

It was observed that the size of the gap varied and that there was a small gap potentially along the entire length of the void formers. The latter does not reduce the protection by the internal concrete cover as it was mainly a result of the void former floating up during concreting and the specified internal cover was obtained.

Fig.4. Void below void former and non-embedded rebar

The gaps below the void formers and any interconnected voids within the bottom rebar layer were repaired by injection of a low viscosity cementitious grout that was able to flow below and around the void former.

The injection methodology included an initial investigation to establish a gap and connectivity below the void former by injecting water as initial repairs showed that curing compound egressed at various locations indication sub-surface interconnected voids and honeycombing. Following trials, injection packers were installed at a spacing of 300mm below the centre line of the void formers, sealed and grout was injected by utilising an injection pressure up to 1 bar at the injection port. The effectiveness and pressure limits of the injection were determined prior to commencement of the works using mock-ups to prevent the deformation / compression of the void former. Injection pressures in excess of 2 bar were assessed to compress the polystyrene void formers by more than 10% causing an increase of dead load and affecting the design load assumptions.

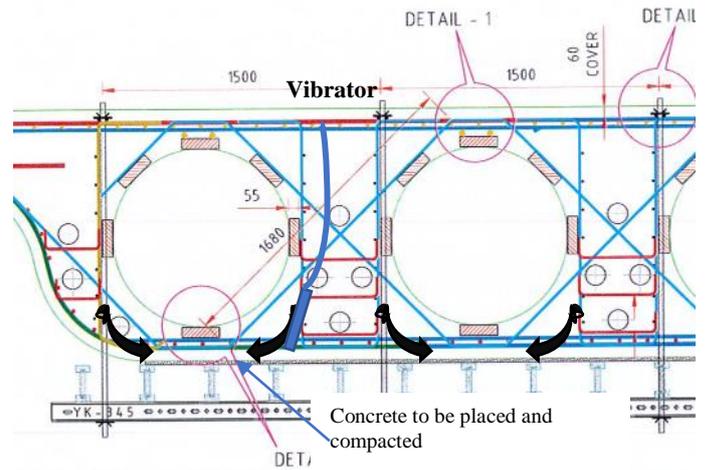
Fig.6. Cross-sectional arrangement

The formation of a cold joint between the two layers was prevented below the ducts; however, cold joints were identified under the void formers. This was a result of the arrangement of the void formers, spacers, post-tensioning ducts, reinforcement bars that were spaced at 125mm and 150mm and the delayed time between the two layers in addition to the partially reduced consistency of the concrete. The arrangement made it difficult to insert vibrating pokers and compact the concrete below the void formers whereas compaction around the ducts was achievable, as indicated in Figure 6 and shown in Figure 7, and also discussed by Grantham [1].

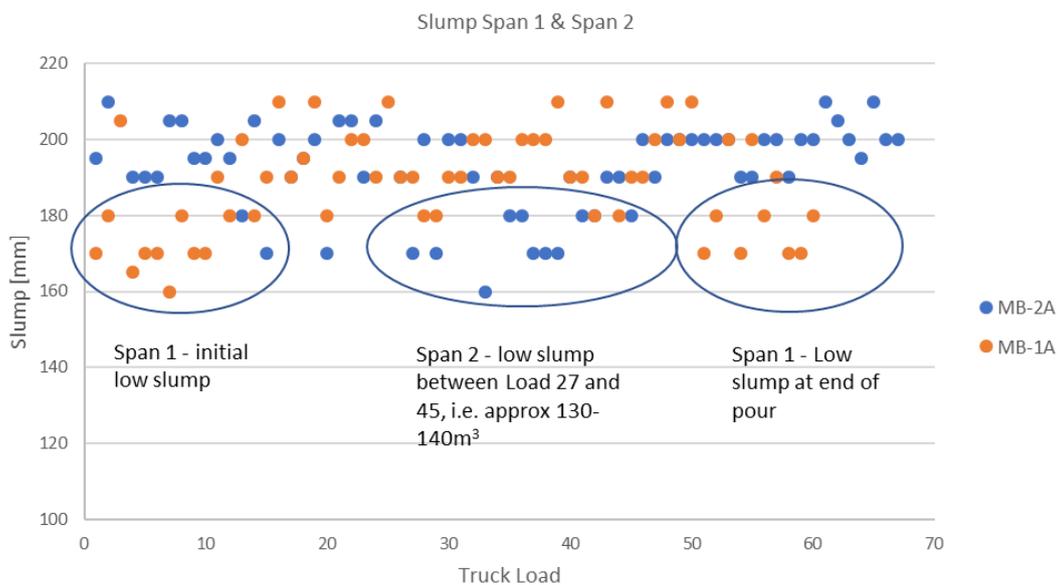
The root cause of the defects was identified to be a combination of varying concrete consistency and concreting / compaction operations. The consistency of the C45/55-10mm concrete (OPC+35% PFA+7.5% MS), as delivered to site, ranged from 160mm to 210mm with periods of lower slumps (130-140m³ of 490m³), as was observed through compaction issues at the time of the pour and can be seen in Figure 5. Such consistency may be considered suitable provided that the concrete is fully compactable in all locations and the pour layers are interlocked during compaction without the risk of cold joint formation.

Fig.5. Slump of Slab 1 and Slab 2 pours

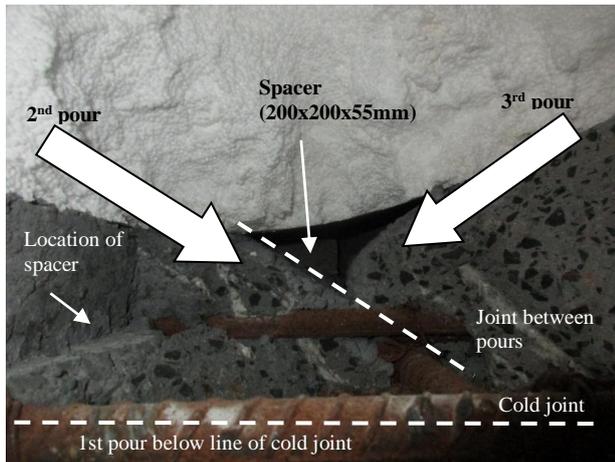
Fig. 7. Root cause schematic

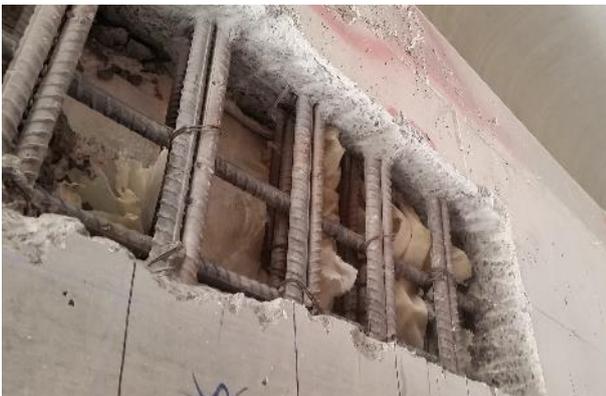
The difficulties encountered during the repairs of the first two strips and observations that the concrete was acceptable below the post-tensioning ducts and outside the areas of the worst visible surface defects led to an optimisation of the repair procedure. Further verifications using only smaller strip break-outs of 1.5m x 0.3m at representative locations along void former lines 1, 3 and 5 were carried out. The 1.5m x 0.3m strip break-outs comprised a hit and miss strategy of three break-outs covering a length of 7.5m along one line. Signs of honeycombing around the reinforcement and up to the void former required continuous hit and miss break-outs including removal of all honeycombed concrete under all void former lines of the respective span. The three hit and miss trials, that were undertaken at the worst visually affected areas without obvious full depth honeycombing, confirmed that full removal of the deck soffits and large strip break-outs below each void former could be avoided. However, this method identified the presence of a large cast-in PE sheet above the bottom reinforcement layer, see Figure 10.

Fig.10. Debris below void former

Nevertheless, any areas showing visible surface defects and cast-in debris were removed and extended to sound substrate if required. This resulted in both shallow and deep break-outs requiring repair using Method A or hand applied overhead application.
