Structural failure of old reinforced concrete river wharf

Abstract. According to the archival documentation the river harbour wharf was constructed around 1912. The quay was divided into 6 separated segments with a length of 32.0 m each. The structure of the wharf consists of the reinforced concrete frames situated perpendicularly to the riverbed. At ground level, the frames are connected by a reinforced concrete deck and longitudinal beams, located along the side of the river and the quay. The frames are also connected along the riverside by the concrete cap situated at the top of the retaining wall made of prefabricated panels and embedded in the bottom of the river. That wall constitutes a direct strengthening and protection of the embankment against the influence of the flowing river water. Basing on the performed inventory inspections, material examination, structural calculations and hydro-geotechnical analyses, the main reasons for the failure of the reinforced concrete wharf of the Odra River were defined. They were: very poor technical condition of the structure, lack of stabilizing anchors at the level of the wharf structure frames, and sudden fluctuations in water level

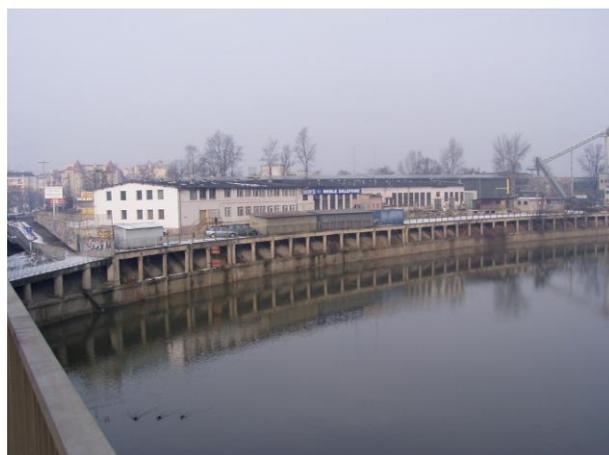
Fig. 2. General view of the wharf before failure.

In the past, the wharf served, among other, as a dockside quay for a brewery located nearby. In recent years, the wharf has been sporadically used for mooring barges. Even though the Odra embankments have been assessed [1] and renovated in recent years over a considerable length, the considered part was left without any technical intervention, repair or protection (Fig. 2).

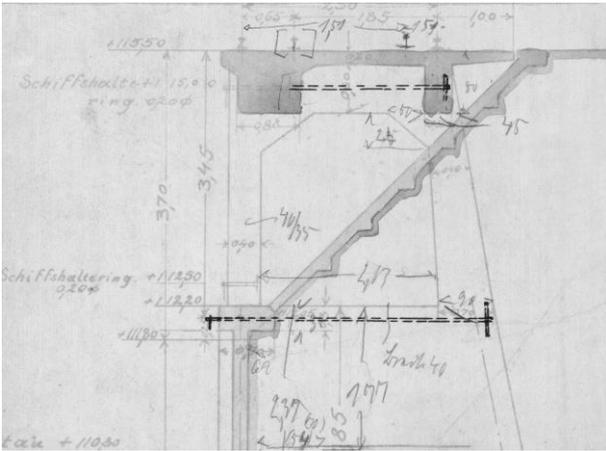
Fig. 6. Archival drawing of the frame with freehand sketches.

In two of the archival drawings it can be seen with the freehand sketches, that the reinforced concrete frames were to be additionally stabilized with steel anchors. In Fig. 3 it is designed by use of a 40 mm diameter rod at the level of the top of the cap covering the retaining walls (Fig. 3) and fixed in blocks located out of the embankment. The second proposal (Fig. 6) consists of inserting additional steel rods at two levels: between upper longitudinal beams and between columns at the level of cap over the retaining wall.

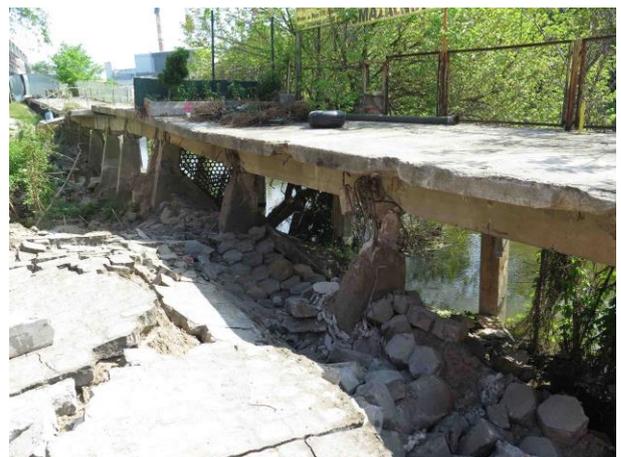
In May 2017 a structural and constructional failure of the reinforced concrete of the wharf occurred over a length of over 100 m, mainly in the area of segments IV, V and VI. At those parts the embankment sloped down towards the river bed and its construction was locally completely destroyed (Fig. 8).

Fig. 8. General view of the destroyed embankment structure.

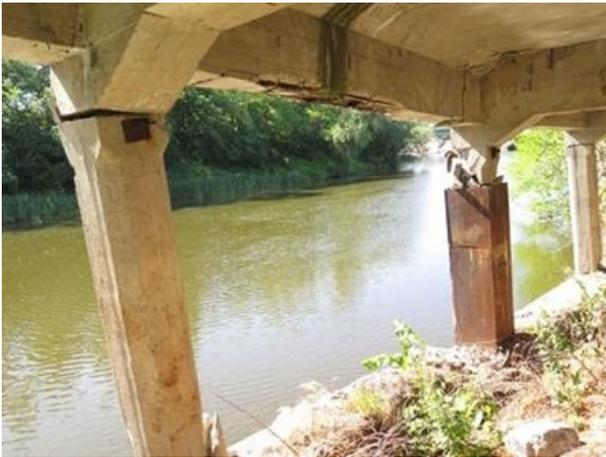
Fig. 9. View of the displaced wharf structure.

During the inspection made immediately after the failure it was also observed that the upper part of the wharf structure experienced about 15 cm displacement towards the river as well as along the shoreline, which was evident in the displacements experienced by the pillars and the reinforcement of columns and beams (Fig. 9).

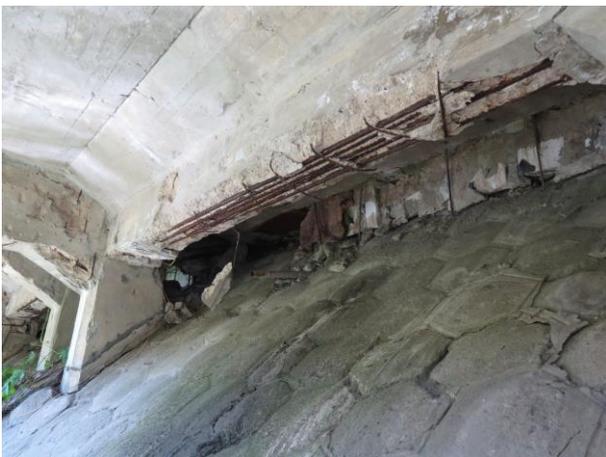
Fig. 10. Corrosion of concrete cover and reinforcement.

Already in the study from 2003 it had been indicated that the technical condition of the wharf was bad and further postponement of its repair might lead to a failure. Since then, no significant repairs had been carried out in the waterfront area and its technical condition had significantly deteriorated (Figs 10 & 11).

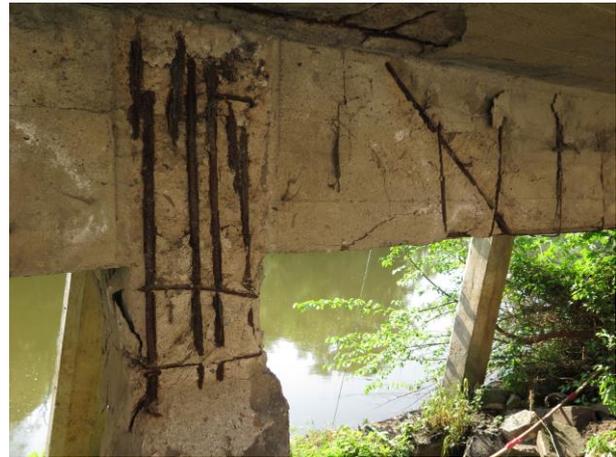
Fig. 11. Corrosion of concrete cover and reinforcement.

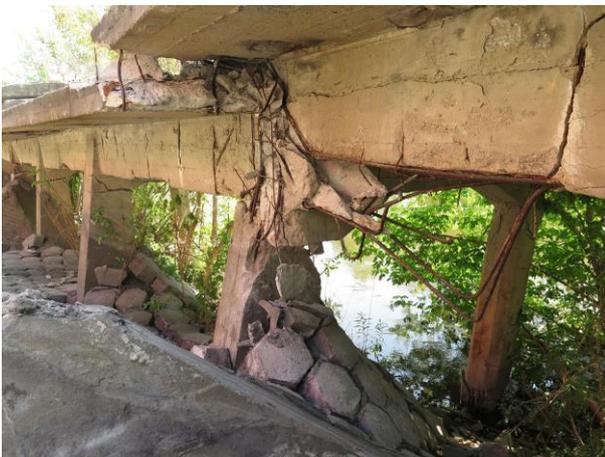
During the failure a great part of the embankment sloped into the river. Geodesic measurements of its shape showed that it moved at the depth of about 3 to 4 meters. Simultaneously, also the reinforced concrete structure of the wharf moved towards the river causing massive cracking of the structural elements (Figs 12 & 13) along with pulling out the reinforcement at the connection points of the posts and the frame girders (Figs 14).

Fig. 12. Damaged wharf structure.

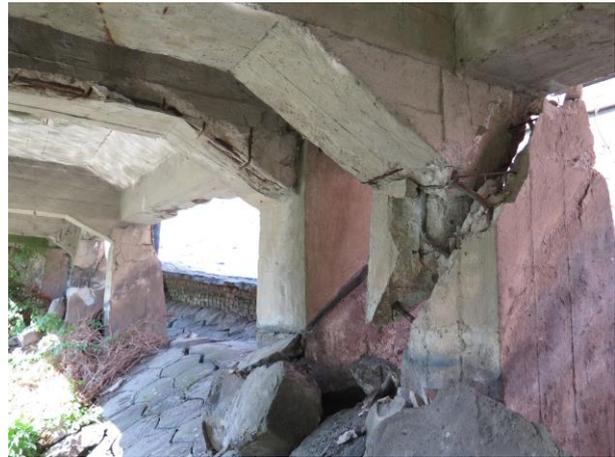
Fig. 13. Damaged wharf structure.

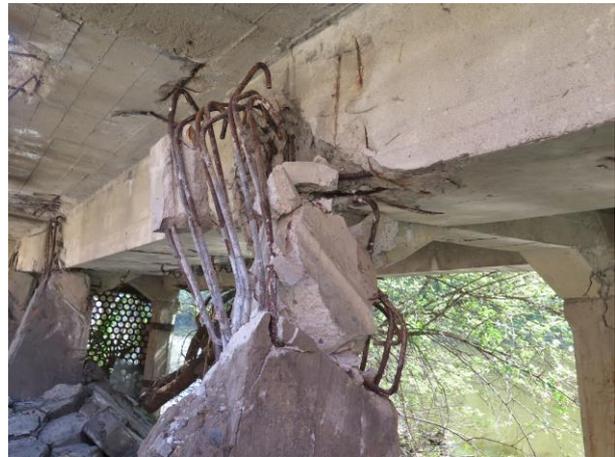
Fig. 14. Column rebar torn out of the frame.

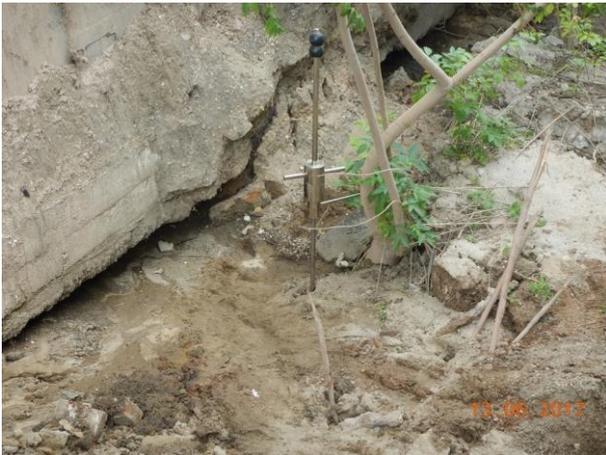
Due to covering of the disaster area with fragments of the destroyed construction, the test could only be carried out in two available places (Fig. 15). Soil research showed that under the 2 m thick layer of loose embankment there are fine compacted sands with a degree of density $I_D = 0.46$ to 0.59 . Results of those tests were used to define embankment soil model for structural calculations.

Fig. 15. Soil examination.
