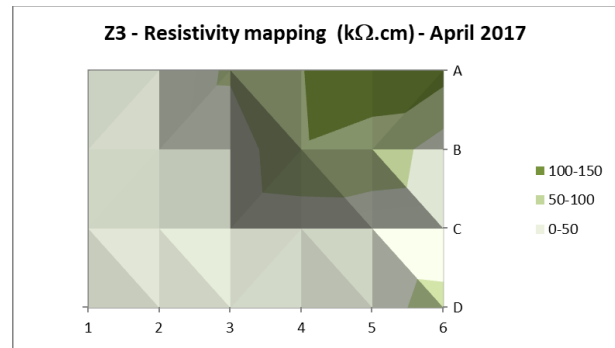
Fig. 5. Resistivity mapping obtained on zone 3 in April 2017.

The first map of resistivity performed in April 2017 on the underside of the southern balcony (Fig. 5), was indicative of an overall moderate risk of corrosion according to the RILEM recommendation [10], with

values ranging between 9 and 124 kΩ.cm and an average of 43 kΩ.cm.

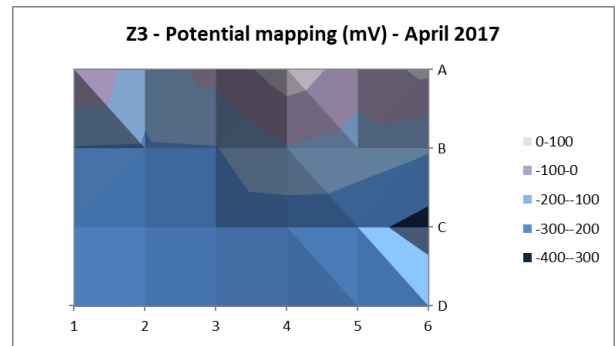
Fig. 6. Potential mapping obtained on zone 3 in April 2017.

On the potential map (Fig. 6) significant gradients [11] (average value: -196mV, maximum gradient: 160mV) could be observed on the lower zone of the map and especially on the point C6.

Polarization resistance measurements were performed on two points of the lower part of the zone and were indicative of a high level of corrosion according to the RILEM Recommendation [12] (C3: 1.550μA/cm² ; C4: 1.213μA/cm²).

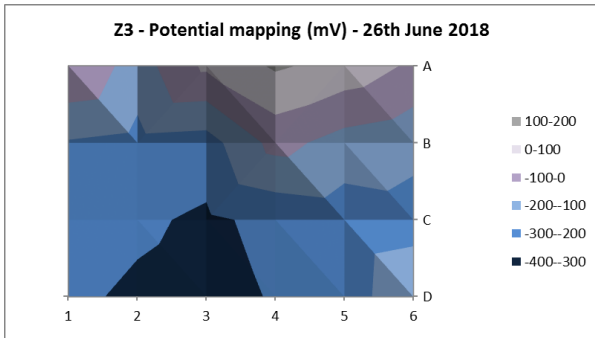
Fig. 7. Potential mapping obtained on zone 3 on June 2018.

On the following three series of measurements performed in March, June and October 2018, almost similar resistivity and potential maps were observed, with nevertheless an increase of corrosion risk on the lower part of the beam (Fig. 7). A clear correlation could be observed between the evolution of the relative humidity in the air and the resistivity and potential values. Thus, when the relative humidity decreases, the resistivity increases and the potentials tend to less electronegative values (Fig. 8 and 9).

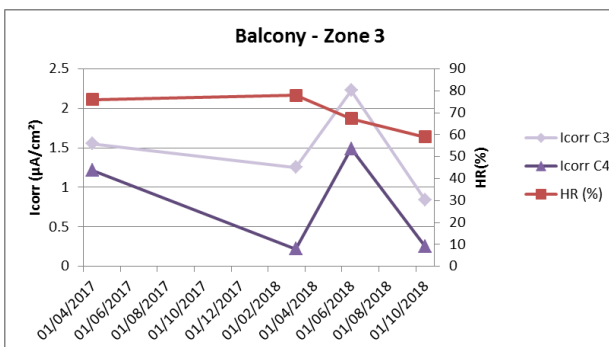
Fig. 10. Evolution of the average corrosion current in zone 3 and of the relative humidity in the air.

The same tendencies were observed for the corrosion currents except in June 2018, where the higher values were obtained (Fig. 10). This could be linked to connection difficulties encountered during the tests that lead to a repetition of the measurements and to an increased moistening of the concrete in points C3 and C4. But during the period of measurement, that lasted one year and a half, the corrosion current on the balcony was indicative of a corrosion level varying between moderate and high.

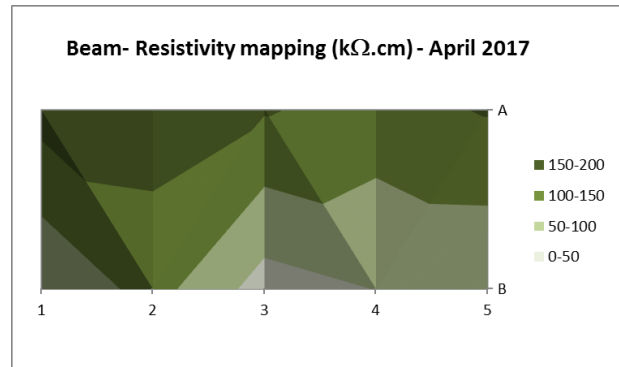
Fig. 11. Resistivity mapping obtained on the beam on April 2017.

On the beam, the resistivity measured was a little higher than in zone 3 and indicative of a risk of corrosion varying from negligible [10] on the upper part of the beam, to moderate on the lower part (Fig. 11). The values ranged between 28 and 176 kΩ.cm and an average of 109 kΩ.cm.

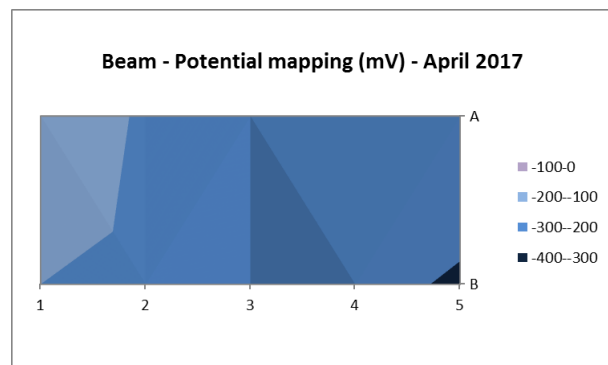
Fig. 12. Potential mapping obtained on the beam in April 2017.

The potential map (Fig. 12) was consistent with the resistivity mapping, indicating a probable risk of corrosion [11] on the lower part of the beam (average value: -230mV, maximum gradient: 95mV). Nevertheless, as for zone 3, it is to be noticed that the potential values are not very electronegative for a concrete both carbonated and chloride polluted.

Polarization resistance measurements were performed at two locations identified on the potential map, on the lower part of the beam. They were indicative of a low level of corrosion [12] (B23: 0.140µA/cm²; C4: 0.204µA/cm²).

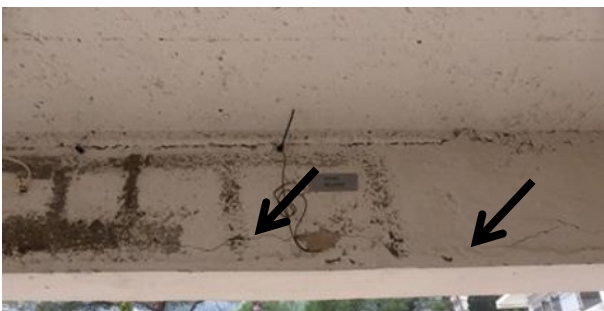
As for the balcony area, similar results were observed on the three following three series of measurements, with again a clear correlation between the evolution of the relative humidity in the air and that of the resistivity and potential (Fig. 13 and 14). If the corrosion currents measured at point B12 were also well correlated (Fig. 15) and indicative of a negligible level of corrosion, at point B23 a continuous increase of the corrosion current could be noticed, in correlation with the opening of a crack (Fig. 16).

Fig. 16. Opening of a crack on the beam in the vicinity of the measurement point B23.

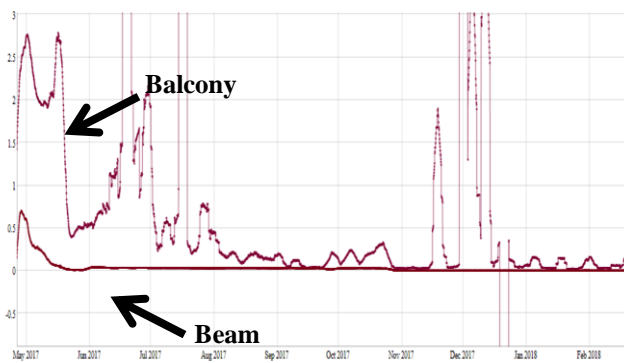
Fig. 20. Corrosion current ($\mu\text{A}/\text{cm}^2$) on the balcony and on the beam.

As the two zones monitored were protected from the rain, electrochemical monitoring was an issue. Effectively, the contact mortar used between the sensors and the concrete gradually dried and the measurements became impossible, quite rapidly for the beam and soon after for the balcony (Fig. 19). Nevertheless, the first data were consistent with the non-destructive testing, with corrosion current values lower in the beam than in the balcony (Fig. 20).
