Corrosion at low moisture content in both carbonated and chloride polluted concrete – Villa E-1027, a case study

Elisabeth Marie-Victoire^{1,*}, Myriam Bouichou²

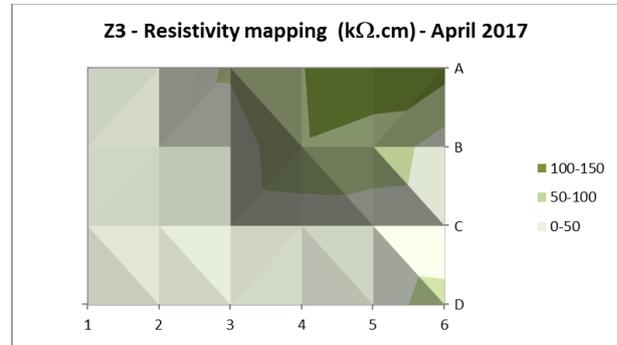
The first map of resistivity performed in April 2017 on the underside of the southern balcony (Fig. 5), was indicative of an overall moderate risk of corrosion according to the RILEM recommendation [10], with

values ranging between 9 and 124 kΩ.cm and an average of 43 kΩ.cm.

Fig. 5. Resistivity mapping obtained on zone 3 in April 2017.

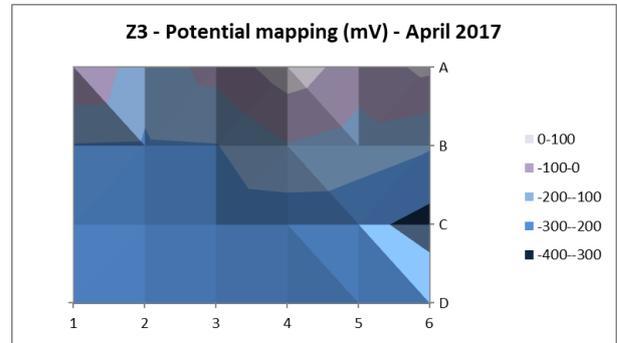
On the potential map (Fig. 6) significant gradients [11] (average value: -196mV, maximum gradient: 160mV) could be observed on the lower zone of the map and especially on the point C6.

Fig. 6. Potential mapping obtained on zone 3 in April 2017.

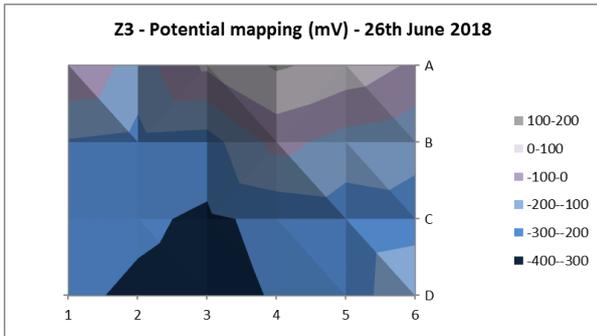
On the following three series of measurements performed in March, June and October 2018, almost similar resistivity and potential maps were observed, with nevertheless an increase of corrosion risk on the lower part of the beam (Fig. 7). A clear correlation could be observed between the evolution of the relative humidity in the air and the resistivity and potential values. Thus, when the relative humidity decreases, the resistivity increases and the potentials tend to less electronegative values (Fig. 8 and 9).

Fig. 7. Potential mapping obtained on zone 3 on June 2018.

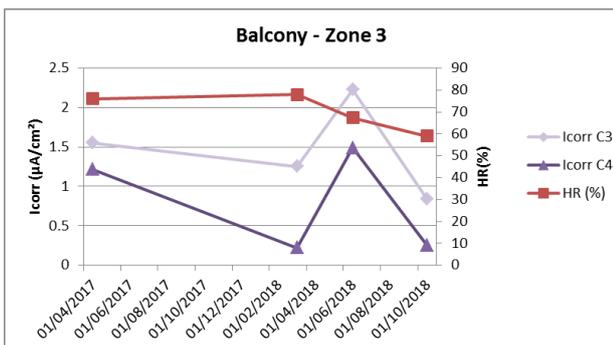
The same tendencies were observed for the corrosion currents except in June 2018, where the higher values were obtained (Fig. 10). This could be linked to connection difficulties encountered during the tests that lead to a repetition of the measurements and to an increased moistening of the concrete in points C3 and C4. But during the period of measurement, that lasted one year and a half, the corrosion current on the balcony was indicative of a corrosion level varying between moderate and high.

Fig. 10. Evolution of the average corrosion current in zone 3 and of the relative humidity in the air.

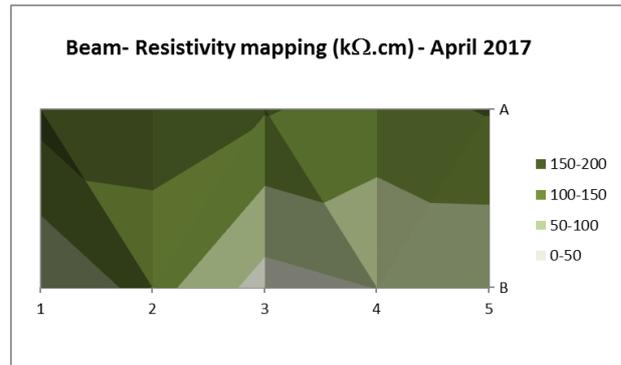
On the beam, the resistivity measured was a little higher than in zone 3 and indicative of a risk of corrosion varying from negligible [10] on the upper part of the beam, to moderate on the lower part (Fig. 11). The values ranged between 28 and 176 kΩ.cm and an average of 109 kΩ.cm.

Fig. 11. Resistivity mapping obtained on the beam on April 2017.

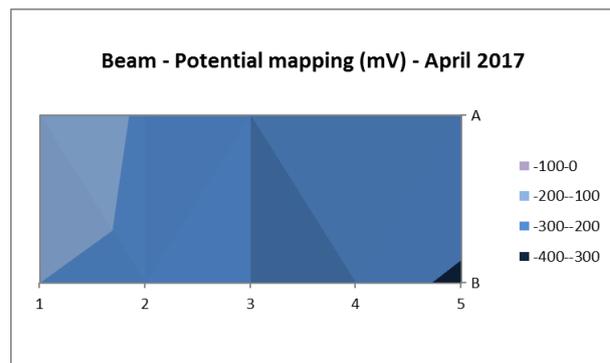
The potential map (Fig. 12) was consistent with the resistivity mapping, indicating a probable risk of corrosion [11] on the lower part of the beam (average value: -230mV, maximum gradient: 95mV). Nevertheless, as for zone 3, it is to be noticed that the potential values are not very electronegative for a concrete both carbonated and chloride polluted.

Fig. 12. Potential mapping obtained on the beam in April 2017.

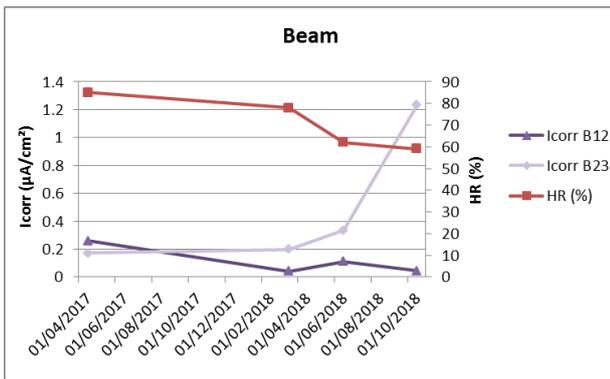
As for the balcony area, similar results were observed on the three following three series of measurements, with again a clear correlation between the evolution of the relative humidity in the air and that of the resistivity and potential (Fig. 13 and 14). If the corrosion currents measured at point B12 were also well correlated (Fig. 15) and indicative of a negligible level of corrosion, at point B23 a continuous increase of the corrosion current could be noticed, in correlation with the opening of a crack (Fig. 16).

Fig. 15. Evolution of the average corrosion current on the beam and of the relative humidity in the air.

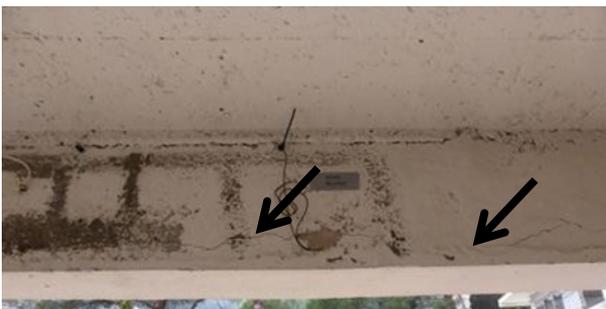
Fig. 16. Opening of a crack on the beam in the vicinity of the measurement point B23.

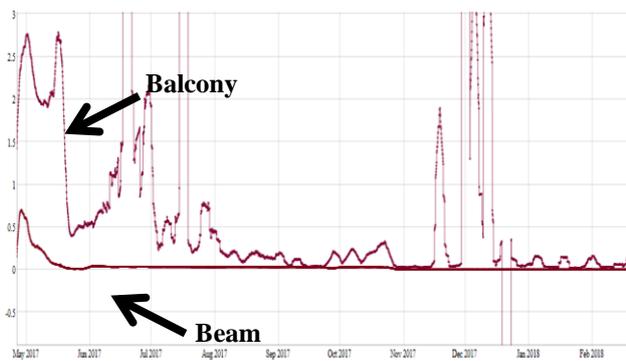
As the two zones monitored were protected from the rain, electrochemical monitoring was an issue. Effectively, the contact mortar used between the sensors and the concrete gradually dried and the measurements became impossible, quite rapidly for the beam and soon after for the balcony (Fig. 19). Nevertheless, the first data were consistent with the non-destructive testing, with corrosion current values lower in the beam than in the balcony (Fig. 20).

Fig. 20. Corrosion current ($\mu\text{A}/\text{cm}^2$) on the balcony and on the beam.
