Application of the complex parameter of strength and ductility to assess the state of the blades' material at different periods of operation

Abstract. The paper is devoted to the study of the material's condition of guide blades made of heat-resistant nickel alloy with different operating time. It is established that the structure of the blade material and their mechanical properties are not satisfactory for further operation. To recover the performance properties and structure of the blade material, several types of heat treatment were tested and the optimal one was chosen. The complex parameter of strength and plasticity is calculated and on its basis the estimation of degree of recovery of blade' material after heat treatment is carried out.

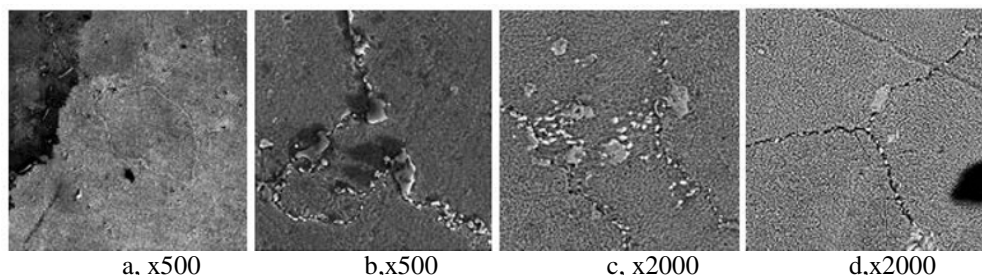
The microstructure (after 25773 hour) of the material trailing edge contains an invalid local allocations of needle carbides (needle length up to 35 microns). Small segregations of carbides $Me_{23}C_6$ are located at the grain boundaries of carbide MeC. The size of the

carbide phase at the grain boundaries varies from 0.5 to 8 microns. Large irregular carbide particles are contained both in the body of the grains of the nickel matrix and along their boundaries (fig. 1 a,b). It is known that the local formation of a large number of carbide particles causes depletion of close zones with carbon and refractory elements. Small particles of the γ' -intermetallic phase (~0,01 - 0,05 microns) have a spherical shape and are evenly distributed over the body of the grains. Partial dissolution and a change in the shape of the particles of γ' -phase are observed, which indicates a decrease in coherence between this phase and the base metal. The described changes occurring with the hardening phase can lead to a decrease in the mechanical properties of the alloy.

The analysis of the microstructure showed that the blade (after 28070 hour) material contains a large number of areas with accumulation of large carbides having a size of 10 to 15 microns. These areas are located mainly at the grain boundaries. The γ' - phase has an irregular “butterfly” shape, and its size is from 0.2 to 0.8 microns. Changes in the structure of the material occurred in all parts of the blade (feather and blade root) (fig. 1 d,c). The microhardness of the material after operation varies over the body of the blade and ranges from 3.7 to 5.7 GPa. Table 1 shows the mechanical properties of the material of the blades.

Fig. 1. Microstructure of the alloy of the guide blade after operation for 25773 hours (a, b) and 28070 hours (c - trailing edge; d - blade root).

Critical changes in the microstructure, a decrease in the mechanical properties of the blade’s material, as well as a large operating time (according to the operating instructions, the maximum operating time is 25000 hours) indicate the need for the use of recovery heat treatment.

Heat treatment was carried out to restore the structure. For machine parts made of nickel alloys, homogenization is used, during which the structure is stabilized and the degree of segregation is reduced, thus increasing the volume content of γ' -phase particles. During high-temperature aging, large γ' -phase particles dissolve. It should be noted that the choice of recovery heat treatment modes to achieve the optimal shape, size and distribution of particles of the hardening phase does not always lead to an improvement in mechanical properties. The formation of Me_6C carbide particles of an unfavorable lamellar form during homogenization at a temperature of 1210°C and further cooling practically eliminates the improvement of properties by controlling the structure of the γ' -phase [4,5,6].

Two modes of heat treatment were tested on the specimens, adjusted for the condition of the blade material after operation: №1: heating to 1200°C, 3 hours, air cooling; № 2: heating to 1200°C, 3 hours, cooling in the furnace.

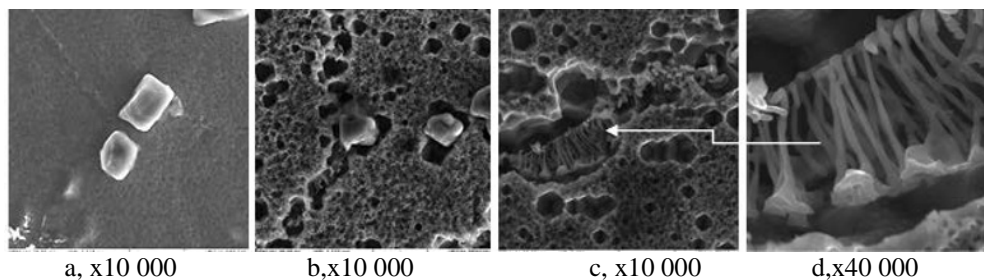
The use of mode №1 for the blade material (after 25773 hours of operation) led to a partial restoration of the microstructure: there was a size reduction of γ' -phase particles, dissolution of small carbides $Me_{23}C_6$, large carbides have a size of ~ 5 microns, which is permissible, but undesirable, since it can lead to embrittlement of the material (fig. 2). The microhardness of the material was - 4.70 GPa. With regards to the mechanical properties of the samples, the use of mode №1 led to their partial recovery, mode № 2 was ineffective.

The application of heat treatment according to the mode №1 for the blade after 28 070 hours of operation also led to a positive change in microstructure, namely: the globular carbide phase precipitate (average size 0.5 to 2 microns). The intermetallic phase has an almost regular cubic shape with a particle size of ~ 0.5 microns, however, in the material of the trailing edge, the intermetallic particles remained in the form of a “butterfly”. The microhardness of the material was 3.10 GPa.

Fig. 2. Microstructure of the blade material after heat treatment: a - mode №1; b - mode №2; c, d – filamentous carbides at the grain boundary.
