Analysis of Constructive Errors in masonry confined in Highly Seismic Countries and Reinforcement of Walls with Galvanized Mesh

Wilder Goñi^{1,a}, Nehemias Maquin¹, José Rodríguez¹ y Ennio Morán¹

¹Ingeniería Civil, Universidad Peruana de Ciencias Aplicadas, Lima, Perú

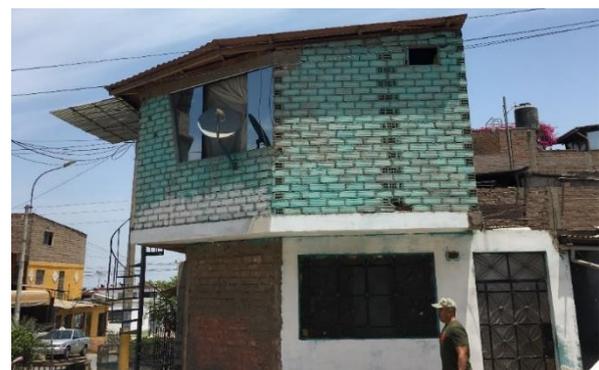
Table 1 identifies the construction errors observed in dwelling No. 3 in sector III (Zone 2) and Figure 2 shows the image of this dwelling.

Item	Constructive errors
A	Lack of continuity of vertical walls
B	Absence of vertical confinement elements
D	Absence of rigid diaphragm
E	Lack of mooring beams
G	Use of tubular brick for structural purposes

Figure 2. Photograph of housing N° 3 in sector III (Zone 2) of the district of Villa El Salvador.

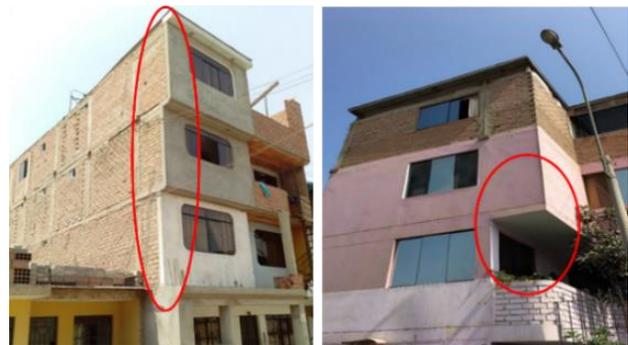
Figure 5 shows that vertical loads are not transmitted directly to the ground, this generates cutting forces in the cantilevers as there is no support between slabs. Standard E.070 [13] indicates that confined masonry walls must be continuous because they perform a structural function of support and transmission of vertical loads. Standard [14] considers a confined wall to be structural when it is continuous from the foundation to its upper level.

Figure 5. Discontinuity of walls in masonry dwellings.

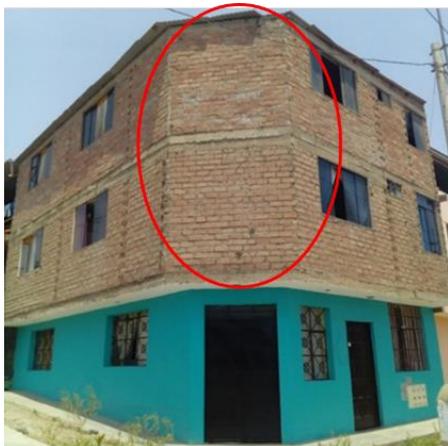
Figure 6 shows the non-confined walls at both ends, which have minimal resistance to lateral and oscillatory loads; and as their shear forces are more intense for the brick wall, the chances of failure and collapse increase. Confinement columns must be placed at the ends of structural walls, at intersections with other structural walls and in intermediate places at distances not greater than 35 times the effective wall thickness, 1.5 times the vertical distance between horizontal confinement elements or 4 meters [15]. Moreover, confined masonry walls may in no case have an unconfined length greater than 25 times their thickness [16].

Figure 6. Absence of vertical confinement elements.

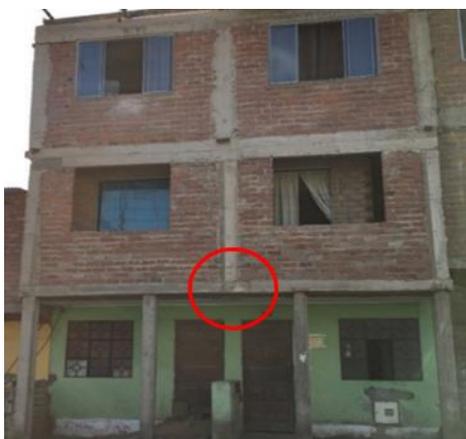
Figure 7 shows that vertical loads are not adequately transmitted to the ground, generating a punching effect on the beams. Standard E.070 [13] requires the continuity of the columns. Confinement columns must be continuous from the foundation to the top of the wall and may be fabricated before or after the wall is erected [16].

Figure 7. Column discontinuity in confined masonry dwellings.

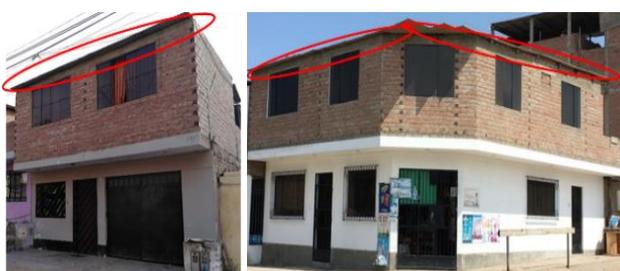
Figure 8 shows that the structural elements in the ends (columns or walls) do not receive the lateral loads, this generates unequal deformations. Standard [16] indicates the placement of horizontal confinement beams at the end of the wall and at vertical free distances not exceeding 25 times the thickness of the wall.

Figure 8. Absence of rigid diaphragm.

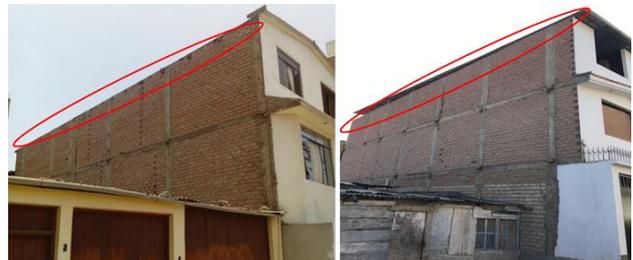
Figure 9 shows that the wall does not act as a whole, since it is not braced at its four ends (columns and beams). Standard E.070 [13] requires the complete confinement of masonry walls in order to increase the ductility of the system and reduce its fragility. The mooring beams must be placed at the level of the foundation, at the level of the mezzanine system and at the level of the deck level [15].

Figure 9. Lack of mooring beams.

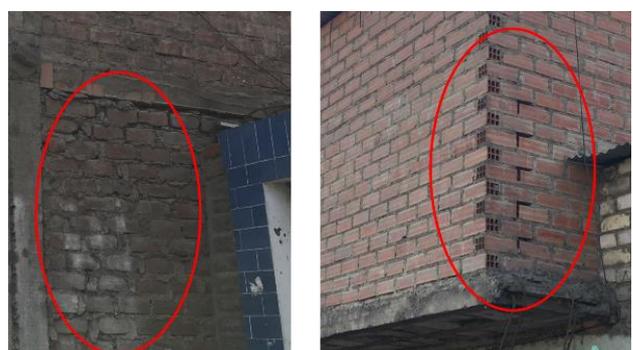
In Figure 10 (Right) you can see the separation between masonry units by the lack of connection of the brick with the mortar, this prevents the wall from responding evenly as a block. The thickness of the joint according to E.070 [13] must be a minimum of 10 mm and a maximum of 15 mm. Standard [14] indicates that if mechanized manufacturing units are used, the thickness of horizontal joints shall not exceed 12 mm if horizontal reinforcement is placed in the joints, nor 10 mm without horizontal reinforcement; if artisanal manufacturing pieces are used, the thickness of joints shall not exceed 15 mm; the minimum thickness shall always be 6 mm to ensure a good connection between bricks.

Figure 10. Inadequate mortar joint (Left) and absence of mortar (Right) between bricks.

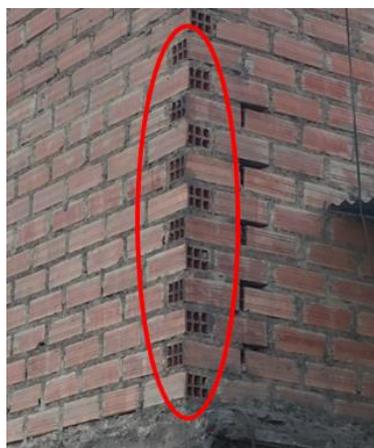
Figure 11 shows the wall made with a brick of low resistance and with many holes, which in the presence of a seismic movement do not support the loads of compression and traction, and the collapse of the wall occurs. For dwellings between 1 and 3 floors in seismic zones greater than 3, the use of solid industrial brick or alveolar brick filled with concrete is obligatory according to standard E.030 [13]. Tubular bricks with horizontal

voids are accepted for confined masonry if their strength exceeds 3 MPa [15].

Figure 11. Tubular brick in a structural wall.

Description	Image
The walls of the houses do not have elements of confinement and the only ones that are going to support the cyclic loads are the tubular bricks, which are not designed for such purpose.	
State According to standard [15] the degree of performance of a tubular brick wall against an earthquake is in the "LOW" category.	Solution Demolish the walls and reconstruct the elements of the building in accordance with the respective building regulations [11].
Methods of prevention Do not use tubular bricks as load-bearing elements in dwellings.	Methods of rehabilitation Use wall reinforcement techniques such as electro welded wire mesh, galvanized wire mesh, geogrids.

The tubular brick wall must be confined on both sides with the galvanized wire mesh and covered with 1: 4 dosing mortar (cement: fine sand). The mesh is fixed to the wall with alcayata nails and placed vertically so that the overlaps remain in the same direction. The meshes of both sides of the wall are connected with annealed wire No. 16 by means of a perforation in the wall. 1.5 cm of mortar cover should be considered, and the mesh must be embedded inside the mortar.
