Field repair of a severely damaged FG/epoxy fuselage

Abstract. The paper presents development of a repair procedure for a severely damaged primary laminate structure of a light aircraft, certified in accordance with CS22. The procedure was developed with the assumption that it would be a field repair carried out by people of average manual skills, who have not been trained in repairs of composite structures. To develop the procedure, a typical FG/epoxy laminate glider fuselage was used. The primary objective of the repair was to restore the original fuselage stiffness, while maintaining possibly low stress concentrations resulting from the repairs. To facilitate development of the repair, an FE model was developed. It was parametrized to be useful for design of similar repairs of similar structures. The experimental work done with the use of a real structure allowed the authors to verify numerical simulations, which were found to be correct.

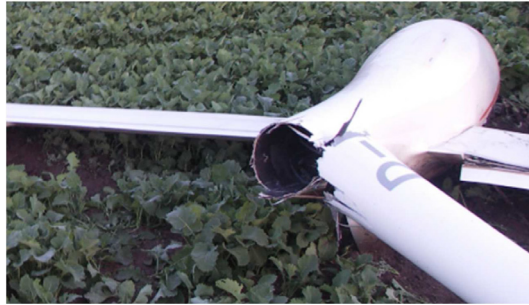
The presented repair technology was designed for structural reinstatement of a severely damaged fuselage, including complete break, Fig. 1 (such damage is often caused by a ground loop). Repair of such damage is not allowed by CS23 [1], but CS22 does not impose any limitation concerning this issue and the presented repair technology can be applied to small aircrafts, motor-gliders and gliders certified under CS22. Often, stiffness requirements are the driving factors and therebystrength requirements are also fulfilled. The described repair procedure could be applied to a solid laminate monocoque structure for which critical buckling load was significantly lower than that needed to overrun materials strength. Development of a suitable repair technology is presented later in the paper. The relevant requirements were defined as follows:

Fig. 1. Typical failure mode of a fuselage caused by a ground loop

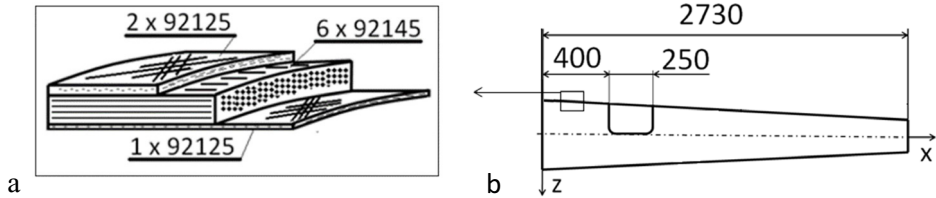
twill fabric (Interglas 92125), six layers of UD fabric (Interglas 92145), and one layer of 2x2 twill fabric (Interglas 92125). The damaged section started 400mm behind the front end of the fuselage. Removal of the damaged laminate resulted in a 250 mm long cut-out encompassing half of the fuselage circumference, Fig. 3b.

Fig. 3. Considered structure (a) reinforcement lay-up and (b) geometry of the fuselage section and location of the cut out

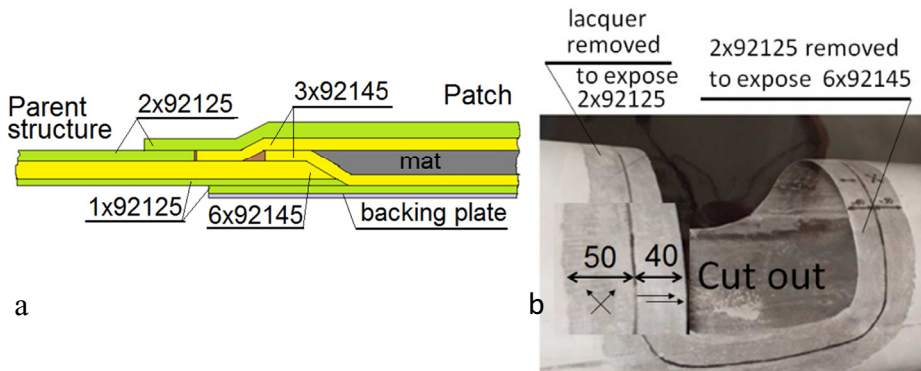
Fig. 4. Patch and parent structure lay-up (a); preparation of the cut-out edges for gluing (b)

A stepped repair was chosen since it is simpler than a scarf one and at the same time offers similar strength [2]. Soft patch technology was chosen for the repair. As recommended [3], restoration of structural continuity in terms of reinforcement directions was attempted wherever possible. To achieve this, the lay-up of the fabric constituting the patch was chosen as shown in Fig. 4a. Sanding was used to prepare the parent structure for gluing. For this purpose, a 50 mm wide strip of the most outer reinforcement layer (92125 fabric) and 40 mm wide strip of UD reinforcement (92145 fabrics) of the parent structure were exposed along the cut-out perimeter, Fig. 4b. Also, sanding was applied for surface preparation of the most inner layer of the fuselage shell. The flowchart of the repair procedure ensuring merger of the fabrics with the same reinforcement arrangement is shown in Fig. 5. First, one layer of 92125 fabric was impregnated at the top surface of an 0.5 mm thick backing plywood plate. Next, with the help of this plate the impregnated but not cured fabric was pressed against the inner surface of the fuselage. For this purpose, a set of bands was used. It was noticed that the band tension affected the camber of the backing plate; thus to minimize possible gaps between the fuselage inner surface and the patch layer, the band tension had to be adjusted. This problem was analyzed with FEM and will be discussed further in the paper. After curing had been completed, the bands were removed and the remaining parts of the patch were formed. It involved placement and

impregnation of 3 layers of UD 92145 fabric (step#2), 3 layers of mat forming filling (step#3), 3 layers of UD 92145 fabric (step#4) and 2 layers of 92125 fabric (step#5).

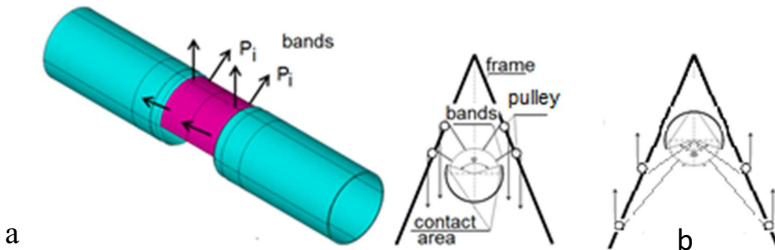
Fig. 10. Application of bands for reducing the gaps between the inner surface of the fuselage and the bottom layer of the patch (a); actual repair: step#1- fixing the first (lower) backing plate (b)

Gaps between the inner surface of the fuselage and the bottom layer of the patch. The manner in which the plywood backing plate overlapped with the impregnated but not cured reinforcement layer could be pressed against the inner surface of the fuselage with the help of a band set is shown in Fig. 10.

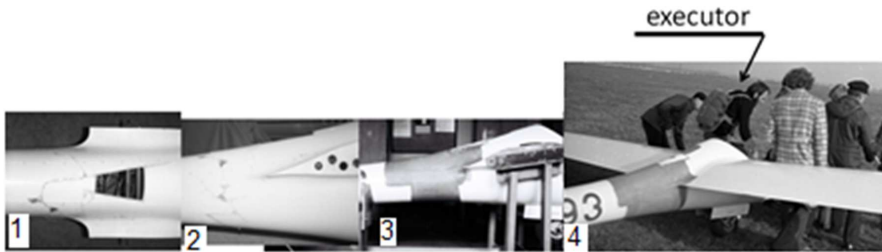
Fig. 13. Actual fuselage damage (1,2) caused by a grand loop, completed repair (3) and the final repair results (4). The patch was intentionally not painted to facilitate monitoring.

The developed technology was applied to a completely broken fuselage, Fig. 13. In general, the patch was fabricated in accordance with the flowchart shown in Fig. 5. The only difference was that after proper alignment of the fuselage parts, the backing plate carrying the impregnated fabric blank was first glued to the lower inner surface of the fuselage and after the curing the upper one was attached as shown in Fig. 5a. Next, steps 2-5 were applied to repair the upper part of the fuselage. After completing the cure, the fuselage was flipped upside down and steps 2-5 were repeated.
