# The analysis of the technological and professional danger factors specific to the works of exploitation of useful rocks from quarries, which can generate risk of accident and / or technological breakdown

Attila Kovacs<sup>1\*</sup>, Sorin Bordoş<sup>1</sup>, Bogdan Garaliu-Buşoi<sup>1</sup>, Claudia Miron<sup>1</sup>, and Sorina Stănilă<sup>2</sup>

<sup>1</sup>National Institute for Research and Development in Mine Safety and Protection to Explosion – INSEMEX Petroşani, 32-34 G-ral Vasile Milea St., 332047 - Petroşani, Hunedoara County, Romania

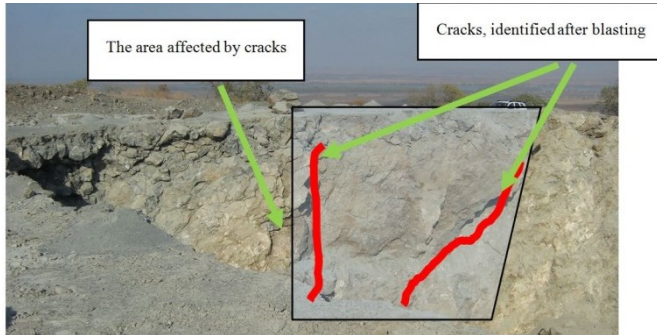
**Fig. 2.** Geological structure of the slope.

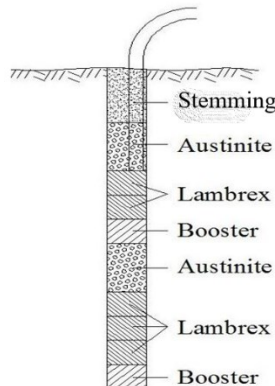
On 14.10.2011, the amount of explosive was 5.25 kg/m of bore hole, the amount of explosive per hole - base load - was 70 kg.

- 2 pcs. Booster 450 g;
- 5 pcs. Lambrex 65x3,125 kg;
- 70 kg Austinite;
- Stemming 3 m.

**Fig. 3.** Loading of the bore hole.

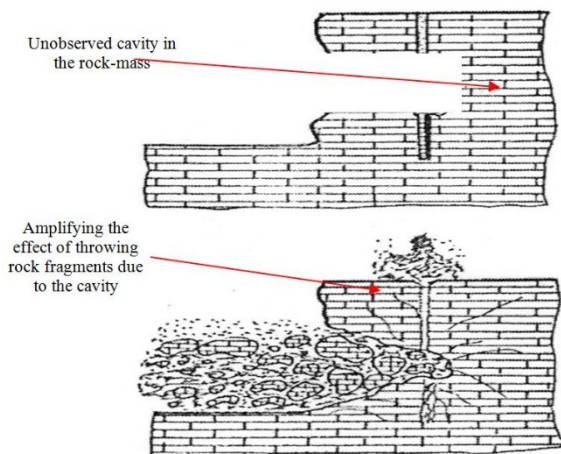
After the geomorphological analysis, tectonic accidents, cracks/fractures, correlation of the hourly data and the location of the blasting works and the event occurs, it is retained as a cause for the occurrence of the event "Fly rocks after the blasting operation due to the presence of previously unidentified cracks/fractures in the front area during drilling and loading of the bore holes".

**Fig. 4.** The throw effect amplification.

The presence of such geological anomalies can lead to overloading the front and modifying the projected parameters (significant decrease of burden) which can result, after the shot, in a displacement effect of the blasted material to considerably larger distances than those established as safety distances for protection people and goods.

Amplification of the off-site throw effect due to the use of the shooting technology described in the frame method, in the absence of identification of the two major cracks revealed after the occurrence of the event [10,11,12,13,14].
