Non uniform settlement of the St. Barbara Church foundations was as the second example. For FEM modeling was chosen in this case software ATENA. For constitutive modeling was chosen similar nonlinear quasi-brittle constitutive model as in the previous case. Quite conservative parameters for numerical modelling are listed in Table 10.

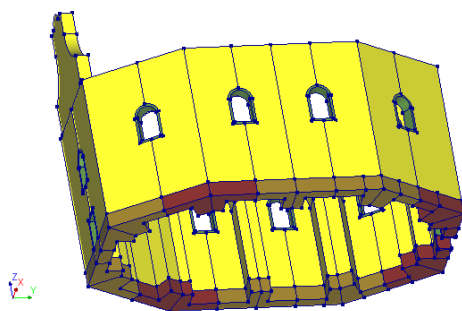
**Fig. 8.** Effect of soil deterioration of subsoil; in red zone was applied additional settlement 2.5 cm.

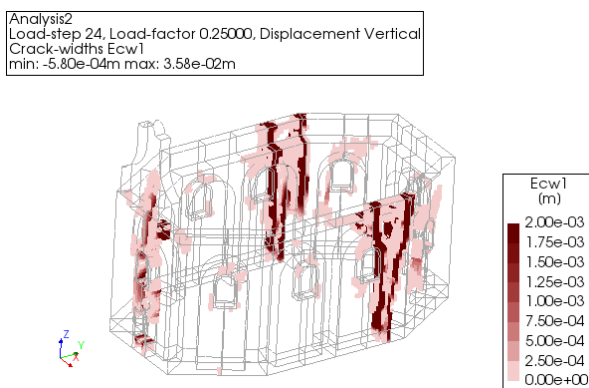
**Fig. 9.** Calculated cracks due to deterioration of foundations.

From the above figure the crack strain obtained in the structures can be found which occurred due to the increased differential settlements. Here it is interesting to notice that most of the crack strains that can be observed here were found to be in accordance of the damage observed on the site. This supports the considered hypothesis behind the occurrence of damages (due to differential settlements). More comments, scenarios of calculations and other details are in [6].

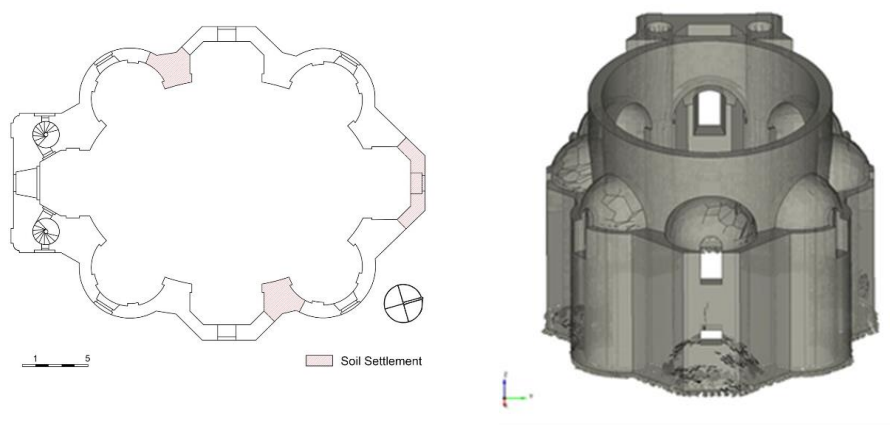
identified through visual inspection. The loads were then applied to the structure in two different intervals. In the first interval, the loads comprised of the self-weight and the dead load were applied to the structure, along with a spring stiffness of 26.36 MPa. This caused a uniform settlement of 18 mm. Additional settlement of 80 mm was applied in the highlighted region, see Fig. 10.

**Fig. 10.** Additional settlements and filtered crack width showing 15 mm (Severe) degree of damage.

Cracks of width larger than 15 mm corresponding to “Severe” degree of damage and expected to disrupt the functioning of the structure were filtered from the smaller cracks, Fig. 10. It was observed that at load step 80 which accords with 80 mm displacement showed a complete arch-like crack formation of thickness 15mm at the rear wall of the church. It is important to note here that, although this load can completely detach the section of the wall under the window, the failure is very local, therefore it is possible, that the superstructure would still prevent collapse. However, it is evident that the wall completely detaches itself from the superstructure and so, a differential settlement of 80 mm was taken as the failure criterion for the church. More interesting and complex information can be found in [8].
