Determination of aircraft hydraulic system pipeline leak cause

Abstract. The purpose of this article is to determine the cause of leak of the aircraft hydraulic system pipeline detected during pre-flight flight preparation. Results of spectral analysis of material, mechanical testing, analysis of defect structure by optical fractography and metallographic analysis are presented.

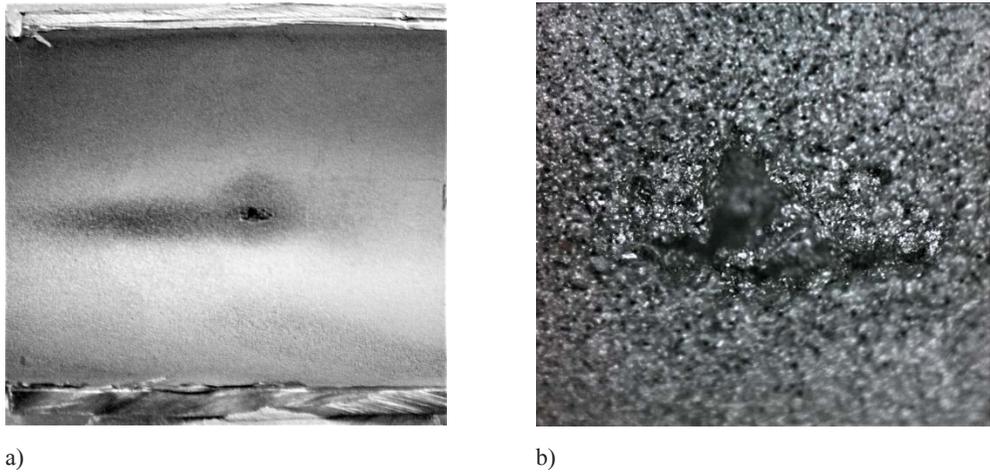
During visual-optical inspection of the external surface of the pipeline, at the place of leakage, no defects were found. After opening the pipeline along the generatrix, a defect in the form of a locally located cavity in the metal, accompanied by a dark-colored section, extended further along the generatrix, was visually detected in order to obtain a sufficient view for inspection of the inner surface. Length of defects ~ 20 mm, width ~ 8 mm. The appearance of the defect is shown in Fig. 1a.

To analyze the structure of pipeline defects, the internal surface was examined by optical fractography. As a result of the pipeline study, it was established: the discovered cavity is directed mainly along the generatrix, spreads deep into the metal and has a "porous, spongy" structure; the dark area of the surface around the cavity, found during visual inspection, is pitting lesions with a diameter of up to 1 mm. The photo of defects obtained at magnification of 20x is shown in Fig. 1b.

Fig. 1. (a) Appearance of the defect on the inner surface of the pipeline, (b) at increase of 20x.

The presence of damages with a porous, spongy structure is characteristic of cavitation wear that occurs when solids contact liquid. Cavitation is the process of formation of vapor-gas bubbles in liquid media, followed by their collapse and the release of a large amount of energy, which is accompanied by hydraulic shocks. The impact of many such microshocks leads to the gradual destruction of nearby solids, the formation of rather deep and complex lesions in the relief. After the appearance of the initial surface damage, the cavitation process is accelerated [7].

Thus, in appearance, the defects are ulcerative corrosion lesions and traces of cavitation wear.

Thus, the sequence of defect formation is as follows. Initially, on the inner surface of the pipeline, point corrosion lesions (pittings) occur at the places of clusters of non-metallic inclusions, then under the influence of the flow of hydraulic fluid, oxide films are removed, which accelerates corrosion processes. Damaged surface undergoes cavitation wear (erosion) due to non-stationary movement of hydraulic fluid. Over time, defects deepen and lead to destruction of the pipeline.

1. Material grade and pipe tensile strength meets the requirements of the material standard.
2. The cause of the pipeline leak is the formation of defects on the internal surface of the pipeline due to the simultaneous corrosion processes and cavitation wear.

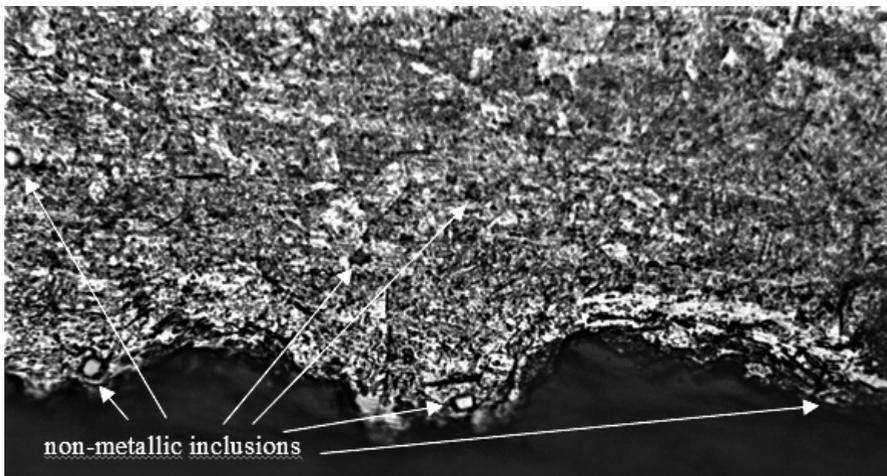
To clarify the nature of the defect, a metallographic study was carried out in transverse microslips. As a result, there are non-metallic inclusions near the defect. Assessment of metal contamination by non-metallic inclusions according to GOST 1778-70 is not possible due to insufficient pipe wall thickness (1.2 mm) under condition of minimum thickness of 6 mm. Also, traces of plastic deformation in the form of enveloped recesses of deformed austenite grains were found in the microslip of the examined section (Fig. 2), which indicates the presence of mechanical influence.

Fig. 2. Microstructure at increase of 500x

The configuration of defects oriented in the direction of plastic deformation of the material, as well as its nature, indicate that they were formed, obviously, at the places of clusters of lowercase non-metallic inclusions.
