# Geo-disasters induced by the recent earthquakes in Japan and Indonesia

**Abstract.** This paper is focusing on the geo-disasters induced by the 2018 Hokkaido Iburi-tobu earthquake in Japan and the 2018 Sulawesi earthquake in Indonesia. The Hokkaido Iburi-tobu earthquake occurred at east of Iburi region in Hokkaido, Japan on September 6th, 2018. Tremendous number of landslides occurred in the mountain areas at Iburi region. Uplift and sinking of road and inclination of houses were caused by liquefaction in the south eastern part of Sapporo city. The Sulawesi earthquake happened at Central Sulawesi Province, Indonesia on September 28th 2018. The ground displacement triggered by the fault movement caused damage to roads and houses. The large scale ground flows induced by liquefaction occurred in some different sites. This paper reviews the damage induced by the geo-disasters and considers the lessoned learnt from the damaging earthquakes happened in 2018.

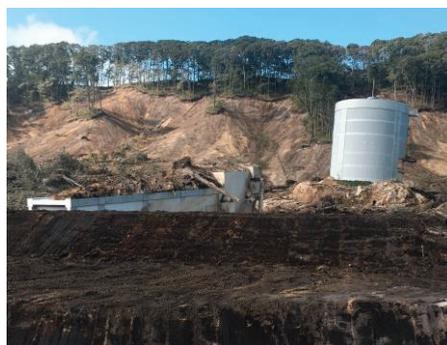
**Fig. 1.** Landslide at Atsuma town

Tremendous number of landslides occurred in the mountain areas at Iburi region. **Fig. 1** shows a landslide occurred in Atsuma town. This photograph also shows the damage to Tomisato purification plant of drinking water supply caused by landslide. The total area of landslides was about 13.4 km<sup>2</sup> according to the Ministry of Land, Infrastructure and Transport, Japan. This scale is biggest in Japan from 1868. One of causes of the landslides seems to be a large amount of water contained in soil because heavy rain fallen in the previous day of the event by a strong typhoon. It is considered that the descent pumice layer deposited in this area is highly permeable, and clay is formed by chemical weathering, therefore, landslide is likely to occur easily.

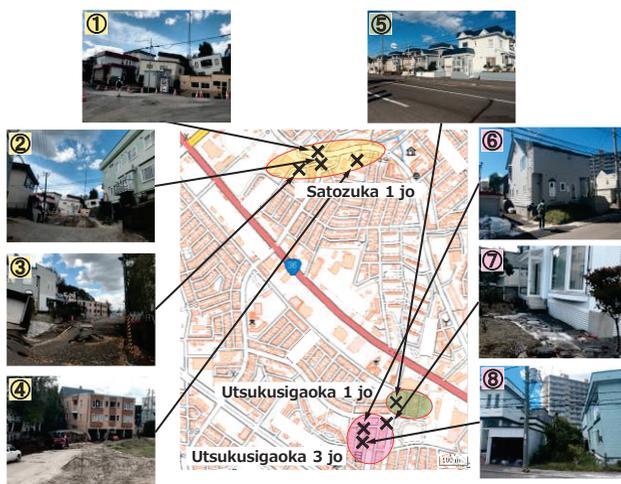
Fig. 3. Damage to houses induced by liquefaction

Utsukushigaoka towns in Kiyota ward, Sapporo city. Fig. 2 shows the location of Satozuka and Utsukushigaoka towns. Some photographs of the damage at each site are shown in Fig. 3. The ground deformation due to liquefaction was the largest and the ground was raised up to about 2m in Satozuka 1jo town shown as yellow portion in Fig. 3. Photo. ① in Fig. 3 shows settlement of the ground and inclination of the houses are remarkable and a puddle of water appeared in front of the house. The road shown in photo. ② collapsed, and the traffic of the vehicle was difficult. Since the ground level before the earthquake was at the top of this utility hole in photo. ③, it is considered that this road subsided about 1 to 2m. The inclination of the surrounding houses was large. Photo. ④ shows accumulated sand in height of about 50cm. It is thought that a large amount of liquefied sand ejected at the sites of photos ① to ③ was accumulated at the location of photo. ④ because the location of photo. ④ is lower than the sites of photos ① to ③.

The green portion in Fig. 3 indicates Utsukushigaoka 1jo town. There were many inclined houses due to liquefaction. The houses shown in photo. ⑤ seems to suffer no damage at first glance, but inclination of houses has occurred. Most of residents have continued to live in the inclined houses just after the earthquake, but many residents moved without being able to withstand the inclination of houses after around one month.

The red portion in **Fig. 3** indicates Utsukushigaoka 3jo town. Many houses caused inclination by liquefaction. The inclination of the house shown in photo. ⑥ was the second largest inclination in Utsukushigaoka town. The residents of this house had moved soon after the earthquake. The surrounding ground of the house shown in photo. ⑦ subsided, and a gap between the stairs and the ground was caused. The houses shown in Photo. ⑧ were inclined to the direction of each house. The right house was with the largest inclination in the Utsukushigaoka town. The utility pole shown in this photograph has settled about 1m.

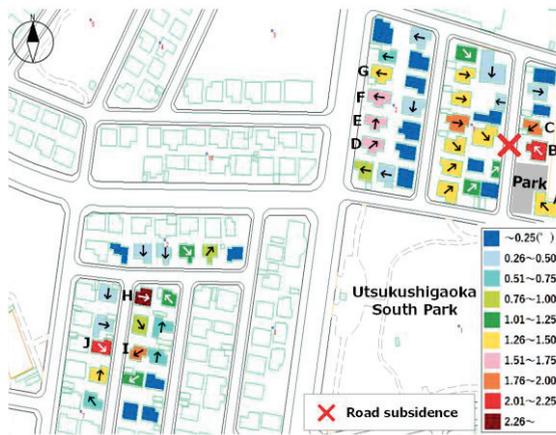
**Fig. 4.** Inclination of houses and its direction at Utsukushigaoka

**Fig. 4** shows inclination of the outer wall of the houses in Utsukushigaoka 1jo and 3jo towns. The inclination was shown in color-coded of every 0.25 ° on the map. Vector synthesis was performed in two orthogonal directions with larger inclination and the direction of inclination is indicated by an arrow in this figure. If the maximum inclination and the synthesized inclination are less than 0.25 °, vector synthesis is not performed and only the direction of the maximum inclination is shown in this figure. The location of the largest subsidence of road is also indicated by red × in this figure. This figure suggests that the houses that were greatly inclined were adjacent and that such houses are inclined in the same direction. Also, the houses were inclined in the direction of the largest subsided road. The number of houses in each inclination angle is shown in **Fig. 5**. Health problems may occur at the houses with an inclination of 0.6 ° or more, and about 53% of the surveyed houses exceeded this value.

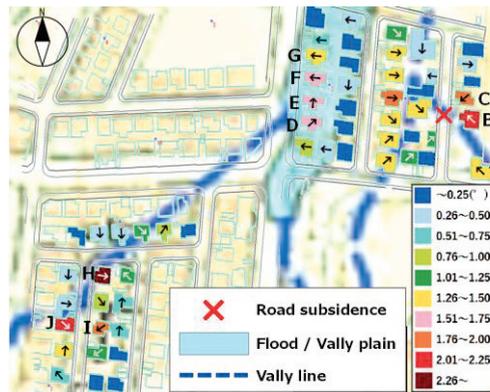
**Fig. 6.** Inclination of houses and the past terrain

**Fig. 6** is superimposed the past terrain [3] on **Fig. 4**. According to this figure, the houses built at a former valley are inclined. It can be seen that the houses of A, B and C with large inclination and largely settled road were located at the former valley. The houses of D and E were inclined in the direction of north and the houses of F and G in the west direction. These areas were formerly flood or valley plain. The houses of H, I and J are also located at the former valley. It is clear that the direction of inclination of the houses coincides with the direction of former valley or flood plain. The surveyed areas of this study was originally recessed areas that erodes mountains, plateaus and terrace, then the area was reclaimed for residential houses. The houses of D, E, F and G were located at the former flood and valley plains, houses A to C and H to J were located at the former bottom of valley plains. It was revealed that the inclination of houses due to liquefaction is greatly affected by the old topography.

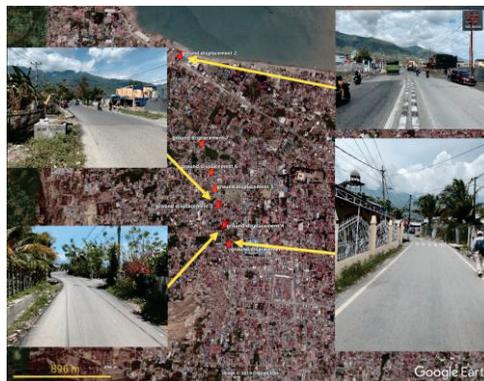
Fig. 8. Location of ground displacement induced by fault movement in Palu city

Large ground displacement was found in some particular areas, such as Kedondong, Pipa Air, Pangeran Diponegoro and Cemara streets in Palu city. **Fig. 8** indicates the locations of the large ground displacement found in Palu city. These large ground displacements agree with the fault movement of left lateral slip. **Fig. 9** shows the fault line at surface estimated by USGS [4]. The legend of this figure indicates estimated amount of slip of fault itself.

The ground displacement triggered by the fault movement appeared in Pangaran Diponegoro, Cemara, Kedondong and Pipa Air, streets. The horizontal displacement of the four roads are 2.7m of Pangaran Diponegoro street, 3.8m of Cemara street, 4.5m of Kedondong street and 5.0m of Pipa Air street, respectively. These displacements make roads bent.

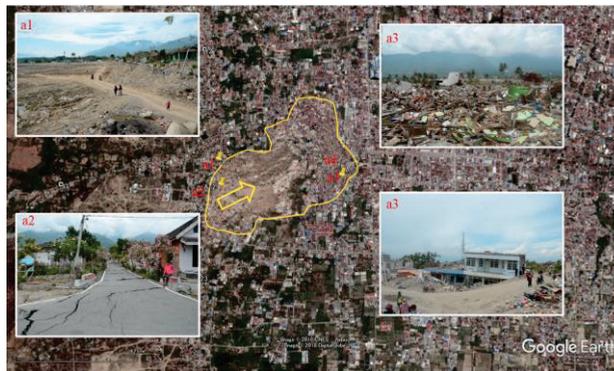
**Fig. 11.** Satellite photo by Google Earth and some photos of damage at Balaroa district in Palu city

**Fig. 11** shows a satellite photograph by Google Earth and some photographs of damage in Balaroa district in Palu city. The direction of the large ground flow is shown by a yellow arrow in this figure. The ground flow occurred from south-west to north-east. Large ground settlements and large tension cracks appeared at the upper side of the flow and collapsed houses were piled up and many houses were buried in the flowed soil at the lower side. Balaroa district is a densely populated area. 600 people were died of the more than 2,000 inhabitants, while more are still missing. The area affected in Balaroa district was around 380,000m<sup>2</sup>. Balaroa housing complex almost disappeared due to the ground flow. It is reported that around 1,700 houses were buried due to lateral ground movement.

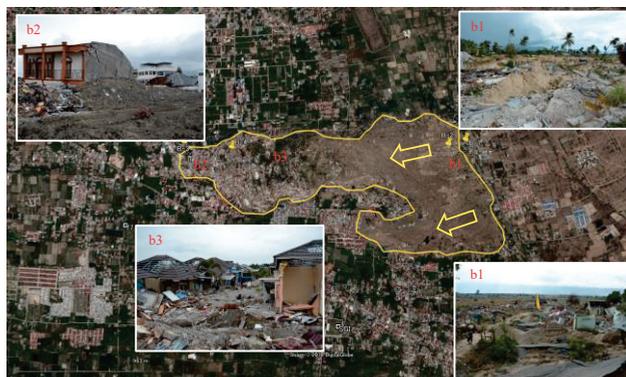
**Fig. 12.** Satellite photo by Google Earth and some photos of damage at Petobo district in Palu city

**Fig. 12** shows a satellite photograph by Google Earth and some photographs of damage in Petobo district in Palu city. The direction of the large scale ground flow is also shown by a yellow arrow in this figure. The ground flow occurred from east to west here. Similar to Balaroa district, more than 700 houses were severely destroyed caused by the ground flow and hundreds of people died here. The area affected in Petobo district was much larger than Balaroa, which is around 150,000m<sup>2</sup>.

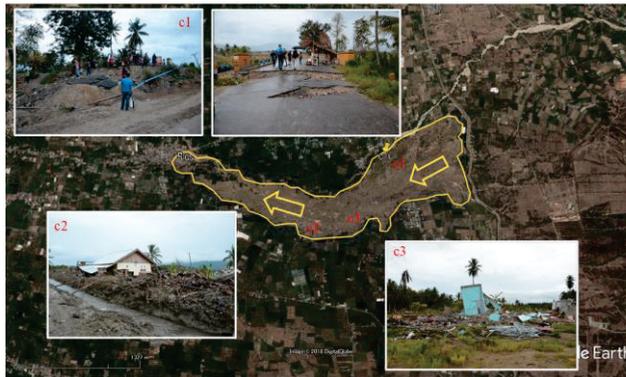
**Fig. 13.** Satellite photo by Google Earth and some photos of damage at Jono Oge village

**Fig. 13** shows a satellite photograph by Google Earth and some photographs of damage in Jono Oge village. The direction of the large scale ground flow is also shown by a yellow arrow in this figure. The ground flow occurred from east to west. Lateral ground flow occurred as well with the affected area around 180,000m<sup>2</sup> in Jono Oge village. In this area, at least 34 high school students who joined a bible camp were killed, but it is suspected that many others are dead.

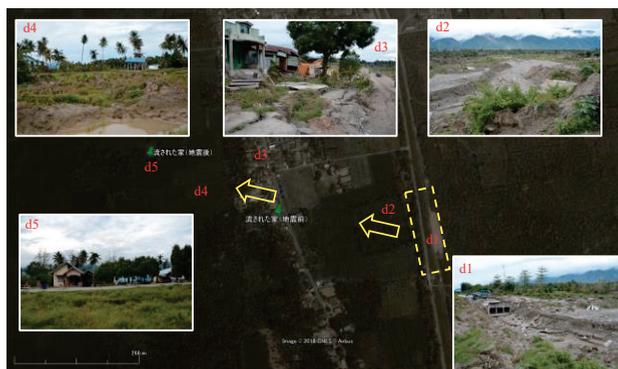
**Fig. 14.** Satellite photo by Google Earth and some photos of damage at Sibalaya village

**Fig. 14** shows a satellite photograph by Google Earth and some photographs of damage in Sibalaya village. The direction of the large scale ground flow is also shown by a yellow arrow in this figure. Sibalaya village is located around 40 km south of Palu city. A satellite photograph of Sibalaya village after the earthquake cannot be obtained yet. In this area, only three people were dead due to building collapse. However, the severe large ground flow also occurred. The road and houses moved laterally up to about 350 meters shown in **Fig. 15**. What made this phenomenon extraordinary is that the moving road and some houses only experienced minor damage. The mechanism of the large ground flow should be clarified in near future.

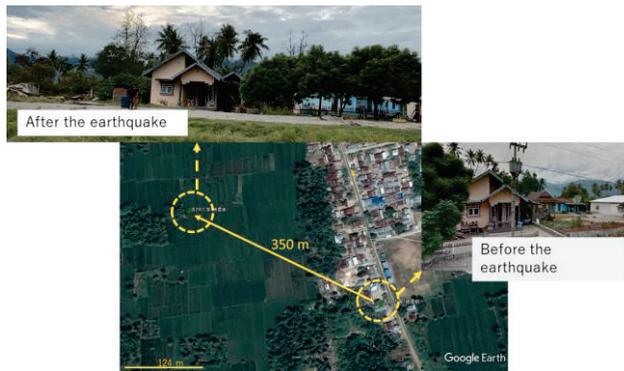
**Fig. 15.** Horizontal movement of houses and road in Sibalaya village
