# Damage to Teluk Palu Bridge in the 2018 Sulawesi Earthquake, Indonesia

**Abstract.** The authors conducted a field survey in the affected area of the 2018 Sulawesi Earthquake, mainly focusing on the damage occurred to the Teluk Palu Bridge in Palu City. It was found that the area around the bridge received approximately 200 gal acceleration and 3 to 6 m tsunami height. From the traces of the tsunami, we estimated that the tsunami reached up to the girder but not up to the arch rib of the bridge. The arch ribs sustained buckling and displaced 2 to 5 m into the water. The main cause of bridge collapse was the earthquake force as local eyewitnesses said the bridge collapsed immediately after the earthquake and before the arrival of the tsunami. In terms of earthquake-resistant design, the following three problems were identified regarding this arch bridge: resisting capacity of the arch rib, resisting capacity of the bearing system, and design concept about the seating length at the pier.

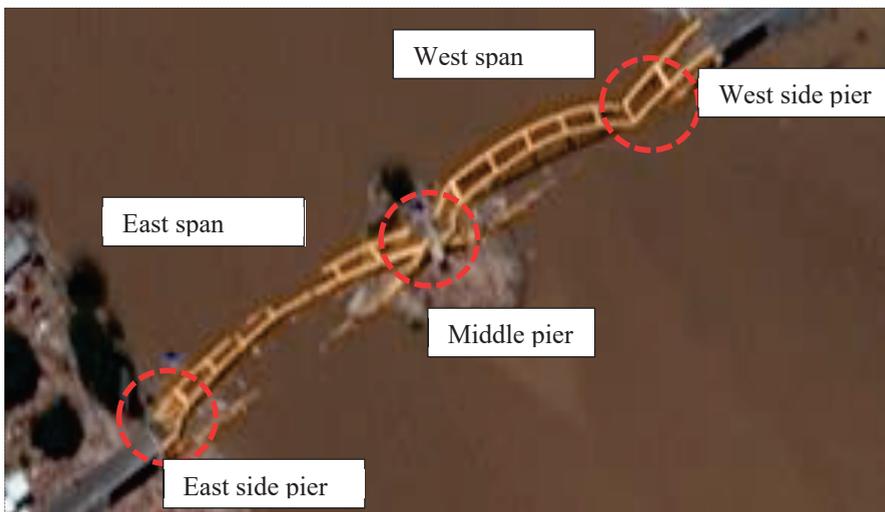
Fig. 4. Damage to the east and west spans of the Teluk Palu Bridge

When visiting the site, we were unable to observe the damage in detail because the bridge was being demolished. Therefore, we inferred the damage based on the information obtained from bridge experts in Indonesia and other related materials. Figure 4 shows the damage to the east and west spans of the bridge<sup>[4]</sup>. Figure 5 shows a closeup picture of the buckled arch rib<sup>[5]</sup>. These pictures were taken on October 1, three days after the earthquake. These pictures show that buckling occurred at three positions. Namely, buckling occurred to the intermediate member between the arch rib base and the lateral beam located on the east side pier of the east span. In the case of the west span, buckling occurred to the intermediate member between the arch rib base and the lateral beam located on the middle pier and to the second lateral beam from the west side pier. In particular, the intermediate member on the east side pier sustained serious buckling at about 5 m from the arch rib base due to the movement in the transverse direction.

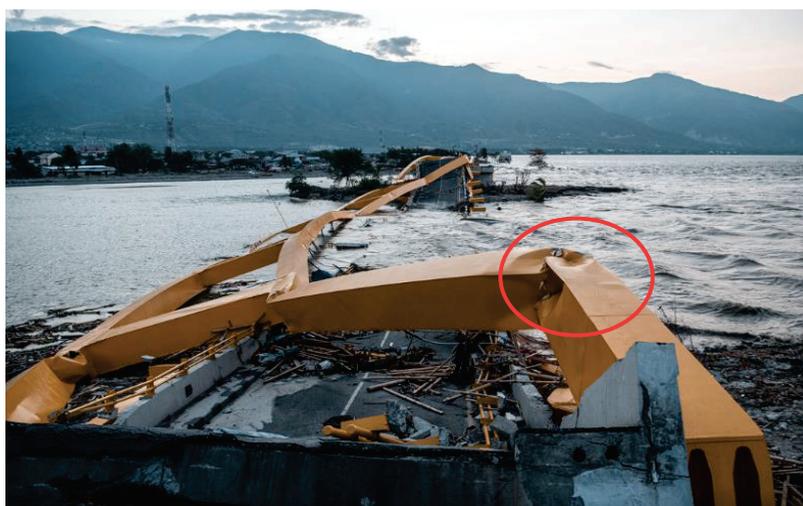
**Fig. 5.** Closeup picture of buckled arch rib

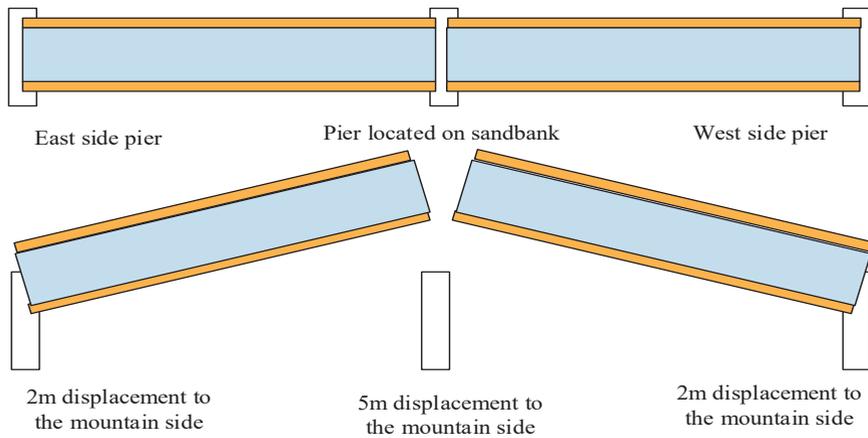
Figure 6 shows the positions of the bridge before and after the earthquake. The following information was obtained from a university professor in Palu. After the earthquake, the east side of the east span and the west side of the west span displaced to the mountain side about 2 m. In addition, the center portion of the bridge, namely, the west side of the east span and east side of the west span located above the middle pier on the sandbank displaced to the mountain side about 5 m. The displacement of the center portion of the bridge is also seen in Fig. 4

**Fig. 6.** Positions of the bridge before and after the earthquake

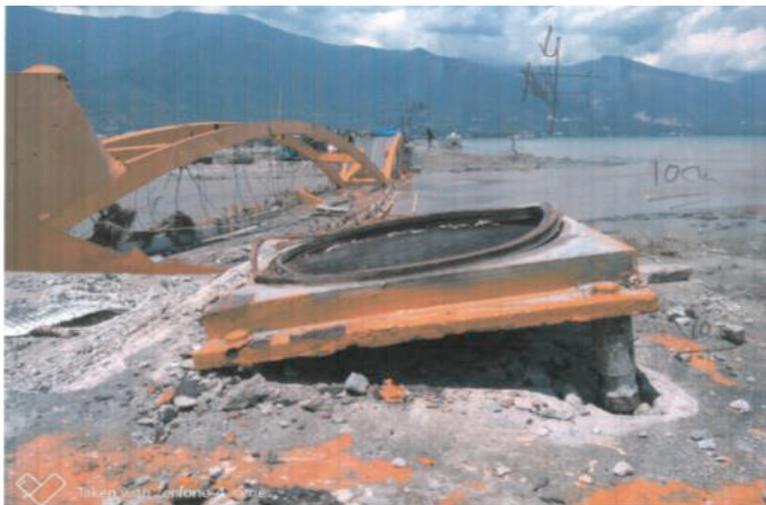
**Fig. 7.** Damaged bearing system at the middle pier

Figure 7 shows the damage to the bearing system at the middle pier located on the sandbank. It is a small-sized system called BPA (Bearing System A type). It is uncommon that such a small-sized bearing system is adopted for an arch bridge. This bearing system was damaged as the superstructure moved. Figure 8 shows the bearing system and the pier at the west end of the west span. It is seen that the bearing system is quite small compared with the size of the bridge. It is also seen the seating length at the pier is not sufficient.

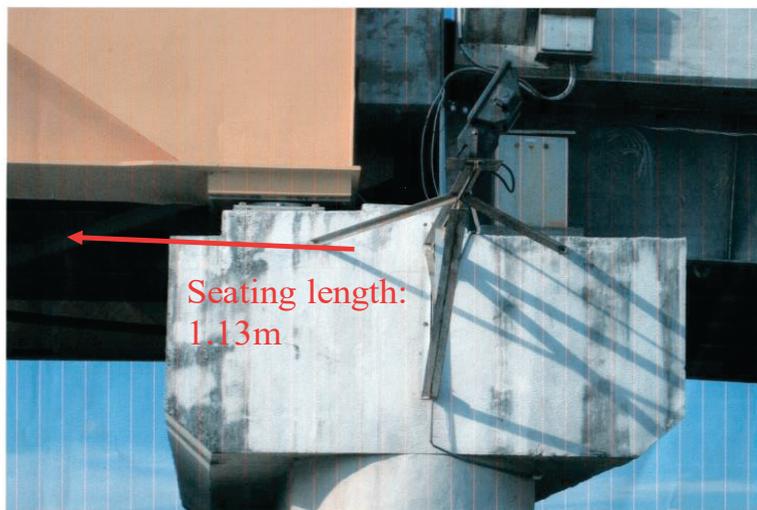
**Fig. 8.** Bearing system at the west side pier

As shown in Fig. 3, the maximum acceleration of the earthquake was 200 gal. This level of acceleration is not strong enough to cause the collapse of the bridge. The seating length should be 1.13 m for this length of bridge if the Japanese design code is applied.

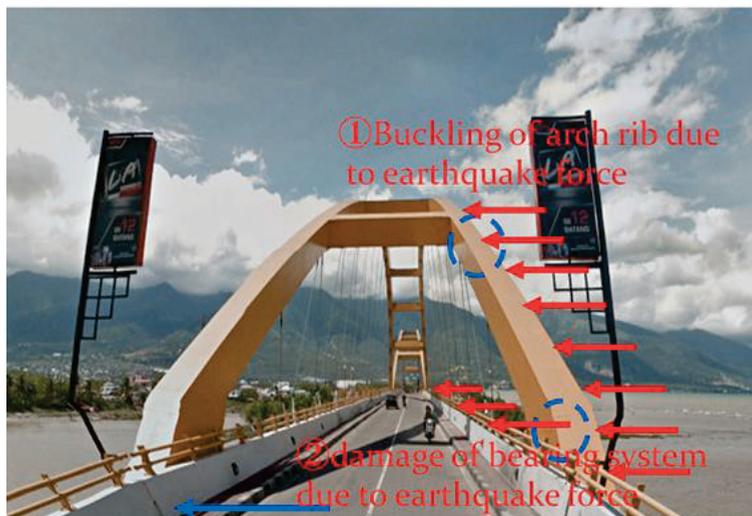
The following two are considered as the possible process behind the collapse of the bridge. The earthquake force acted on the superstructure in the transverse direction, as shown in Fig. 9 (The picture of the bridge was extracted via the Internet<sup>[5]</sup>). As a result,

- 1) The arch rib buckled due to the earthquake force in the transverse direction and moved largely to that direction. Then, the whole superstructure also moved to that direction and fell into the river, partly because of the insufficient seating length at the pier.
- 2) The bearing system was damaged when the earthquake force acted on the superstructure in the transverse direction and the superstructure moved to that direction. As the seating length at the pier was not sufficient, the bridge fell into the water.

Fig. 9. Direction of earthquake force

For further clarification, we need to evaluate the resisting capacity of the bridge members by obtaining design drawings of the bridge. In particular, we need to deepen the following three design problems.

- a) Resisting capacity of the arch rib, particularly the resisting capacity of the member at a position about 5 m from the arch base.
- b) Performance of the bearing system under earthquake loading
- c) Design concept for the seating length at the pier
