Grouting performance of the Pandan Duri dam shacked by Lombok earthquake 2018

Didi S. Agustawijaya^{1*}, Muji Wahyudi¹, I Wayan Yasa¹, Keke F. Ashari¹, and Ausa R. Agustawijaya²

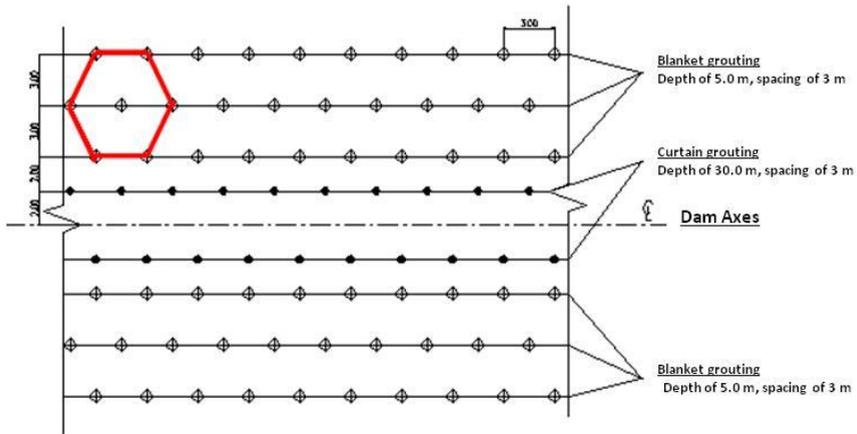
The dam was supported by a grouting support system in a hexagonal pattern (Fig. 4). The main purpose of grouting is to reduce permeability, but it could also increases shear strength, reduces compressibility, and reduces internal erosion on foundations. The installations might add shear strength to the base of 15 kg/cm^2 , so these were also intended to increase the stability of the dam shacked by earthquakes. Since the tectonic instability might be very much possibly to occur in Lombok Island [19, 19].

Fig. 4. Grouting installation of trapezoidal pattern [7].

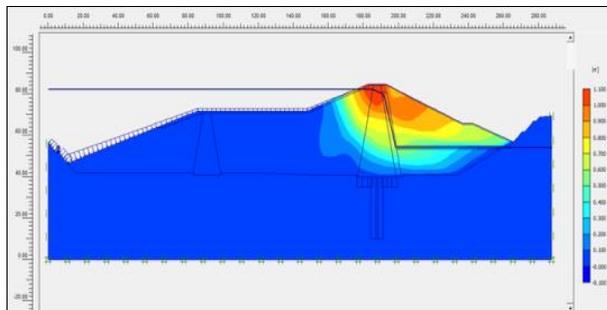
The elevation of the LWL was +264.0 m above the mean sea level (MSL), or 34 m above the dam base, while all dimensions of the dam were as stated earlier in the dam design. Numerical analysis shows that the FoS reduced significantly after earthquakes (Fig. 5), although the index was still 1.77, which was still in the range of stable conditions over 1.5.

Fig. 5. The LWL model after earthquake events.

However, the displacement could play an important role in the stability of the dam. The numerical analysis shows that the displacements of 8.9 cm might occur after the earthquake events. This displacement should be fine for the stability of the dam.

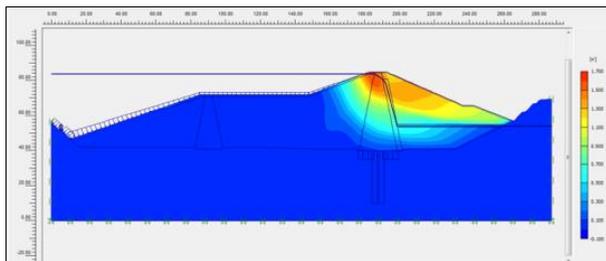
The elevation of flood water level (FWL) was +282.75 m above the MSL, or 1.25 m below the crest of the dam. The FWL model after the earthquake events shows that the FoS slightly reduced from the LWL conditions to be 1.76 (Fig. 6). But, the displacements could be significant, in which the dam could displace down to 164 cm after the event. This could be significant for the stability of the dam.

Fig. 6. The FLW model after earthquake events.

From the SF analysis, it can be seen that the SF value was greater than 1.5, which indicated that the dam was still safe influenced by earthquake forces. The grouting support system might be effective as a reinforcement and addition of resisting forces. When earthquakes occurred, of course, dynamic loads propagate through the dam foundation, then affected the dam slopes. As consequences, an increase in driving forces was followed by a decrease in the factor of safety of the dam. Grouting would, therefore, play a part in the stabilization of the dam.

Based on numerical analysis, the grouting installations of the Pandan Duri dam was able to stand earthquake forces after the event in 2018. The factor of safety was still over 1.5; although, flood might worsen the stability of the dam, since the FWL conditions tended to have a lower stability index than that of the LWL. Displacements could be significant in the stability of the dam as these could reach 1.64 m after the event. Stability enforcements are certainly required to strengthen the dam for future similar events that may possibly provide worse stability problems.
