# Analysis of the risks generated by the tailings ponds near the city of Borșa

**Abstract.** The paper presents the risks regarding the physical and chemical stability of the tailings ponds grouped under the name of Ds (D1, D2, D3, D4) located on the right bank of the river Cisla near the residential area of Baia Borșa and Colbu tailings pond upstream of the residential area of Borșa. The closure of these tailings ponds was done in a defective manner, without complying with the design and execution rules provided in the Technical Regulation on waste storage. There are two types of risks: first type, due to chemical instability that produces continuous acid drainage and the second type, regarding physical instability, due to erosion and extreme weather conditions which could lead to failure of the dams, with very serious consequences, causing material damages and loss of life. The risk of breaking the dams is even higher as it is located in the vicinity or upstream of residential areas located in a geographical structure of valley type containing the river Cisla with high debit.

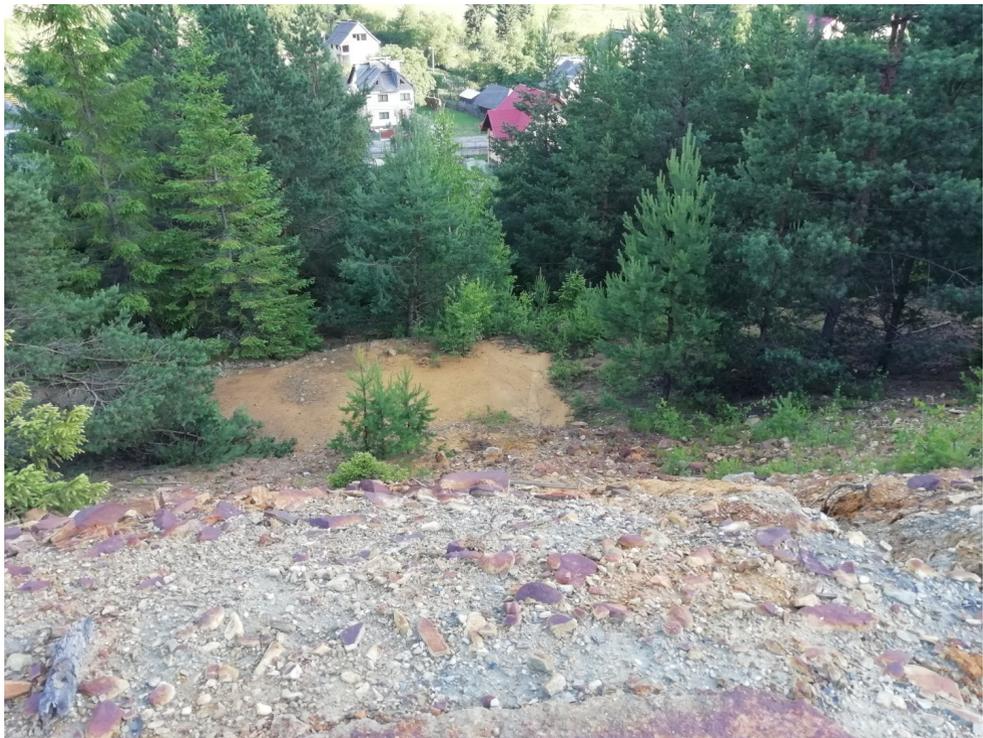
Ponds D1, D2 and D3 are located on the right bank of the river Cisla, in the vicinity of residential areas and present risks of physical and chemical stability (Figures 1 - 3). They have been rehabilitated, but with many deficiencies: without slope correction and without waterproofing, they have ravines through which material is entrained in the river, and geogrids are mostly revealed by entrainment of deposited material (consisting in many areas of sawdust and pieces of wood).

**Fig. 2.** The condition of the slope of pond D and the proximity to the living areas (sursa foto: A. Bud, 2020).

The vegetation on the slopes is made up of well-developed fir trees, which apparently give the idea of stability, but this state contributes to the increase of physical instability in the lower part of the roots (the slope is made of fine, granular material).

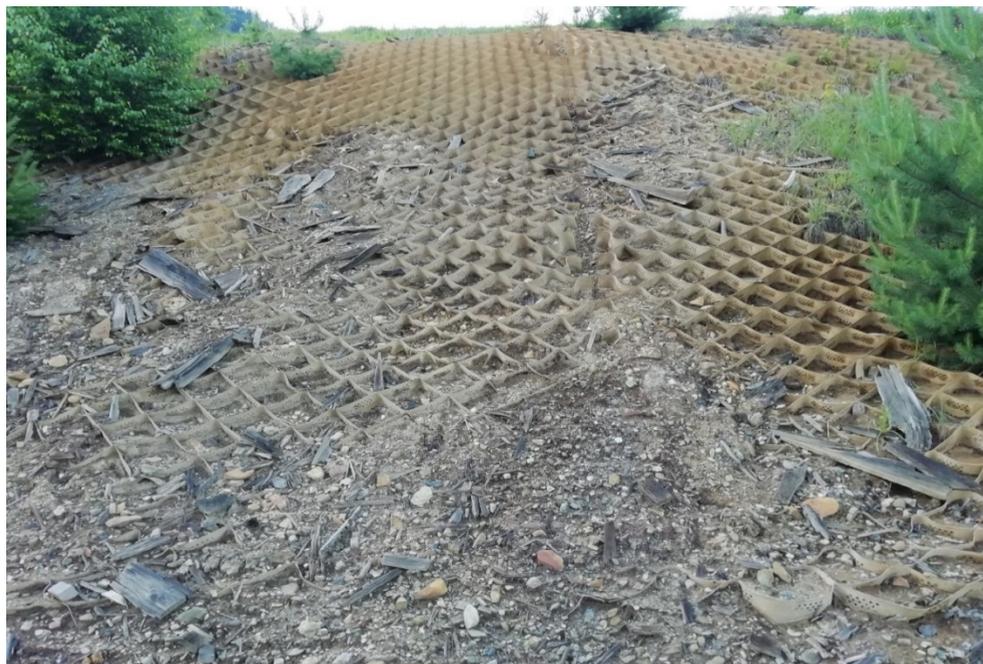
**Fig.3.** The condition of the slope on ponds D1, D2, D3 (sursa foto: A. Bud, 2020).

Pond D1 was put into operation from 1956 to 1970. It is a coastal pond on the right side of the valley of the river Cisla upstream of the confluence with the brook Valea Fătului. The surface at the top level is 7 ha, and at the level of the priming dam is 2.2 ha. The elevation is to altitude of 764.69 m with dam height of 51.72 m. The amount of tailings is 2.85 million tons. The slope angle is 28° (the Technical Norm [5] provides for a maximum of 18°).

Pond D2 is located on the right slope of the Cisla river valley downstream of the confluence with Valea Fătului. It is a coastal pond and operated between 1972 and 1995. The area at the top level is 7.78 ha, with a tailings amount of 6.68 million tons. The maximum height is 27.67 m, with a slope angle of 26°. Pond D3 is also on the right slope of the river Cisla, downstream of the confluence of the brook Valea Fătului. It is a coastal pond operated between 1980 and 1995, with an area of 6.61 ha at the top level, a capacity of 3.97 million tons and dam height of 32 m with the slope angle of 24°.

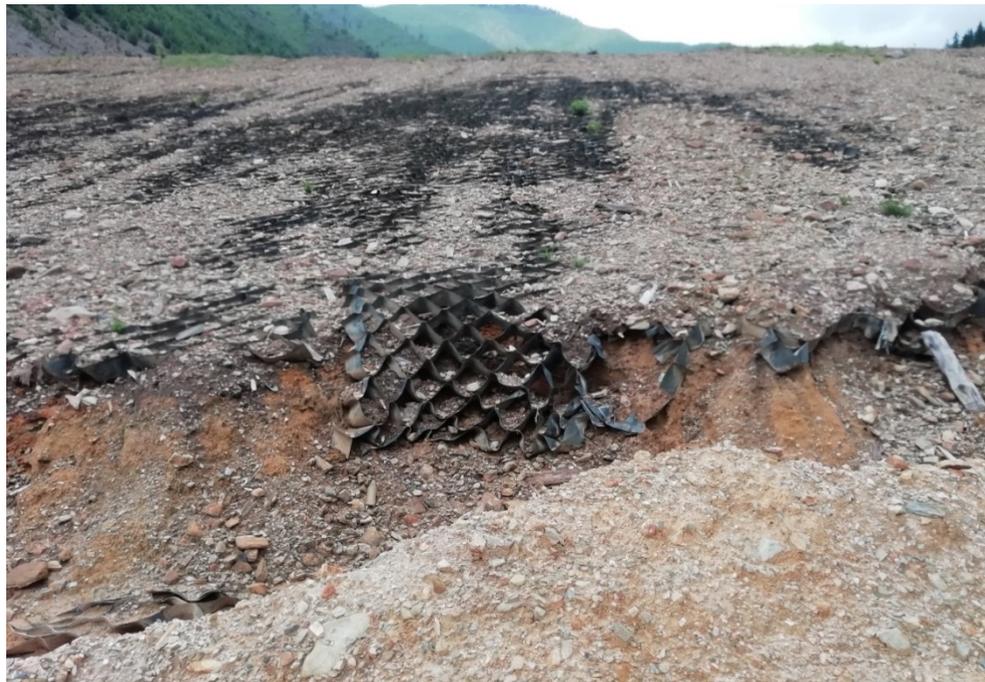
Colbu ponds (1 and 2) are rehabilitated with completely compromised slopes - almost complete unveiling of geogrids, without vegetation, and at the base, acid water leaks (Figures 4 – 6). An aggravating fact, which increases the level of risk, is given by the cutting of the forest on the slopes, both in the area of the ponds and upstream. In the emissary, at the base of the pond, there is still a sterile flotation today - which had to be relocated and stored on the pond, later waterproofed the same time with the whole pond.

**Fig. 4.** The condition of the Colbu tailing pond – external slope (sursa foto: A. Bud, 2020).

The previous photos show the advanced stage of degradation of the slope rehabilitation works, the deforestation upstream and the level of reactivity of the pond through the drainage of acid waters with heavy metals at its base. Also, the acid drainage irreversibly compromises the works made of concrete with Portland cement. Photo 5 shows the leaks through the dam and the detachment of the concrete stones from its base.

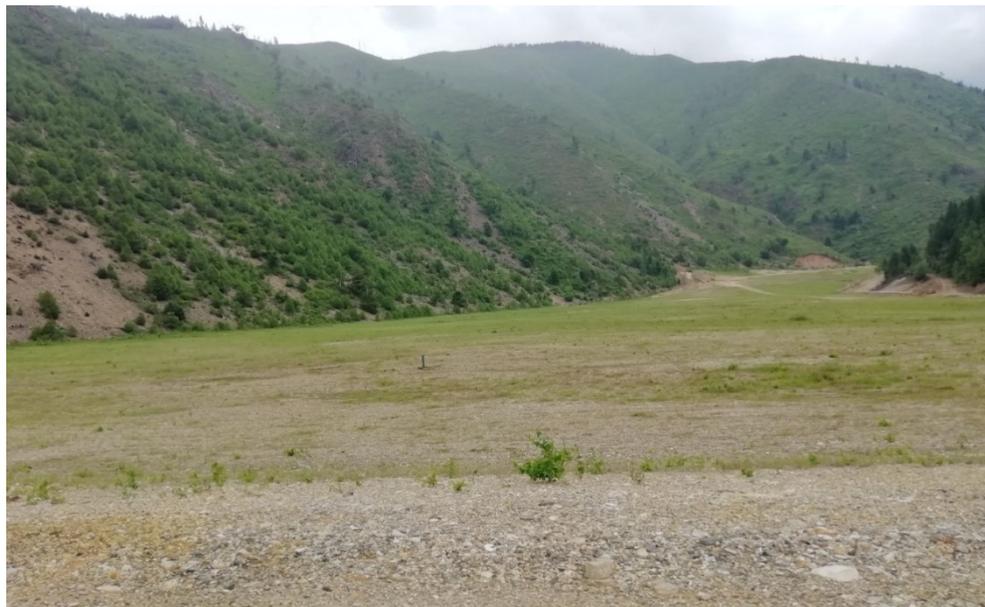
**Fig. 5.** Colbu pond- internal slope and versantul din amonte defrisat (photo A. Bud, 2020).

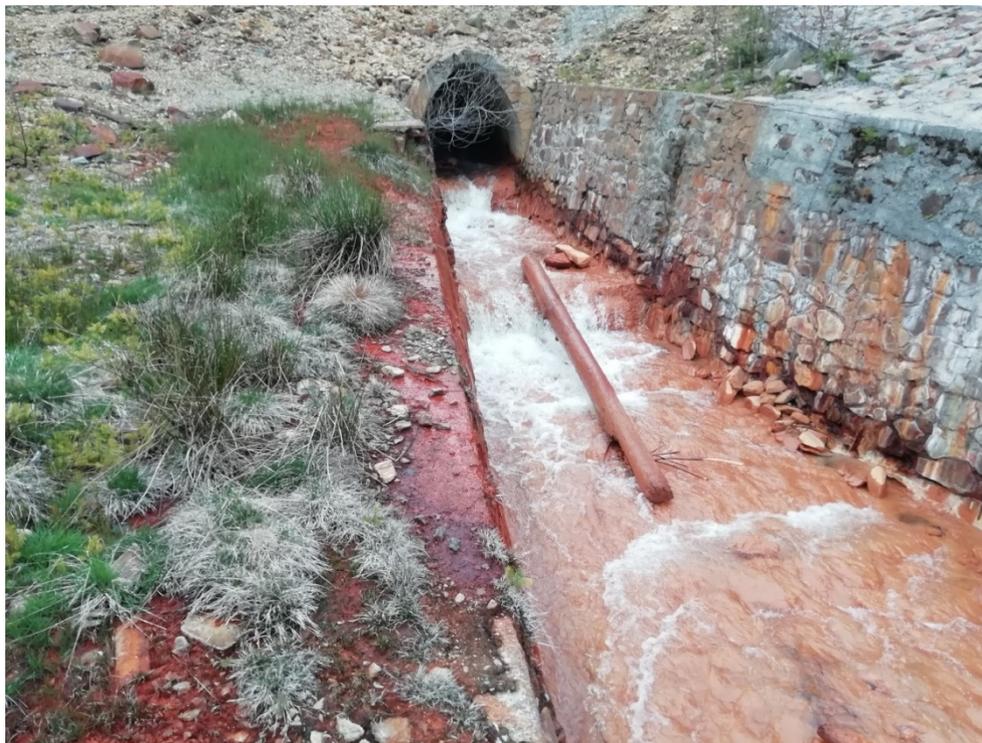
**Fig. 6.** Acid leaks at the base of Colbu tailing pond (sursa foto: A. Bud, 2020).
