Repair of local damages to precast prestressed slab elements at a parking garage

The aim of this paper is to present and discuss the magnitude of damages as well as repair methods for a precast slab in a parking garage of a shopping centre. Numerous structural defects that raised concern were located at the connection zone of prestressed elements. The assessment of the condition of the structure led to necessity of urgent repair.

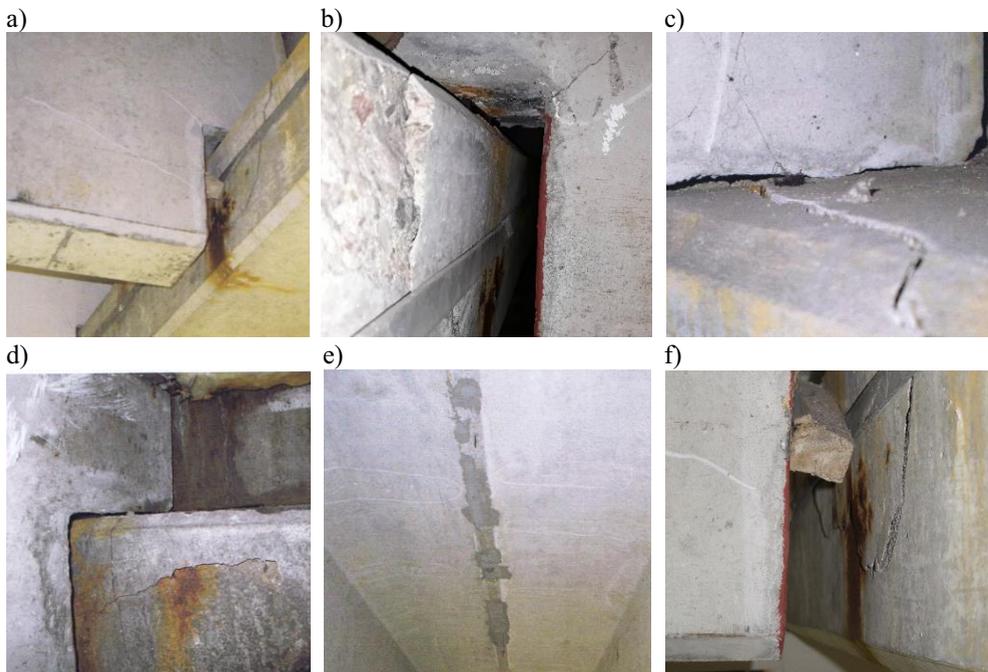
During exploitation of the structure, damages occurred to the double T-slab elements and the inverted T girder. The effected zone was mostly the connection at the pinned support (axis H). The damages to double tee slab elements were the following: the diagonal cracks of 0.3 mm width inclined 30 to 50° in the notch zone (figures 2a, 2b), cracks, splits and concrete spalling (figures 2a, 2b, 2c), surface rust stain and efflorescence (figures 2e). The damages to inverted T girders were the following: splits and concrete spalling (figures 2b, 2c), and surface rust stain (figures 2a, 2d). At the pinned support the elastomeric bearings were crushed. It was observed that the splitting of the concrete often crosses the centre of elastomeric bearings (figure 2c). In the mid span of the double tee elements transverse cracks with efflorescence were found (figure 2e). Many of the expansion joints were exceeding the designed value of 25 mm. One of the expansion joints was 66 mm wide and it was blocked by a wooden scantling (figure 2f).

Fig. 2. Damages to the double T slab elements and the inverted T girder.

If was found that the assessed precast slab was subjected to excessive loading from the top. During renovation of the pavement a layer of subbase and cobblestone was added, which was not considered in the design. Moreover, the loading zone for delivery trucks was located unfortunately directly above the connection of the precast elements. This type of loading was not taken into consideration during the design. The characteristic value of variable load assumed in the calculations was equal to 3.90 kN/m², while the value of the extreme load was 15 kN/m², which was based on the weight of a fire engine. Overloading resulted in crushing of the elastomeric bearings. The double T slab elements became directly supported on the inverted T girder, which provoked uncontrolled rotation of double T precast elements, deformation of the dowel bars, and additional force on the edge of the inverted T girders. Concrete splitting and spalling were obvious consequences of crushed elastomeric bearings. The splitting of the concrete was crossing the centres of the elastomeric bearings and they

were going in the vicinity of the dowel bars and sleeves. The cracks observed in the midspan of the double T slab elements were characteristic for overloaded elements. Their direction was perpendicular to the direction of tensile stresses. At the supports, the diagonal cracks resulted from shear forces, since the value of the bending moment is small. Beyond overloading of the structure, some errors that occurred during assembly of the precast elements were identified. The executed dilatation gaps were much wider than those designed. It was concluded that the girders were forced to fit dowel bars, which resulted in their initial deformation.

Numerous cracks, concrete splitting and spalling, progressed corrosion visible in the form of surface rust stain and white efflorescence in the crack zones raised alert and concern about the safety of the structure. It was stated that the precast elements were at risk of failure and urgent repair was necessary.

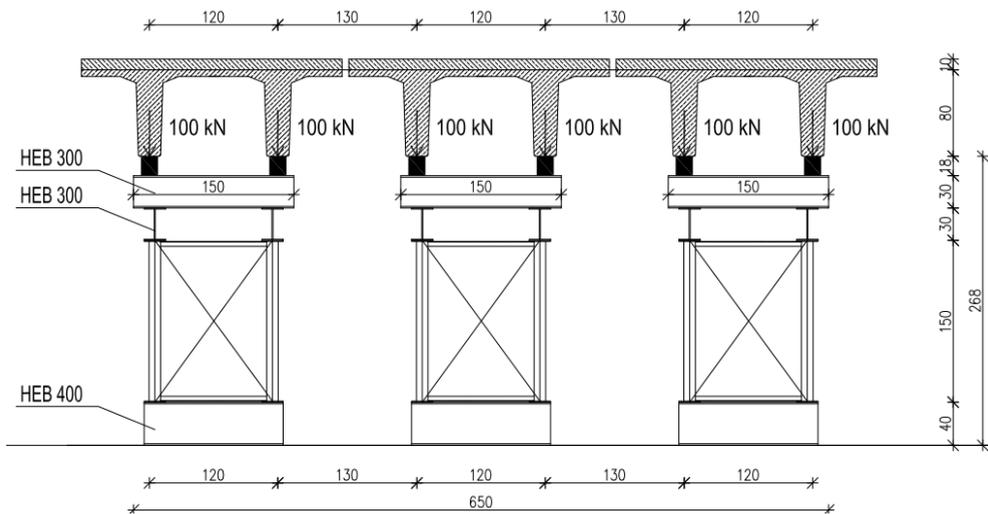
Fig. 3. Schema for the heavy lifting of the precast slab.

Due to the critical state of the structure, the repair works started immediately. The goal of the works was to solve the problem of cracks and splits in the concrete and crushed elastomeric bearings. The damaged part of the structures was put out of service. The double T elements were temporarily supported on both sides, at the distance of 50 cm from the axes of previous supports. The slab was lifted with the use of a jack to provide necessary space for work including strengthening of the double T beams, protecting the inverted T girder and changing of the elastomeric bearings. It was a challenging task, because of the composite action between the precast elements and the reinforced concrete slab. The pavement was removed to observe the cracks at the top of the slab. In order to avoid damage to the continuous slab, also the spans adjacent to the damaged ones were lifted. It was necessary to select the adequate number of jacks, the value of force, and the places of support (figure 3). During the unloading process the vertical displacement of the pre-cast members as well as the supporting girder were monitored with the use of analogue gauges. The space of 11 mm was reached without damage to the composite slab. It was possible owing to the special gasket placed between the prefabricated elements and the cast-in-place slab at the stage of construction. In figure 4, photos from the lifting of the slab are presented.

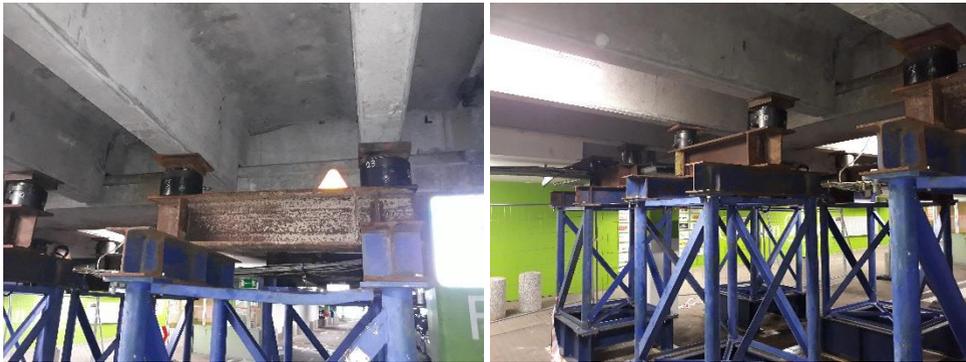
Fig. 4. Heavy lifting of the precast slab.

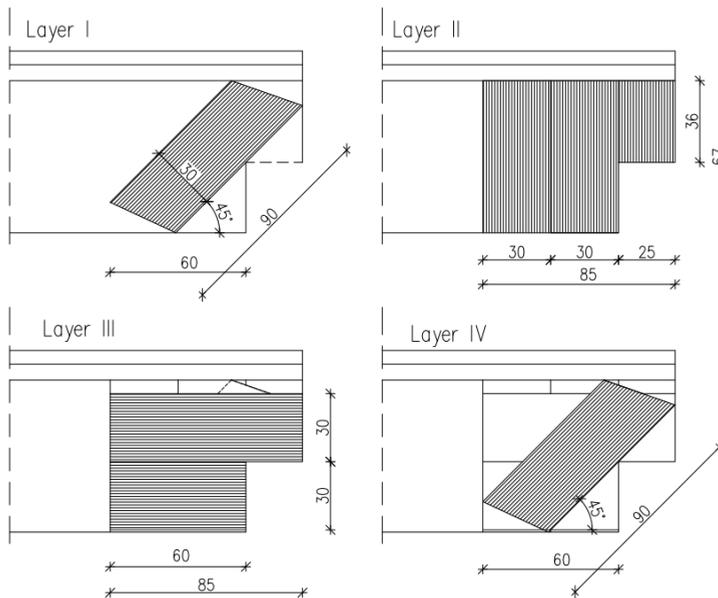
Fig. 5. The orientation of the consecutive layers of FRP wraps.

The process of unloading of the structure facilitated further evaluation of damages. The wooden scantlings and undesired utilities were removed. At the zones of connection of the precast elements, the structure was cleaned from the spalled concrete and mortar in order to fully evaluate all damages. The final version of the project for repair could be elaborated. It included strengthening of double T beams with FRP wraps (figure 5) and protecting the inverted T girder with steel angles (figure 6). Strengthening with FRP wraps became a recognized solution for strengthening of reinforced concrete and other types of structures [5-7]. However, since FRP wraps application in strengthening is a comparatively new solution, the design specifications regarding them still undergo development. There are several available design specifications, for example [8-10].

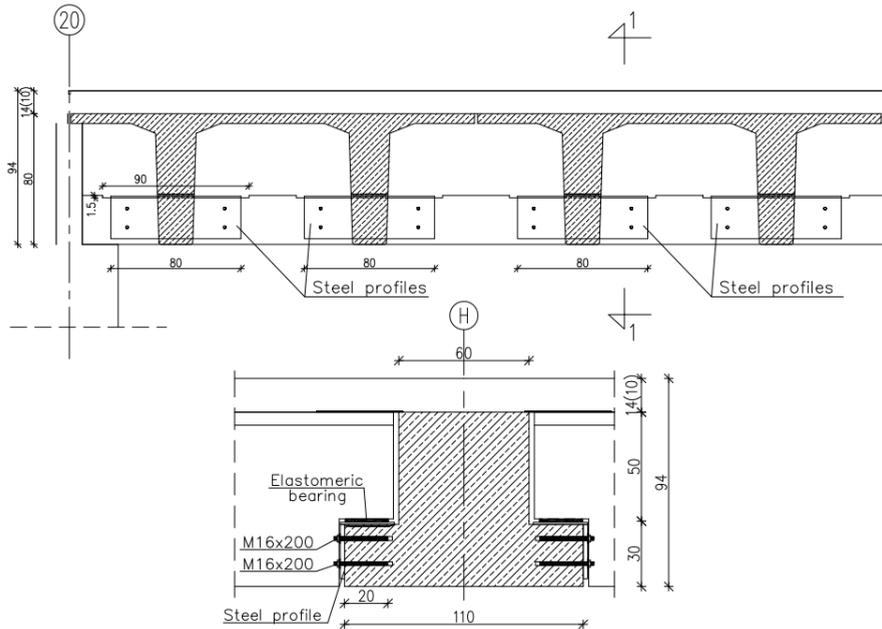
Fig. 6. Protecting of the inverted T girder with a steel angle.

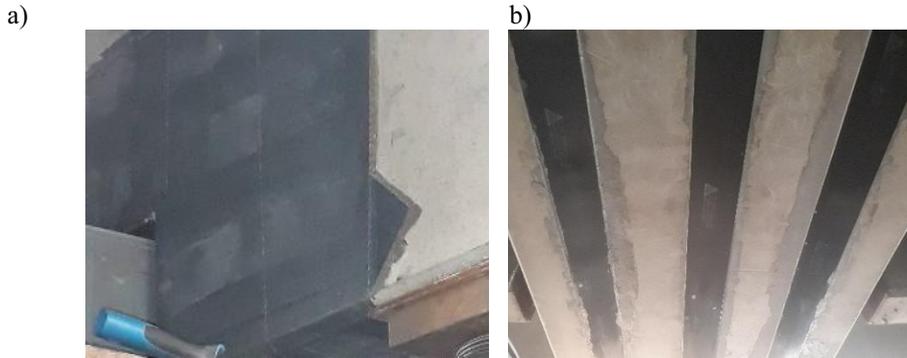
Fig. 7. Strengthening with FRP wraps.

The repair of the structure was started with surface sanding to clean the concrete surface of double T beams and the inverted T girder. Then they were refilled with the PCC mortar. After the curing time of the PCC mortar, the precast girder surfaces were primed for strengthening with aramid FRP wraps in the area with the distance 1.2 m from the support axis. The four layers in the different orientations of FRP wraps (each 0.166 mm) were applied according to the design. They were intended to cover the webs from both sides and envelope them from the bottom (figures 7a). The wet lay-up process with the use of resin was applied. The manufacture restriction was that the next layer must be applied within the 60 minutes (wet to wet). Otherwise, if this time limit was exceeded, it was required to wait at least 12 hours for curing, before starting application of the next layer of FRP wrap. As well, along the bottom flange of the inverted T girder, FRP laminates were applied (figure 7b). Unloading and lifting of the slab, resulted in change of internal forces in the structure and closure of transverse cracks.

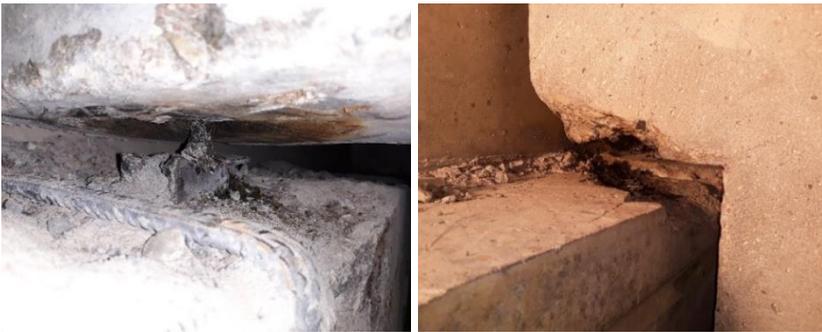
Fig. 8. Removing of the elastomeric bearings and the dowel bars.

The inverted T girder was trimmed 15 mm at the zones of support of the double T beams. It was noticed that the dowel bars needed to connect the precast elements were located too close to the edge of the inverted T girder, which caused cracks in the elements. The damaged elastomeric bearings and the dowel bars were removed (figure 8). Steel angles L 250 x 10 x 250 x 20 mm were used for to protect edges of the inverted T girder and to provide proper support for the precast slab members (figure 9). In the steel angles the holes were prepared and injectable adhesive anchorages were used. Additionally, a resin was used to connect the steel profiles to the concrete surface. Once the full compressive strength of the resin was reached, in the gaps between the steel plates and the precast girder new reinforced elastomeric bearings were placed (figure 10). The elastomeric bearings were designed individually to fit the remaining space. When the curing time of the FRP materials was reached, the structure was slowly lowered to its original position. All temporary supports were removed, and the structure was returned to service.

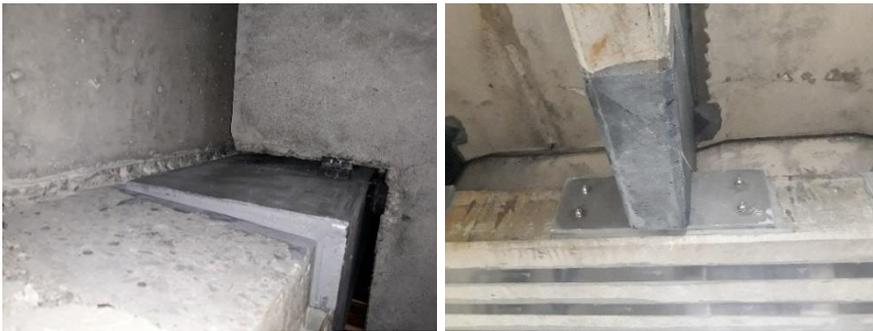
Fig. 9. Application of a steel angle for the inverted T girder.

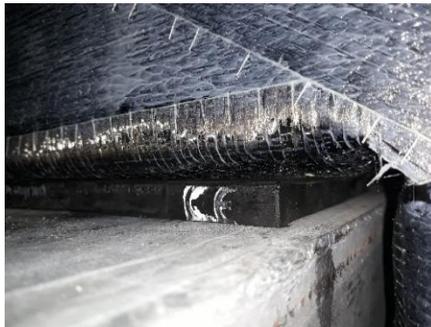
Fig. 10. New elastomeric bearing.
