Diagnosing the technical condition of modern diesel injectors using thermal infrared cameras

Marek Idzior¹ and Wojciech Karpiuk^{1*}

¹Poznan University of Technology, Institute of Combustion Engines and Powertrains, 61-138 Poznań, Piotrowo 3, Poland

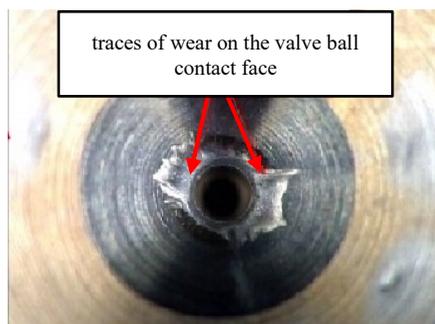
The first generation injectors manufactured by Bosch were used as test subjects (Figure 2). Before starting the tests, the types of defects of actuators and precision pairs, which occur in the above-mentioned injectors, were categorized (Table 1). Due to the common occurrence of mechanical damage of the control valve ball seat surface, it was decided to perform controlled damage of this element. An example photograph showing damage to the ball seat is shown in Figure 3.

**Fig.3.** Control valve seat damage [3].

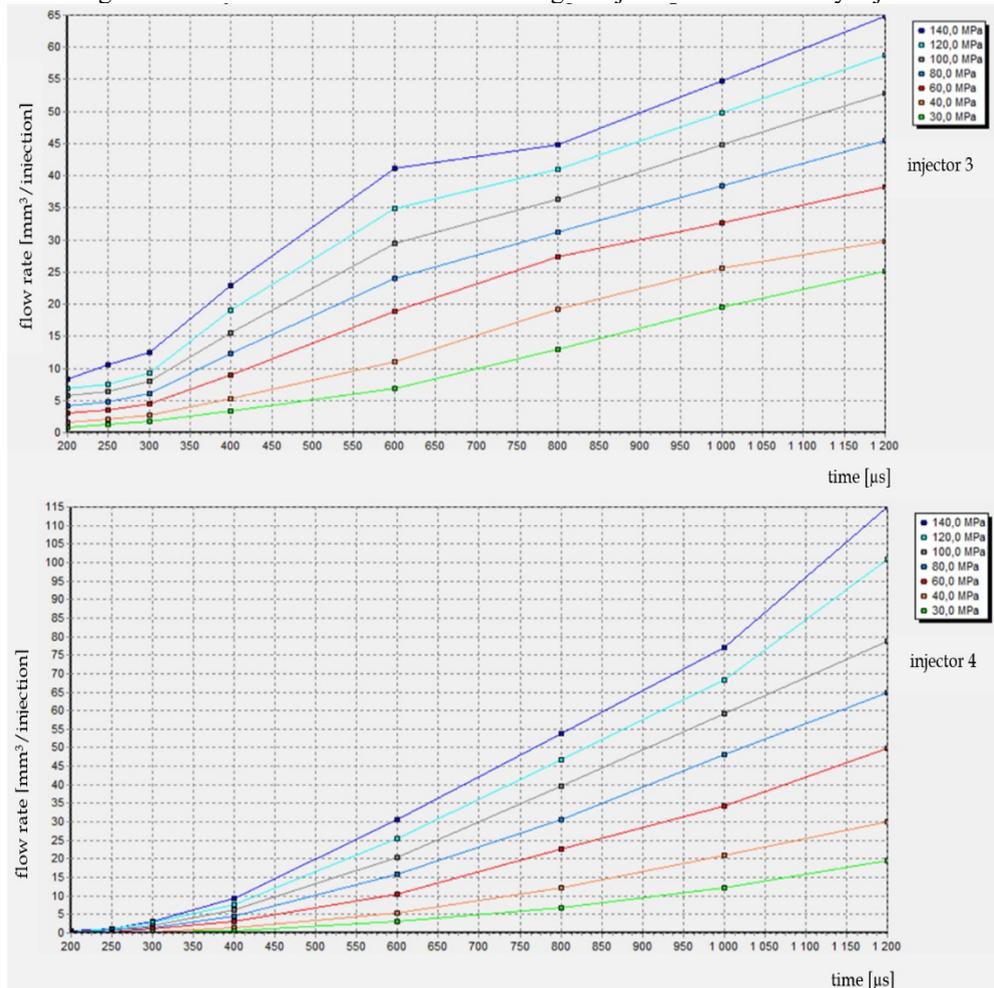
injector is characterized by too low fuel dose (by more than 12%), as well as definitely too high amount of fuel that goes directly to the overflow - as much as 240 [mm³/1 inj], which is 275%. The fourth injector is within the allowed ranges of output and overflow.

The characteristics of the selected injectors performed on the test table are shown in Figure 6. The figure shows the characteristics of the damaged injector and the healthy injector.

Fig.6. Characteristics of selected injectors made on test table (injector 3 – damaged; injector 4 – working).

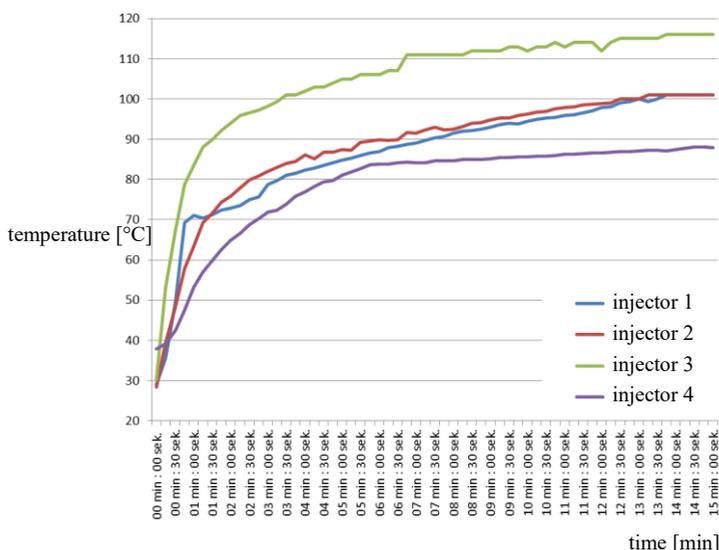
The data series presented in Figure 7, showing the results of body temperature measurements of the tested injectors in the area of the control valve seat, allow us to notice the differences in the rate of heating of the tested injectors. In the case of injector 1, it can be observed that it heats up to a temperature of about 70°C within the first minute of measurements. At the same time, the body temperature of injector 2 was about 65°C. The highest temperature change in that period of time was observed for injector 3. During the first minute of measurements, the body in the area of the control valve seat heated up to about 80°C. The only working injector (No. 4) reached a temperature just close to 50°C during the first minute of testing.

Fig.7. Temperature change of the tested injectors body as a function of working time.

It should be noted that the last injector also had the highest temperature at the start of the test, which is further emphasized by the fact that its heating was the slowest. Similar correlations can be seen for half of the test duration. Over the next six minutes and thirty seconds of measurements, the temperature of the first injector increased by about 20°C.

For the second injector, the temperature rose by 30 °C at the same time, to reach about 95 °C in the middle of measurements.

After seven and a half minutes of operation, the body of injector no. 3 at the location of the control valve heated up to a temperature of over 110 °C, which is an increase of 30 °C compared to the temperature it reached in the first minute of operation. The last injector at the specified time point reached a temperature of 85 °C which represents a temperature increase of about 35 °C.

The next time point at which the body temperature was analyzed is when the test ended. During a time interval of 15 minutes, injector number 1 reached a temperature slightly above 100 °C. Injector number 2 also reached the same temperature, while injector number 3 reached 116 °C at the end of the test, which was 6 °C higher than at the halfway point. The last injector at the end of the test had a body temperature at the location of the control valve of 86 °C. Figures 8 and 9 show the change in body temperature, respectively, of the injector 4 (working) and 3 (damaged), visible during the measurements.

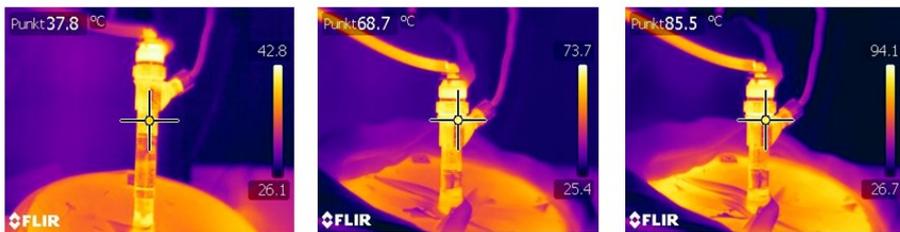
Fig.8. The change in body temperature – injector 4.

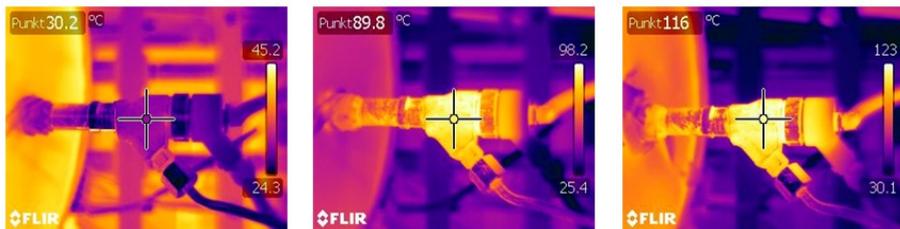
Fig.9. The change in body temperature – injector 3.

to the control valve seat, more heat is released, which can be observed with the use of a thermal imaging camera, thus confirming the correctness of the proposed method.
