# Cause analysis of surface micro-cracks on 12Mn pipeline steel

Yushi Tian<sup>1,2,\*</sup>, Shaoyang Chu<sup>2</sup>, Lijun Xu<sup>2</sup>, Jun Wei<sup>2</sup>, Shengtao Qiu<sup>1,2</sup>, Rong Zhu<sup>1</sup>

**Abstract.** In order to find out the causes of defects in 12Mn pipeline steel produced by a Chinese steel pipe plant, the characteristics of the defects are analyzed and discussed by means of metallographic microscope, scanning electron microscope, ASPEX scanning electron microscope and transmission electron microscope and so on. The physical and chemical tests results show that there are several typical micro-cracks after slight grinding the pipe outer skin in which a few large particles of brittle alumina reside, which possess the macro-characteristics of continuously curving and extending along the radial direction as well as many clear and smooth inner edges and few secondary branches, so that the cracks are not experienced a long and high-temperature oxidation process. The industrial tests indicate that most of the defects have been proved occurred in the quenching and tempering process of the steel pipe production. The main cause of steel pipe cracking is the stres

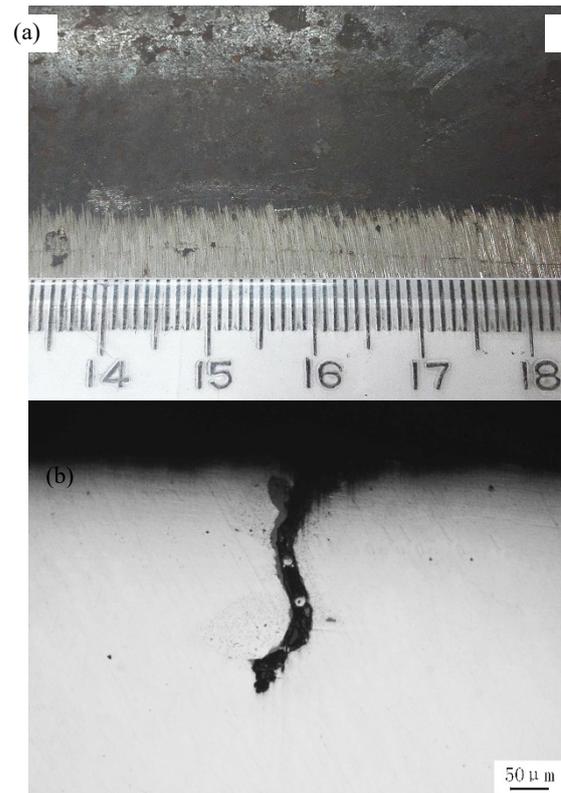
Generally, most of the defects on steel surface are not easy to be found by naked eyes after ultrasonic flaw detection. It is observed that there are several typical micro-cracks after slight grinding the pipe outer skin, as shown in Fig. 2 (a). These micro-cracks are mainly linearly distributed under the outer skin of the steel pipes, most of which are in the shape of slender single line, with the length of about 5 ~ 30cm as well as the width of about 30 ~ 100  $\mu\text{m}$  and the depth of generally less than 1mm. Fig. 2 (b) shows the morphology of the polished cross section of a crack bearing sample, which possesses macro-characteristics of continuously curving and extending along the radial direction as well as many clear and smooth inner edges and few secondary branches.

Figure 2. Morphology of typical surface micro cracks (a) after grinding; (b) crack depth

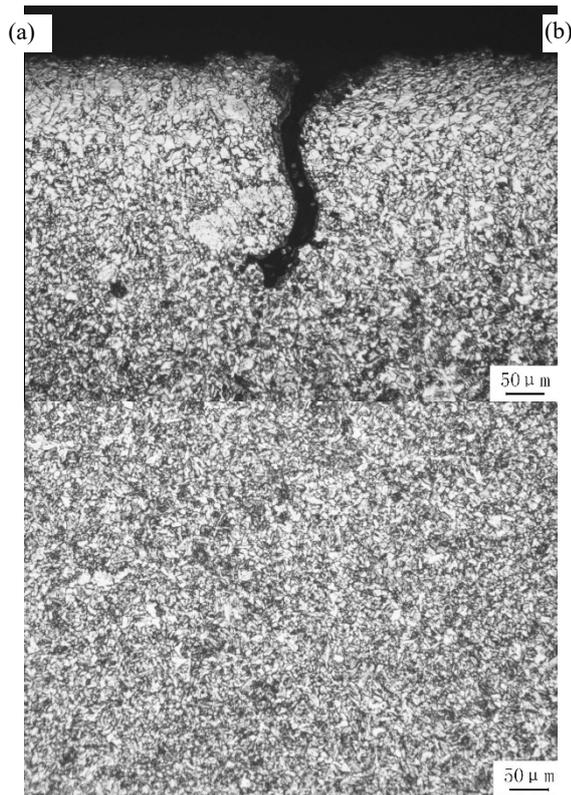
The defects bearing samples were etched with 4% nitric acid alcohol solution after being polished, the microstructures near a crack are shown in Fig. 3. The ferrite grains are slightly coarse near the crack end region, while relatively uniform near the crack tip region, as shown in Fig. 3 (a), which indicates that the region where a crack is located can bear a strong thermal stress during quenching. There is no obvious decarburization phenomenon on both sides of the crack, which shows that the crack is not experienced a long and high-temperature oxidation process. The extension line of the crack tip could be clearly visible in the area where the crack extends along the radial direction of the steel pipe, as shown in Fig. 3 (b), and the matrixes around the crack tip are considered as tempered pearlites which distribute evenly.

**Figure 3.** Metallographic structure of surface crack of quenched sample  
 (a) crack body; (b) crack tip

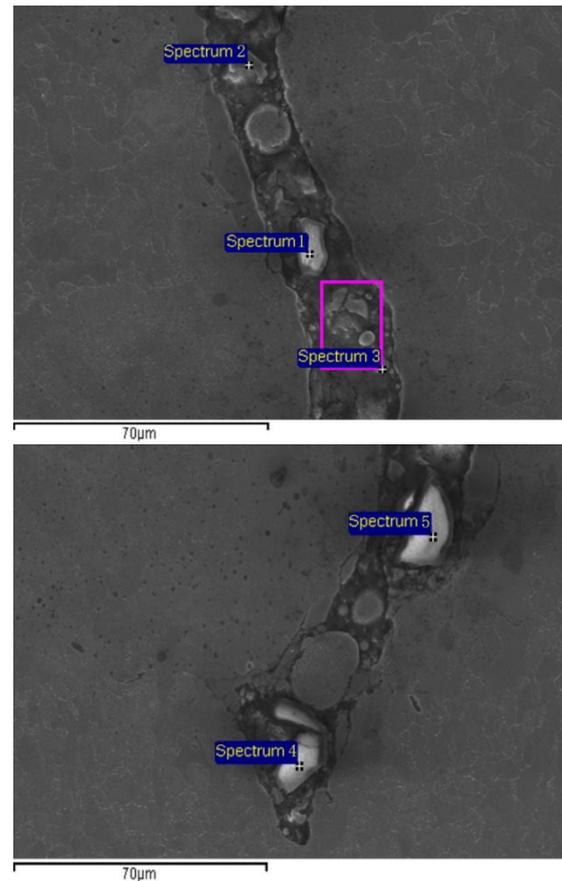
Fig. 4 and Tab. 2 describe the morphology and chemical compositions of inclusions in the crack. The inclusions which are in shape of oval and distributed in the middle and tip of the crack are mainly identified as single-phase alumina with the size of 20 ~ 50 μm. The chemical compositions of the inclusions are almost the same, and there has been found a small amount of titanium element in the crack. Generally, alumina inclusions whose size are less than 100 μm are mostly deoxidized products. In addition, they are difficult to float up and to remove by liquid slag in molten steel, and eventually remain in solidified billet. Alumina inclusions, whose sizes are hardly changed during hot deformation, are characterized by brittleness. If the large size of brittle inclusions gathers in steel pipe, stress concentration point can originate from hot deformation or heat treatment process, which is the most important reason for steel pipe cracking.

In the quenching stage of steel pipe production, the surface layer of steel pipe bears the strong dual effects of thermal stress and transformation stress, which are easy to form a large stress concentration around the large-size alumina inclusions. Once the instantaneous stress exceeds the fracture strength of the steel matrix, micro-cracks will form and extend along the low strength grain boundary.

**Figure 4.** SEM morphology of the inner surface crack of the sample

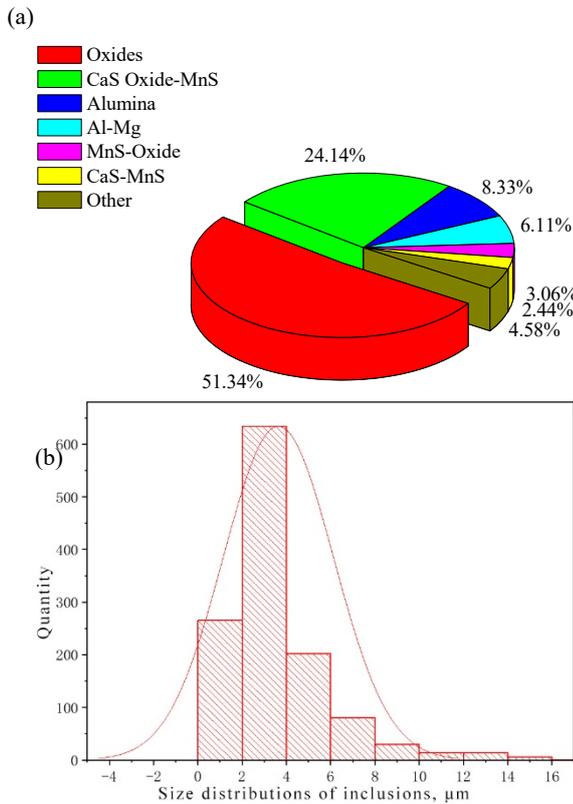
ASPEX scanning electron microscope was used to detect inclusions on the across section with an area of 24.8 mm<sup>2</sup> near the crack, and the size of inclusions is characterized by average diameter. The results show that a total of 1249 inclusions are detected. Fig. 5 (a) shows the main types of inclusions analyzed, in which oxide inclusions account for the highest proportion, followed by sulfide and alumina. Fig. 5 (b) shows the size distributions of the main types of inclusions, it can be seen that most of the inclusions are within 10 μm in diameter, especially that within 2 ~ 4 μm, but there are still a small number of large-size inclusions over 20 μm.

**Figure 5.** Main types and size distributions of inclusions  
 (a) main types; (b) the histogram of size distributions

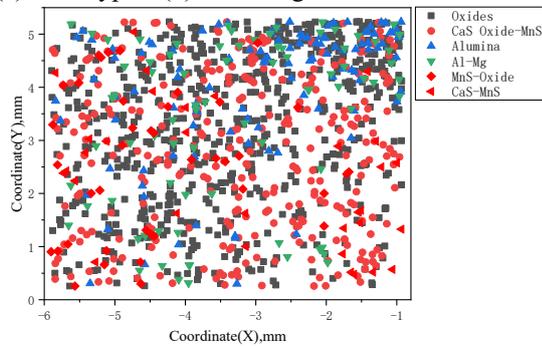
ASPEX can record the coordinate position of inclusions in the detection area, where Y represents the radial direction of steel pipe and X represents the tangent direction of steel pipe circumference. It can be concluded that the distribution of inclusions on cross section of the sample is not uniform, as shown in Fig. 6 and Fig. 7. Many inclusions gather together in an area of the cross section in which there are a few large inclusions scattered, whose

size are larger than 30  $\mu\text{m}$ , which contributes to favorable condition for stress concentration during steel pipe quenching.

**Figure 6.** Location distributions of main types of inclusions

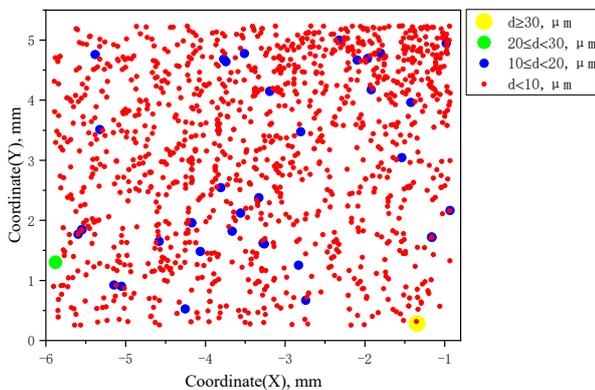
**Figure 7.** Location distributions of main types of inclusions

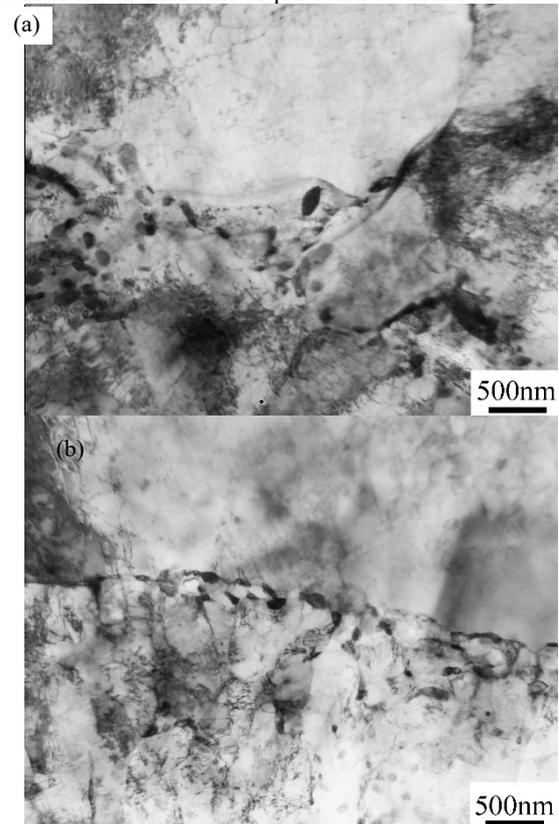
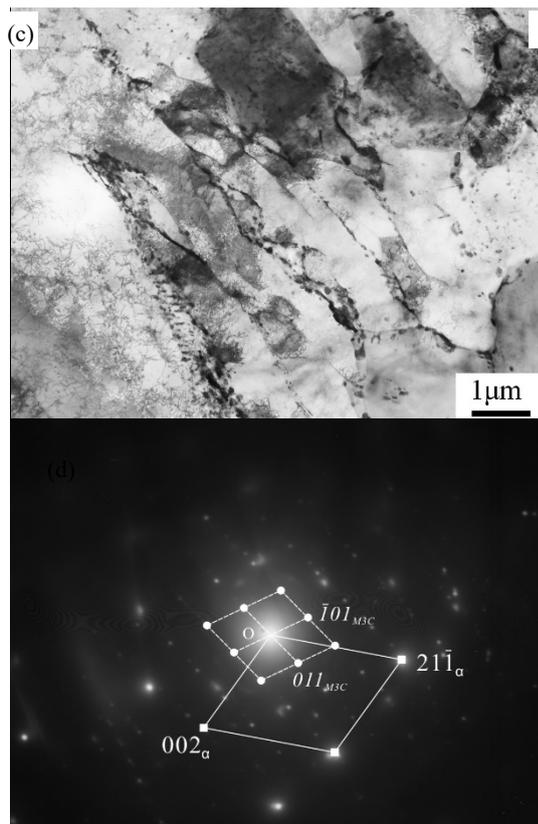
Fig. 8 shows a transmission electron microscope photograph of the matrix near a crack, where Fig. 8(a) and Fig. 8(b) show the typical morphology and location of precipitates, most of which are in the shape of spherical with the size of about 100 ~ 300nm, and distributed along the grain boundary. The diffraction pattern of Fig. 8 (d) shows that these precipitates are granular cementite, and that no other types of precipitates are found.

Fig. 9(c) shows the morphologies of ferrite grain distributed near the crack, which have the characteristic of strip shape. This indicates that the recover behaviors of most ferrite grains only occur at 550 °C tempering temperature, whose dislocation cells and dislocation lines gradually disappear and dislocation density decreases as well as multilateralization occurs, so that sub-grains are formed. The mechanical mixtures of the recovered ferrites and granular cementite form tempered pearlite, which effectively eliminate the residual internal stress in the steel pipe and obtain good comprehensive mechanical properties. All the properties of tempered steel pipes without cracks meet the requirements of API 5L.

**Figure 8.** Precipitates near the crack (a) and (b) the location of the precipitates; (c) grain shapes; (d) diffraction pattern

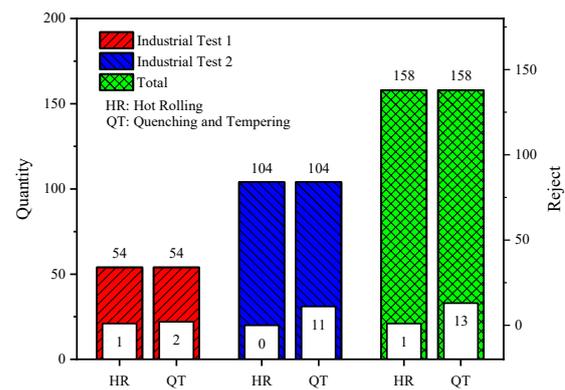
In order to determine the source process of steel pipes cracking, there were 158 hot rolled pipes selected from the same casting scheme for two industrial tests, where 54 steel pipes were tested in the first time and 104 steel pipes were tested in the second time. Fig. 9 shows the flaw detection results of the industrial tests and indicates that there is 1 unqualified steel pipe occurred after hot rolling process in the first test while 0 unqualified steel pipe in the second test, and 2 unqualified steel pipes occurred after quenching and tempering process in the first test while 11 unqualified steel pipes in the second test.

To sum up, there is a total of 1 unqualified steel pipe occurred after hot rolling process with the defect rate of 0.63% and a total of 13 steel pipes occurred after quenching and tempering process with the defect rate of 8.23% in all 158 steel pipes tested. Therefore, it's almost certain that most of the defects have been proved occurred in the quenching and tempering process, and that almost all of them are considered as micro-cracks under the outer skin of the steel pipes.

**Figure 9.** Industrial test results

In order that increasing cleanliness of steel billets should be effective it must be planned systematically. The total oxygen content in steel can be more stringent controls for decreasing large inclusions on optimizing the steelmaking process, such as adjusting soft blowing time, improving protective casting, avoiding slag entrapment, using a new type tundish covering agent and so on. The subcutaneous micro-cracks of steel pipes have been eliminated since taking steelmaking process optimization measures, so that the product quality and productivity of steel pipes are significantly improved.
