Structural and material assessment of historic reinforced brick masonry elevator for grain – a study case

Abstract. The grain elevator was erected around 1940 and is situated at the Odra River embankment. It has a rectangular plan with the longer side perpendicular to the former port wharf. The structure of the building is mixed, made of reinforced concrete and brick masonry. The entire facility was founded on a reinforced concrete foundation slab. The ground floor columns, supporting the silos, the walls of the ground floor, the floor above the ground floor with silo drainage funnels, the inter-story ceilings of the technical route, the roof concrete frames and the attic ceiling are made of reinforced concrete. The main part of the structure consists of 74 interlocked grain silos, with a square cross-section. The walls of the silo chambers are brick, reinforced with steel bars in each joint. The article presents the results of diagnostics of the technical condition of the assessed object, including material analyses (concrete, brick, steel), as well as the results of static and strength calculations of the main load-bearing elements of the object conducted in order to verify the

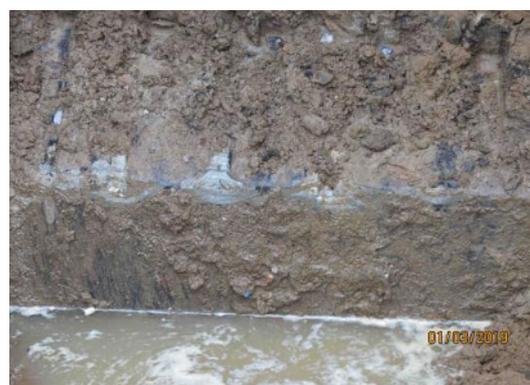
According to the archival documentation as well in made outcrops, the entire building was built on a foundation slab of 75 cm thickness, protruding 0.5 m beyond the face of the external walls (Figs 3, 6, 11). In the drillings made inside the building, the presence of the upper reinforcement of the slab with smooth steel bars was in accordance with the archival documentation - Ø8 mm bars in the span every 14 cm and Ø20 mm between the columns approx. every 20-22 cm. Groundwater appeared in the trench at the foundation level of the building (Fig. 11). There was also no visible damage to the slab or walls above it which would indicate poor operation of

the foundations. In connection with the above it was assumed that the building foundations are in good technical condition and would be able to safely transfer the designed loads related to the adaptation of the building for residential purposes.

Fig. 11. View of the foundation slab outcrop.

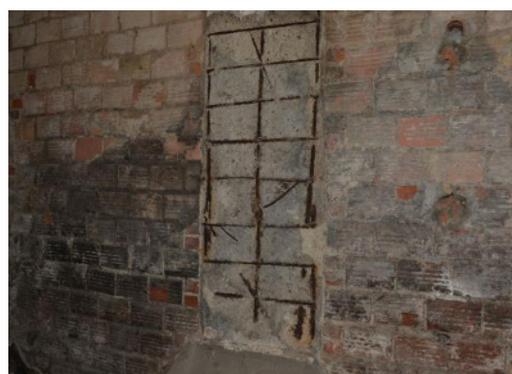
Fig. 12. Example of the ground floor columns' reinforcement corrosion.

In static calculations it was proved that the columns have sufficient load-bearing capacity to transfer the designed loads. Generally, the technical condition of the columns was assessed as good. No damage was found, except for a few columns at the outside wall where the concrete cover and the reinforcement itself were deeply corroded (Fig. 12).

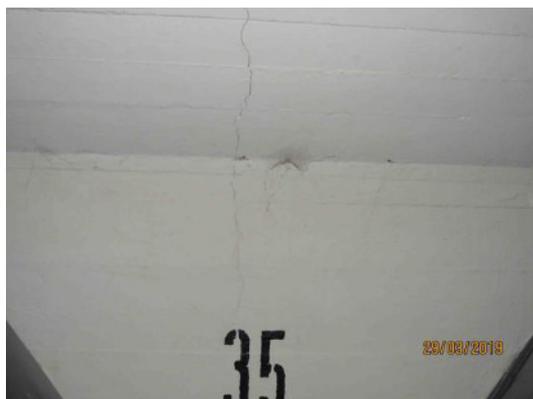
The ceiling above the ground floor was made in the form of a reinforced concrete slab with a thickness of 90 cm, it rests directly on the pillars of the ground floor and also serves as the bottom of the silos - there are discharge hoppers in it. The technical condition of the ceiling was evaluated as poor. It had cracks in every area of the silo chambers (Fig. 13).

Fig. 13. Cracks in the slab over the ground floor.

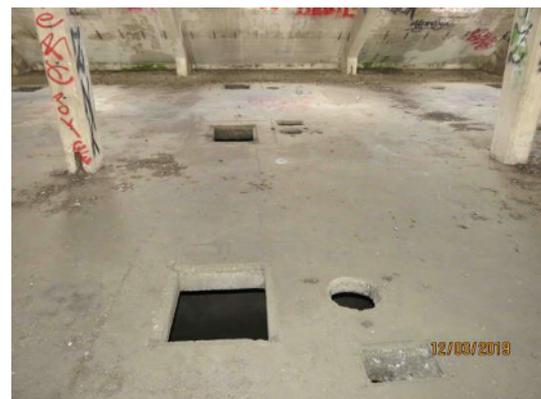
The attic ceiling covers the entire surface of the building and the silo chambers - their charging and technological openings are located in it (Fig. 15). The ceiling is 12 cm thick and is cross-reinforced at the bottom with Ø10 mm bars every 18 cm, and above the supports (chamber walls) with Ø10 mm bars every 18 cm. No upper reinforcement was found in the open-pits above the chamber walls, while lower reinforcement was found in accordance with the archival documentation. The static calculations showed that despite the lack of support reinforcement, the floor has sufficient load-bearing capacity to transfer the new designed loads. Despite local mechanical damages, its technical condition was assessed as sufficient.

Fig. 15. The attic slab over the silo chambers.

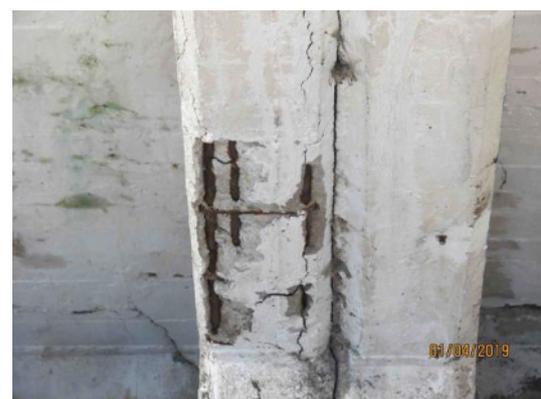
Fig. 16. Local destruction of the roof frames reinforcement.

The reinforced concrete frames of the roof were in a satisfactory technical condition, although most of them have cracks, and several have suffered from significant local loss of the cover and corrosion of the reinforcement (Fig. 16).

The static calculations showed that when the existing Klein board would be left between the roof frames, the upper rafters of the frames would not have sufficient load-bearing capacity to transfer the designed loads related to the roof insulation. In the case of dismantling the Klein slab and replacing it with a glass roof cover the frames would have sufficient load capacity.

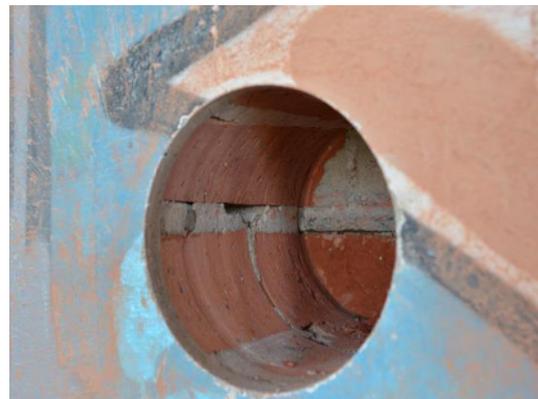
For the testing of structural strength of brick walls, 3 core boreholes of Ø150 diameter were taken from the walls of the silos (Fig. 17) and tested to failure in compression. From the destructive tests the compressive strengths were obtained as follows:

Fig. 17. Borehole in the masonry silo walls.

Comparatively, the results of sclerometric tests for bricks were made. In those cases rebound numbers obtained were between 42 and 58. Based on the visual inspection and charts from the research literature [6, 7, 8], for all masonry elements, a characteristic value of the strength was assumed as $f_k = 5,600 \text{ kPa}$, material coefficient $\alpha_m = 0.5$, design strength for compression $f_d = 5,600 \times 0.5 = 2,800 \text{ kPa}$, the material elastic coefficient $a_m = 1,100$ (according to the adopted design code PN-67/B-03002).

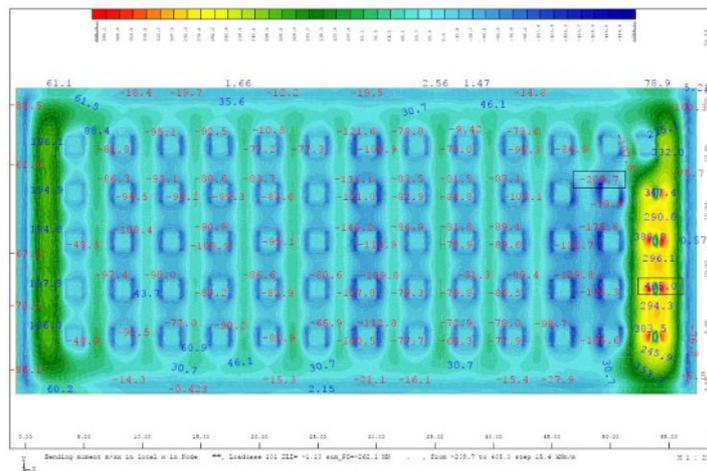
Calculations of the foundation slab were performed as for the slab on an elastic foundation (Fig. 18). The arrangement of the soil layers under the slab was adopted in accordance with geotechnical tests, additionally assuming that the groundwater level was stabilized at the foundation level. As the building was used for a long time with high loads and there was a significant consolidation of the soil underneath it, the foundation slab was additionally calculated as for the inverted mushroom ceiling, evenly loaded with ground resistance (Fig. 19).

Independently, from the static models used for the slab, calculations showed that after the building is adapted for residential purposes the foundation slab will be affected by much lower loads than when the building was operated as a grain elevator, and that it has sufficient load-bearing capacity to transfer the designed loads.

Fig. 18. Bending moments M_{xx} – model of slab on elastic foundation.

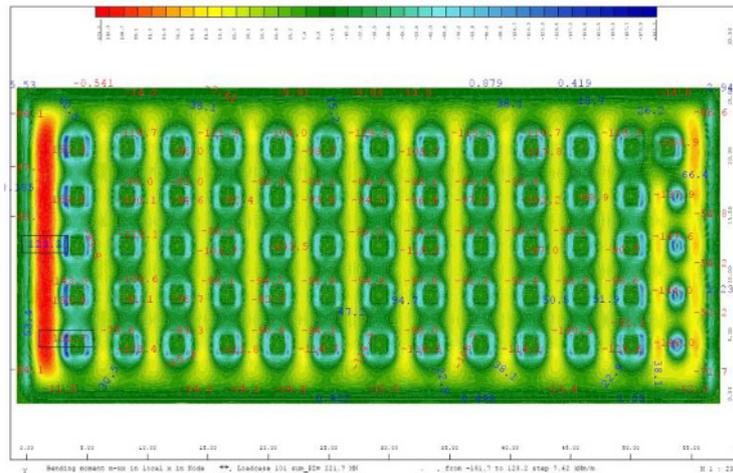
Fig. 19. Bending moments M_{xx} – model of inverted mushroom slab.
