Impressed current cathodic protection of reinforced concrete in ATEX-zones – Case study: concrete slab in an industrial building

Bjorn Van Belleghem^{1,*}, Ben Smits², Hans van den Hondel³, Mathias Maes¹, Tim Soetens¹

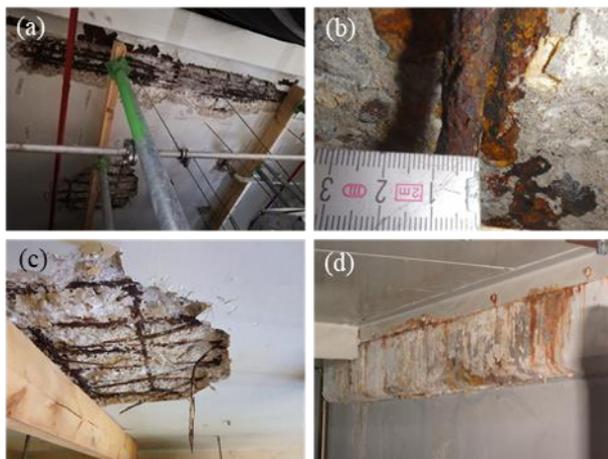
The damage, visible at the bottom of the concrete slab, was mainly characterized by cracking, spalling and delamination of concrete due to corroding steel reinforcement (see Fig. 2a). Pitting corrosion of the reinforcement was noticed (Fig. 2b), which at some locations had led to breaking of rebars (Fig. 2c). Also, deposition of corrosion products in the surrounding concrete matrix was detected (see Fig. 2b) and damage (cracking) of previously executed patch repairs was observed.

Next to the damage phenomena related to reinforcement corrosion, visual traces of leakages were observed at the edges of the floor slab (Fig. 2d).

Fig. 2. Examples of damage phenomena at the bottom of the concrete floor slab.

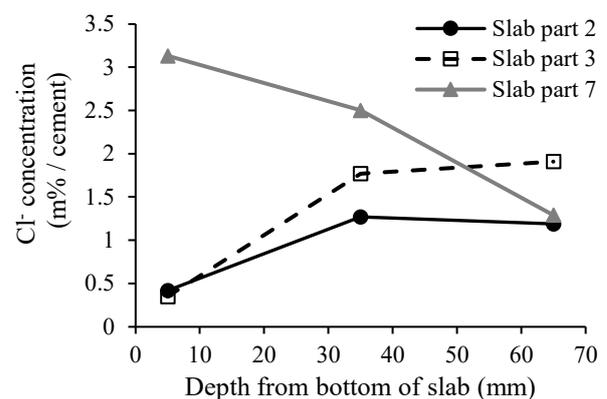
Fig. 3. Chloride concentration profiles.

In slab parts 2 and 3, an increasing chloride profile from the bottom of the slab was detected. As the cores in these parts were taken near the middle area of the slab, this suggests a chloride ingress from the top of the slab.

For slab part 7, the chloride concentrations decreased from the bottom of the slab, which can be explained by the fact that the core in this part was taken near the unsupported edge of the slab where traces of leakage were noticed. It can thus be assumed that the chloride ingress at this position mainly occurred from the bottom due to leakage of chloride containing solutions at the edge of the slab.

For all three locations a very high chloride concentration, ranging from 1.3 to 2.7 % by mass of cement, was measured at a depth of 30-40 mm from the bottom of the slab. This indicates a very high risk for chloride-induced reinforcement corrosion.

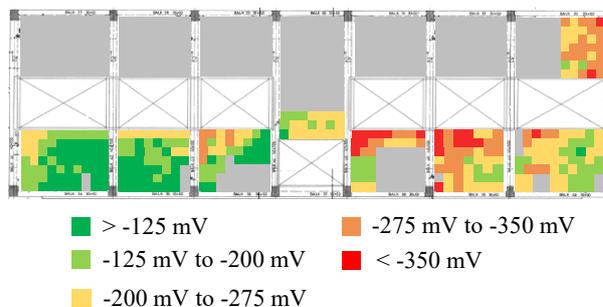
The potential mapping colour plot (Fig. 4) qualitatively shows that in general more positive half-cell potential measurements are obtained for the left half of the floor slab (slab parts 4, 5, 6 and 10) compared to the right half of the floor slab (slab parts 1, 2, 3 and 7).

Fig. 4. Half-cell potential mapping.

Next to the general difference between the left and right half of the slab, more negative values of the half-cell potential near the edge of the slab parts adjacent to the openings in the middle area can be observed (Fig. 4). The higher risk for reinforcement corrosion near the edges of the slabs can be linked to the visually observed leakages (see Fig. 2d).

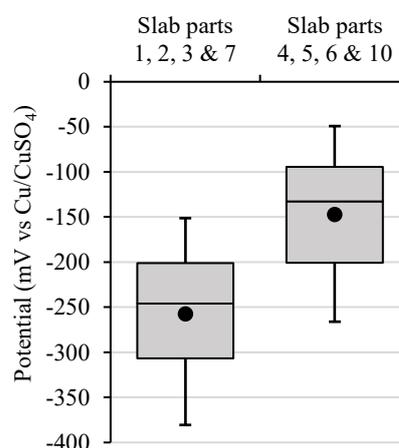
A quantitative analysis of the measured half-cell potential values in both halves of the floor slab is represented by the box plot in Fig. 5. A significant difference in half-cell potential was obtained between the left and right half of the floor slab, indicating a significantly higher risk for reinforcement corrosion in the latter half of the slab.

Fig. 5. Box plot of the half-cell potential data (● = mean value).

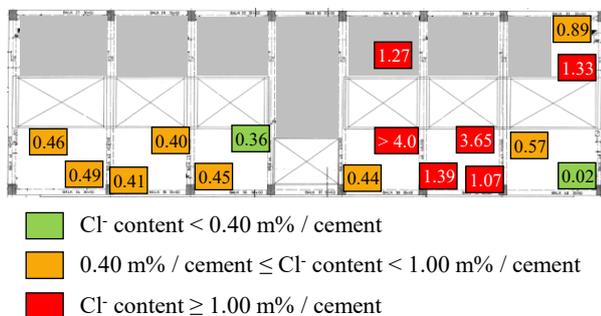
Fig. 6 shows that the chloride concentrations at the reinforcement for all locations in the left half of the slab (i.e. slab parts 4, 5 and 6) were close to 0.40 % by mass of cement, which is commonly considered as the critical chloride concentration (cf. standards EN 1504-9:2008

[3] and EN 206:2013 [4]). For the measurement locations at the right half of the slab, 6 out of 10 measured chloride concentrations were higher than 1.00 % by mass of cement, indicating a very high chance for initiation of corrosion.

Generally, the chloride concentration measurements showed a good correlation with the half-cell potential measurements in the sense that the risk for chloride induced reinforcement corrosion was significantly higher in the right half of the floor slab compared to the left half.

Fig. 6. Chloride concentration (m% / cement) at the level of the reinforcement.

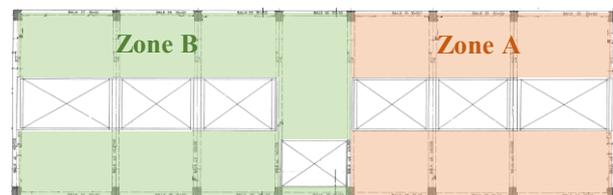
Fig. 7. Zones of the CP system.

As the condition assessment showed a considerable difference in the severity and risk for reinforcement corrosion between the right half and left half of the concrete slab, the two halves were divided into two separate zones in the CP system, further referred to as zone A and zone B (see Fig. 7) with a surface of 100 m² and 130 m², respectively.

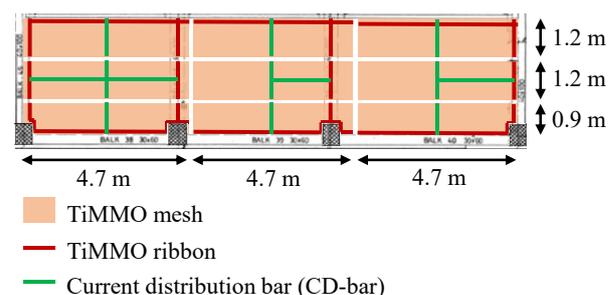
Fig. 8. Detail example of the anode field design for slab parts 1, 2 and 3 (one anode field = TiMMO mesh + ribbons at locations above beams and at the unsupported edges of the slab).

As shown in Fig. 8, slab parts 1, 2 and 3 were divided into 9 separate fields (6 fields with dimensions of 4.7 m x 1.2 m and 3 fields with dimensions of 4.7 m x 0.9 m). Each field contained a titanium current distribution bar (CD-bar), welded to the TiMMO mesh and ribbons within one field in order to distribute the current from the power supply to the TiMMO anode. Each field also contained an anode connection by means of a copper wire which was connected to the current distribution bar. A photo of the installed anodes is shown in Fig. 9.

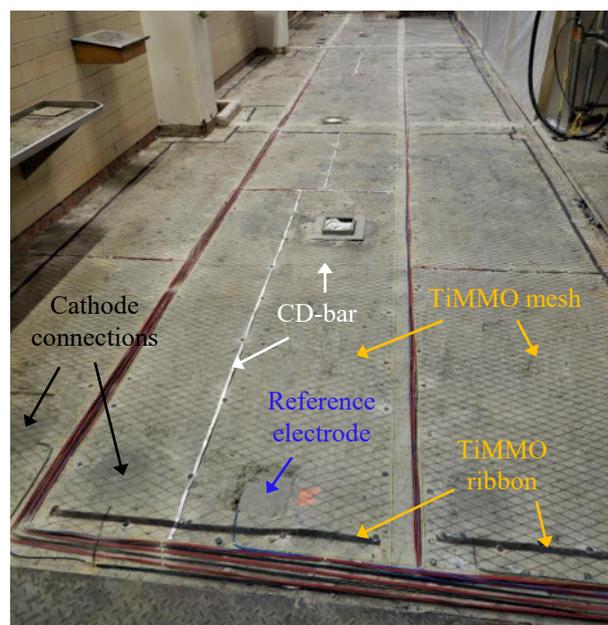
Fig. 9. Installation of the ICCP system.

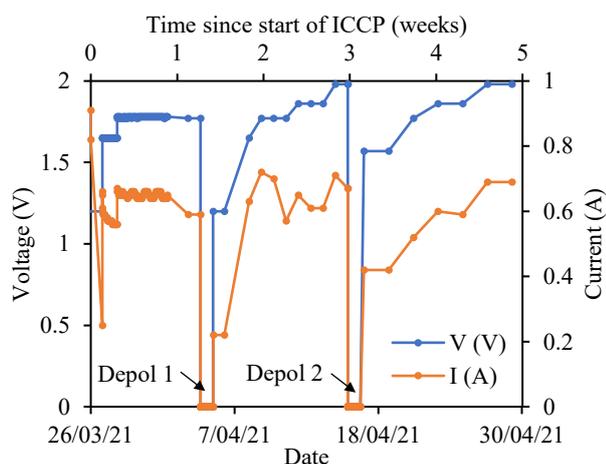
Fig. 11. Applied voltage and measured current of the ICCP system in zone B during the first 5 weeks (commissioning period).

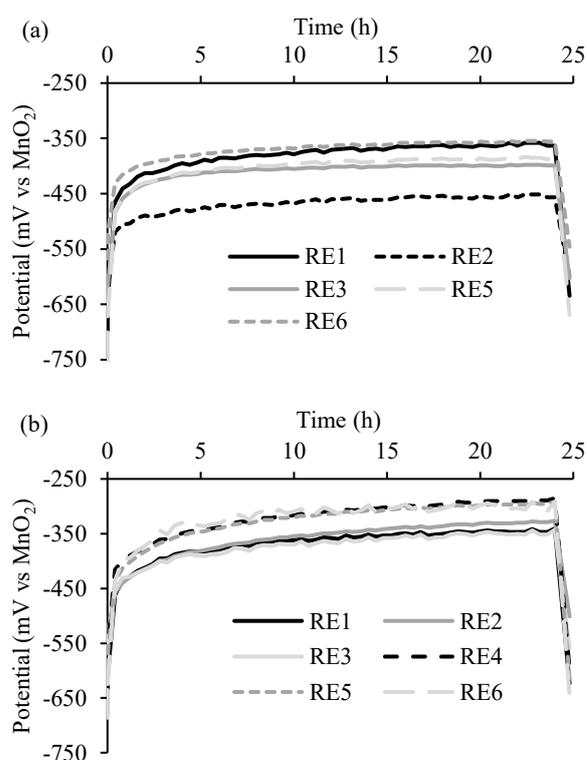
At all measurement locations in both zones of the ICCP system, a minimum depolarization (i.e. potential decay over 24-hours) of 100 mV was obtained, indicating that the steel reinforcement was sufficiently protected against corrosion (cf. the ‘100 mV depolarization criterium’ given in the European standard EN ISO 12696 [6]).

Fig. 12. Depolarization measurements for (a) zone A and (b) zone B at day 21 (16/04/2021).

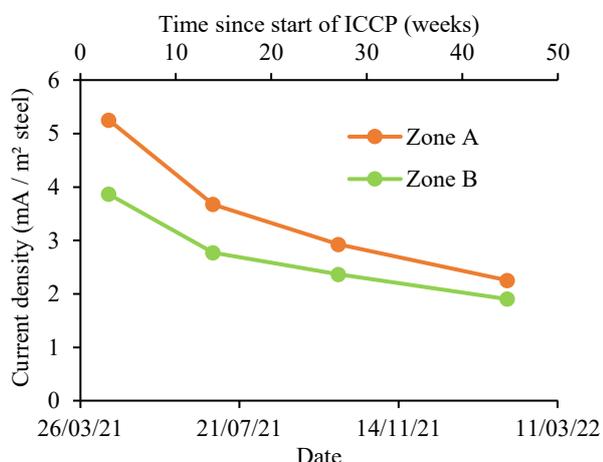
The current density is higher for zone A compared to zone B, which can be linked to the higher corrosion activity at the reinforcement in the former zone.

Fig. 13 also clearly shows that the current density decreases with time for both zones, which can be attributed to a decreasing current demand of the reinforcement due to continued polarization of the steel. Furthermore, the difference in current density between zone A and zone B also decreases with time, indicating

that the high corrosion activity in zone A is effectively countered by the CP system, as the current demand becomes more similar to zone B.

Lastly, the current density lies within a general range of 1.9 to 5.3 mA/m² steel. This is much lower than the adopted design current density of 20 mA/m² steel, indicating that the design was conservative.

Fig. 13. Evolution of current density.
