Performance evaluation of patch repairs on historic concrete structures (PEPS): the evolution of conservation repairs on the Historic England Phase II test sites and PEPS Phase II results

Nicola Lauder¹, and David Farrell²

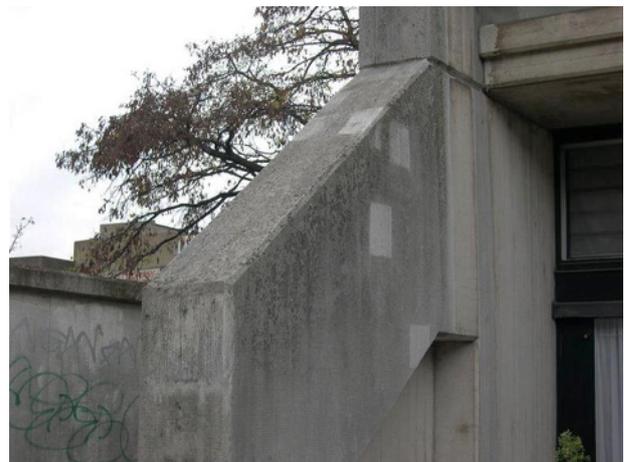
At the Alexandra Road Estate (an extensive housing development dating from the 1970s), repairs were needed after only 25 years because of the low cover to the steel reinforcement when the estate was built and subsequent corrosion. Many areas of corroding steel stained the white concrete surfaces. Approximately 11,000 patches had been placed during a repair contract between 1997 and 2001. When Historic England was first involved in this site in 2001, information on the specification of the commercial products used for the repairs was sought, but unfortunately data sheets were no longer available. The repairs were specified as being 3mm thick, but this was later increased to 6mm, still thin but dictated by the workmanship of the original construction.

Figure 1 shows how the patch repairs appeared during the Phase II assessment in 2019. They had not coloured down to blend with the parent concrete, nor did they allow biological growth to establish. Shrinkage cracks were evident around the edges as well as cracking and crazing within the patches. The patches contained no large aggregate to match with the parent concrete and the texture was also different. In some patches, steel was found to be corroding and hollowness was also detected. The Phase II tests showed that the cover to the steel was often only a few millimetres deep and sometimes it was breaking through the top surface. The patch surfaces

repelled water suggesting that they were early polymer-modified mortars.

Figure 1. Typical 1997 polymer modified mortar repairs on the Alexandra Road Housing Estate in London. The estimated 11,000 thin patches had shrunk and cracked, and the polymer type surfaces had failed to allow normal algae and mould growth to become established.

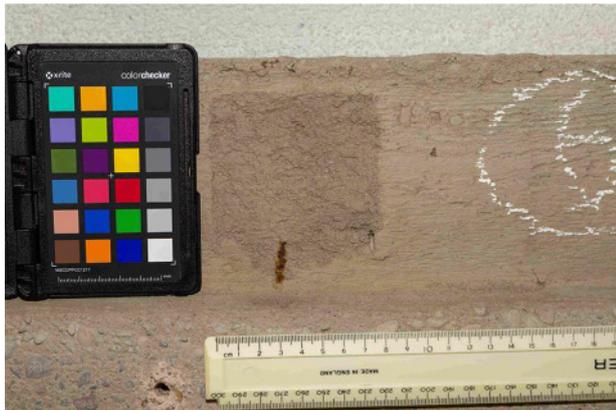
Many of the patches showed defects including cracking, crazing, poor texture and match to the parent concrete as well as ongoing corrosion of steel reinforcement with shallow cover; an example is shown in Figure 2. Cover meter readings indicated that the steel within the patch had only a few mm cover but hammer tapping showed that most patches were still bonded to the parent material. The repairs did not contain any large aggregate to match with the original concrete and the texture was poor. Both the parent and patch surfaces absorbed water suggesting that this polymer modified mortar was different to the one used in 1997 on the Alexandra Road estate.

Figure 2. Typical modern (2010) polymer-modified shallow repair patch from the Phase I repairs at a block of residential flats – this showed a poor surface finish which had been unified with the parent by coatings. Ongoing corrosion of embedded steel was noted in many of the patches.

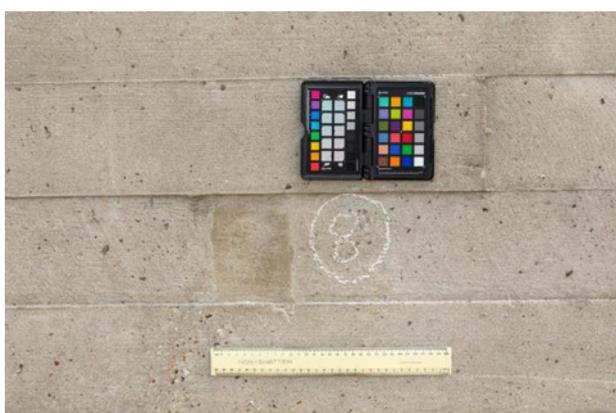
Figure 3. Small like-for-like mortar patch repair at the National Theatre (most probably over some form of redundant wall fixing) which showed reasonably good colour and texture to the parent concrete after 6 years exposure.

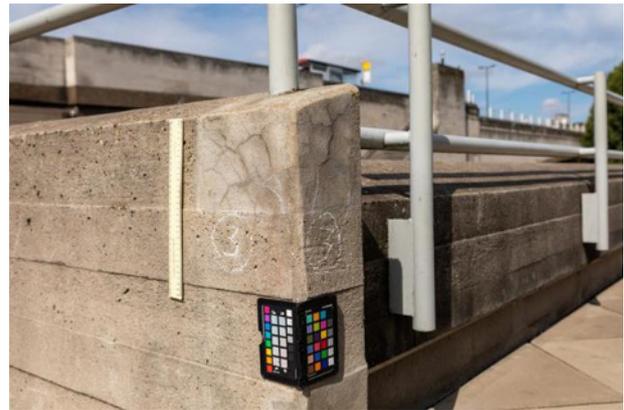
Figure 4. This repair patch at the National Theatre had been made using a polymer modified repair mortar with a thin like-for-like mortar layer (12mm) on top in 2013. Some 6 years later it was showing cracking and crazing to the outer layer

The results from some of the later repair patches at the National Theatre were disappointing. The results showed that the early small like-for-like repairs had both a good colour and texture match to the parent and were still in a good condition after six years. However, some of the later ones, where the contractor started to mix a commercial polymer-modified repair base layer with a like-for-like mortar top layer were poor. This is not particularly surprising as polymer-modified repair mortars have excellent adhesion to ordinary cementitious concrete and can be applied in very thin layers, whereas like-for-like cementitious concrete repairs have a much lower adhesion and need to be applied as thicker layers. Like-for-like concrete repairs have very poor adhesion to polymer modified mortar surfaces and the mixing of these two different materials is not recommended.

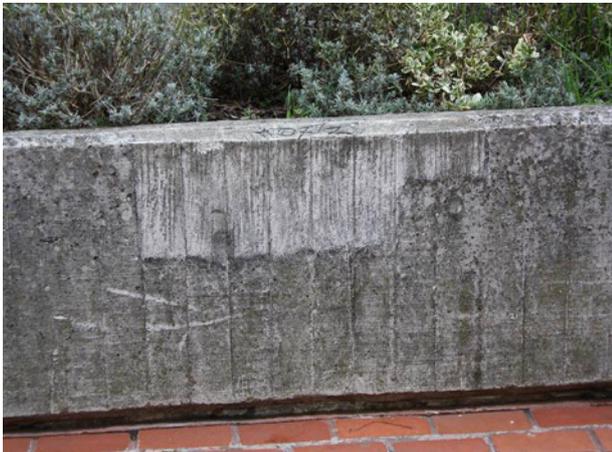
Figure 5. Like-for-like concrete trial repair from 2001 at the Alexandra Road Estate showing reasonable weathering which supported mould and algal growth after 5 years. The board-marked surface finish was poorly made using a bark grained roller which tended to pull shallow repairs out.

An example of one of the early 2001 like-for-like patch repairs at Alexandra Road was tested in 2019 as part of the PEPS Phase II assessment and is shown in Figure 5. This 2001 patch repair replaced an earlier 1997 commercial repair. When the 1997 repair was chopped out, it showed that there were only two small areas of steel within the large area covered by the patch repair. The repair mortar used was a 1:3 mix of white Portland cement (WPC): silver sand. The patch repair was a maximum of 10mm deep, and a surface roller had been used to provide the board marks to the surface. The outer surface of the patch had slowly weathered (neutralising the alkaline cementitious component and washing sand particles out) and this increased the porosity and allowed biological growth to become established within around 8 years. The repair was fully intact and showed no cracking or shrinkage after 18 years exposure although the surface texture and finish to the repair was considered to be poor. However, it did illustrate that unmodified cement mortar repairs were possible and they could provide a reasonable life. Some of the other thin 2001 trial repairs showed cracking, crazing and sometimes shrinkage, mainly due to their inadequate thickness.

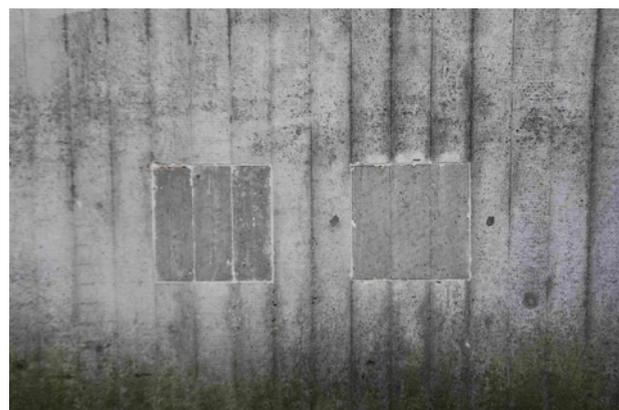
Figure 6. These pre-cast like-for-like concrete panel repairs were installed at the Alexandra Road Estate in November 2006. When they were assessed in 2019, they exhibited hollowness behind the panels and the white grout surround stood out.

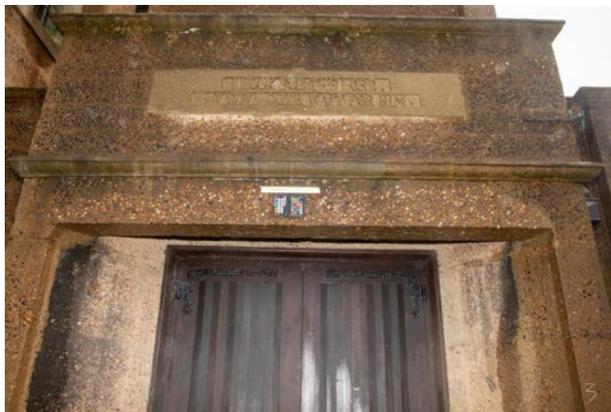
Figure 7. Like-for-like patch repair above a door at St John and St Mary Magdalene church in Goldthorpe. The repair had been made using an identical mix to the original concrete with a yellow dye to match to the parent; the surfaces had been brushed after setting to blend in with the parent concrete.

Most of the repairs were still in very good condition when assessed in 2019 and an example is shown in Figure 7. The colour and texture match of the patch (above the door) to the parent was very close and the patches had

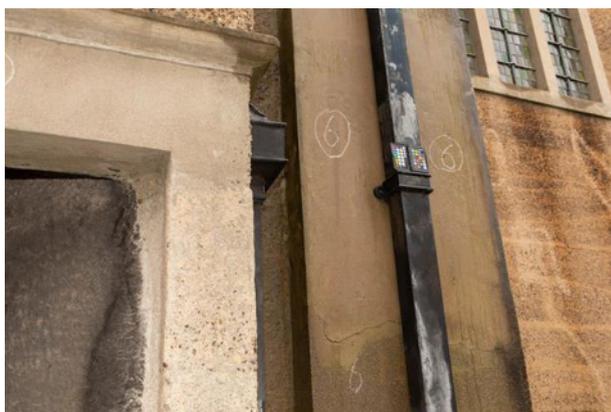
Figure 8. A large-scale patch repair at St John and St Mary Magdalene church which exhibited cracking, and which had also failed to be surface brushed after setting. Hammer trapping indicated hollowness behind.

to the parent concrete. Dye was added to the repair concrete mix to match the yellow parent concrete. The assessment of the repairs in 2019 showed that a few of them exhibited cracking, shrinkage and delamination from the substrate and were starting to fail. The Phase II tests showed that there were marked differences in the finishing of the 'failing' repairs and that of the good repairs, suggesting that the problem may be due to workmanship issues. The Phase III testing will hopefully confirm if this is the reason for the failures.

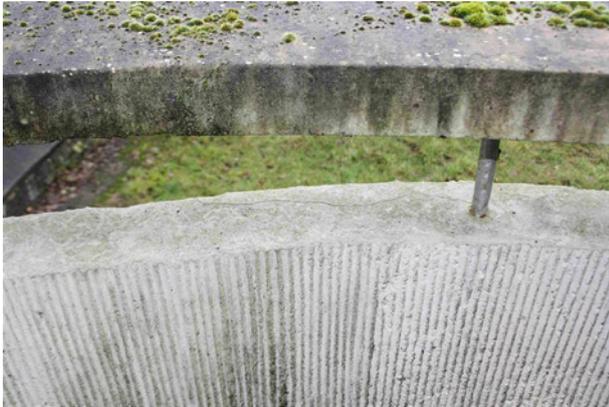
Most of the repairs were still in a good condition when assessed in 2019 although a few showed some defects. The biggest repair project was carried out at the bear ravine which had been in a very poor state and required significant repairs in 2014. Five years later, cracks were evident as well as shrinkage and moss growth (Figure 9), although most of these coincided with relatively thin repairs at parapets and balustrades. Another explanation may be that the repair concrete had too high a water:cement ratio or that the repairs were allowed to dry out too fast. It is hoped that the Phase III assessment will be able to confirm why this had occurred and will inform future repairs.

Figure 9. Dudley Zoo - cracks noted to a repaired parapet wall of the prow to the bear ravine, Dudley Zoo. Note also the moss growth established in fine shrinkage cracks to the upper balustrade rail.

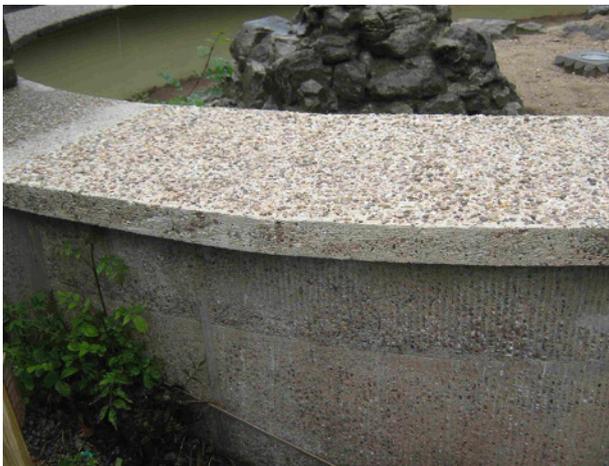
The final Tecton structure to be repaired was the meerkat enclosure in 2015. The in-house workforce had become more experienced since the work started and more time was given to the repair of this structure. No defects were found in 2019 and the repairs were all in very good condition. Figure 10 shows an example where a large section of capping to the wall had been replaced. The like-for-like concrete repair provided a good match to the parent concrete, including in terms of colour and surface finish (it had been brushed after setting). The surfaces had started to weather after four years' exposure which had

Figure 10. Replacement section of concrete capping to the meerkat enclosure at Dudley Zoo made using like-for-like concrete and with surface finishing to match the parent concrete in 2015. This had weathered and had established algal and mould growth within four years.

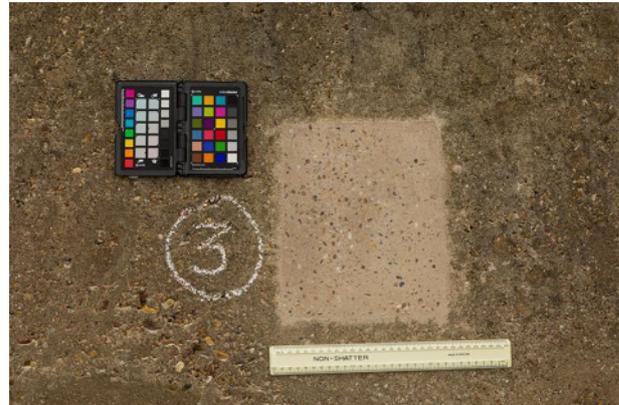
Further like-for-like patch repairs were carried out at the church of St Thomas More in Sheldon in 2015. Dr Farrell was involved with the initial assessment of the concrete and provided outline specifications for the like-for-like repairs. The appointed contractor started by preparing a slab library using different mixes of sands, cements and aggregates together with different surface finishes. The slabs were held against each elevation and different concrete surfaces on the building and the best match agreed. Many different patch repairs were carried out to the church and when they were inspected in 2019, they were all found to be in good condition. An example of a small patch repair is shown in Figure 11. The surface finish of the repairs to match the parent concrete was good although the new concrete had yet to weather sufficiently to allow biological growth to establish.

Figure 11. St Thomas More church, Sheldon – showing a typical patch repair made using like-for-like materials and brushed after setting to match the parent in 2015. This new concrete was still weathering in 2019 prior to establishing algal and mould growth.

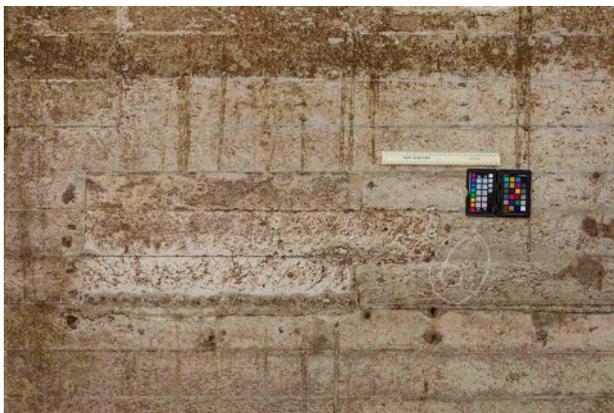
Figure 12. Typical patch repair using a like-for-like mix to the board-marked concrete on the Listening Mirrors after 14 years exposure. This showed good weathering with mould, algal and even red lichen growth on the new surfaces.

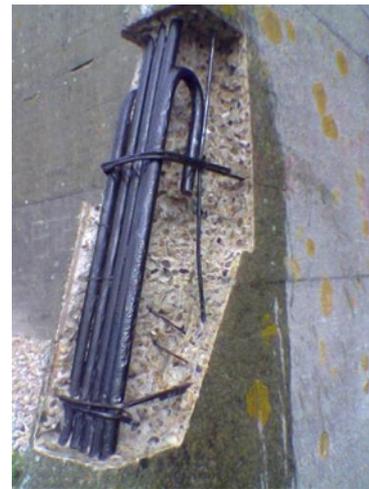
Figure 13. A section of damaged concrete buttress at the Listening Mirrors which had been broken open, all steel cleaned and suitably repaired using a like-for-like mix with board-marked shutters – image taken in 2005.

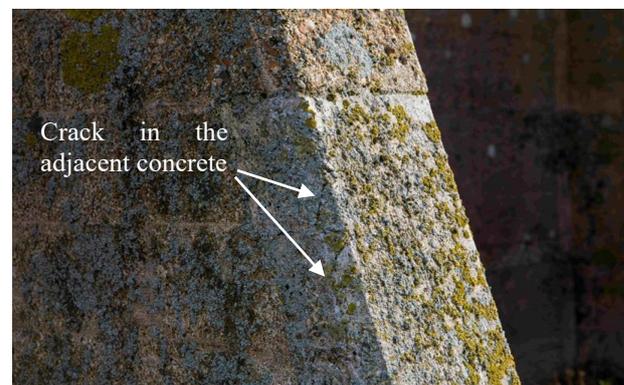
Of the ten patch repairs at the listening mirrors, nine were found to be in good condition after 14 years exposure. However, one of them revealed fine cracks during an inspection in 2018. On reviewing record photographs, it was noted that the cracks lined up with a large vertical steel reinforcing bar which had been fully cleaned of corrosion product (rust) using very high-pressure water jetting (4,200psi), Figures 13 and 14. It was also clear that all the other nine patch repairs had been fitted with new steel reinforcement and the old corroding steel cut out and removed. It is possible that the cracks might either be due to the incipient anode effect (where steel just outside the patch repair starts to corrode as a direct result of the repair) or that there were still some chlorides, or just corrosion product, remaining on the steel surfaces which had allowed the process of corrosion to continue. It is hoped that the Phase III assessment will confirm what is affecting this particular patch repair.

Figure 14. Image of the same repair taken in 2019 showing the weathered repair with lichen and moss growth now fully established. However, this patch was now exhibiting cracking suggesting ongoing corrosion of the underlying steel bars.

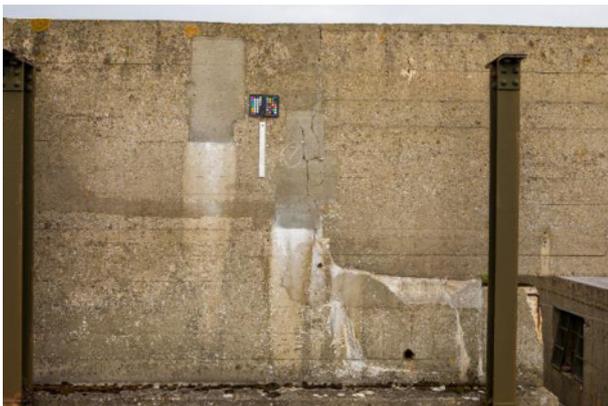
Many of the repairs (approximately 35%) were failing and an example is shown in Figure 15. The O&M manual for the repairs stated that the repair mix did not contain any sand; being only cement and large aggregate (mainly flint). The repair mix therefore contained an excess of cement. Many of the repair patches showed calcite leakage from the bottom of the patches indicating that

unreacted calcium hydroxide had leached out. Some of the patches showed cracking and delamination and the cover meter survey indicated that this was associated with the presence of steel reinforcement behind. The suggestion is that some of the embedded steel reinforcement was continuing to suffer from on-going corrosion even after the repairs had been made. However, not all were subject to corrosion. Some of the repairs which do not directly face the sea were still in a reasonable condition and not subject to defects when assessed.

Figure 15. Patch repair using a like-for-like mix at Landguard Fort which was failing after 8 years. This appeared to be related to ongoing corrosion of the embedded steel. Note also lime leaching from the base of the repair due to excessive cement used in the repair mix.

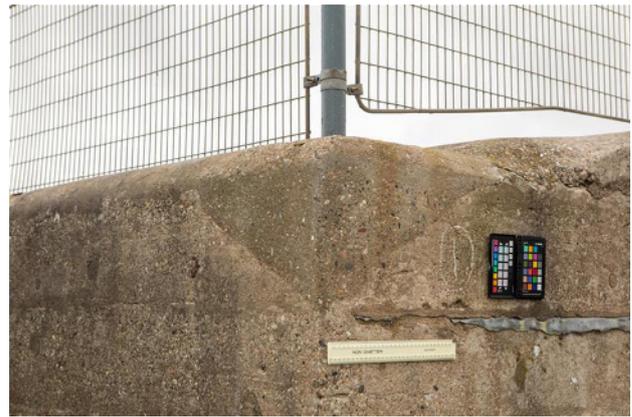
Figure 16. Patch repair of the concrete corner at Tynemouth Priory and Castle coastal battery using a like-for-like concrete mix with plain shutters and using external supports. The surface was abraded after setting to match to the parent and this patch had almost fully blended in after 10 years.

wooden supports were used to fix the shutters in place. The specified like-for-like concrete repair mix was poured in at the top and a poker used to vibrate it. The shuttering was struck early, and the surfaces of the repair brushed using mechanical abrasion to reveal some of the aggregate to match the parent. The patch surfaces have weathered over the past 10 years and now support biological growth.
