Performance evaluation of patch repairs on historic concrete structures (PEPS): preliminary results from an American case study

2.1 Case Study USA03

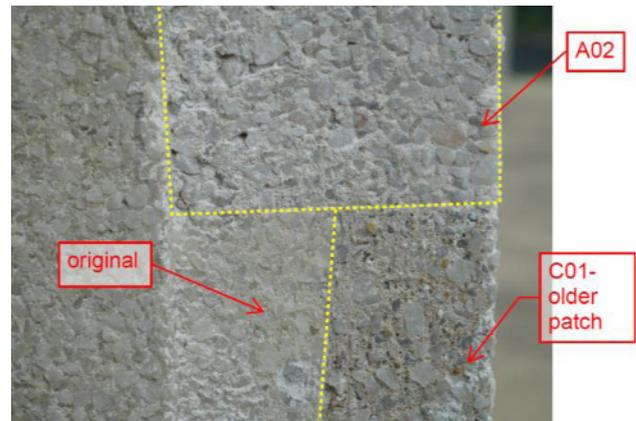
Figure 1. Intersection of repair A02, the original concrete, and repair C01.

The repair from campaign C was not assessed in detail during the Phase II visit and was only assessed as an adjacent area to a campaign A repair that was assessed (A02). It was noted that repair C01 did not match the cement paste colour of the original, but had similar texture, profile, and exposed aggregates. The edges appeared to have been sawcut and have sufficient depth to reach behind the reinforcement. No signs of deterioration were visible during this survey in 2019. Based on the depth of repair and the exposed aggregate finish, it is likely that this repair was carried using a form-and-pour approach, with some form of abrasion used to remove the formed face of cement paste and expose the aggregate.

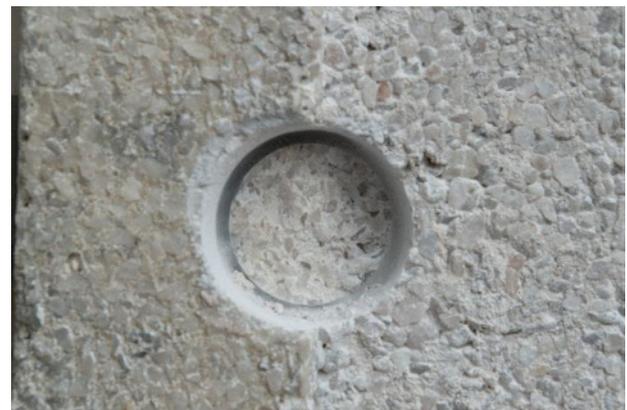
Coring at the bond line between A02 and the original concrete (Figure 2) revealed that the concrete was well consolidated, bonded, and with no air voids or signs of segregation. In fact, the interface between the materials within the core hole was barely perceptible.

Figure 2. Core at bond line of repair A02 and original concrete.

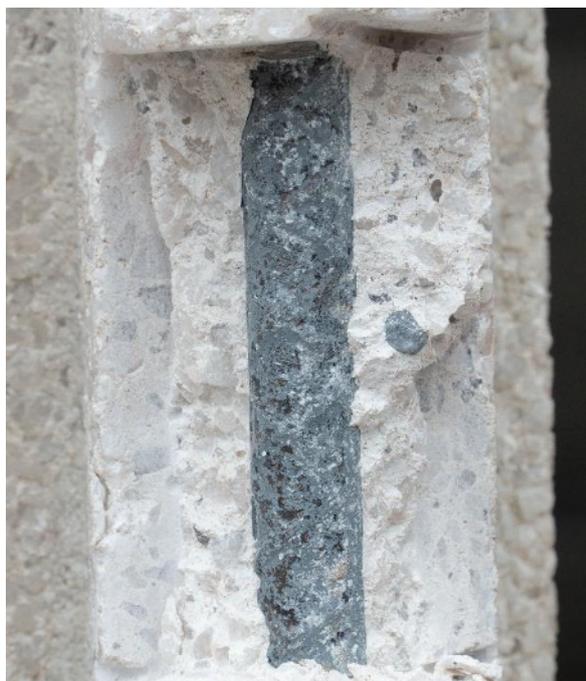
An inspection opening of repair A08 (Figure 3) revealed that the reinforcement remained in good condition and the zinc-rich epoxy primer coating was fully intact, with no indication the repair techniques applied deviated from those documents and previously described.

Figure 3. Inspection opening of reinforcement within a patch from the most recent repair campaign (A08).

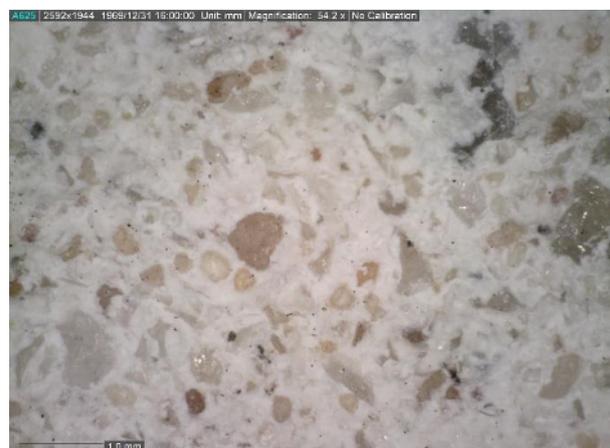
Based on this colorimetric data, the patches from repair campaign A show a clear difference in colour to the original concrete when both are dry and when both are wet. The reason for this difference may be explained by examining digital microscope images taken on site. Figure 4 shows an image of repair A02. When compared to the original concrete (Figure 5), there are clear differences in the matrix and aggregates.

While petrographic analyses are yet to be completed on samples of the repair materials, the microscopy carried out on site appears to show fine aggregates that are more angular than those found on the surface of the original concrete, with some darker aggregates and possibly with a finer grading. However, the excess of cement paste makes this difficult to compare without petrographic analyses of a cross-section.

Figure 4. Digital microscope image of repair A02 *in situ*, $\approx 55x$ magnification.

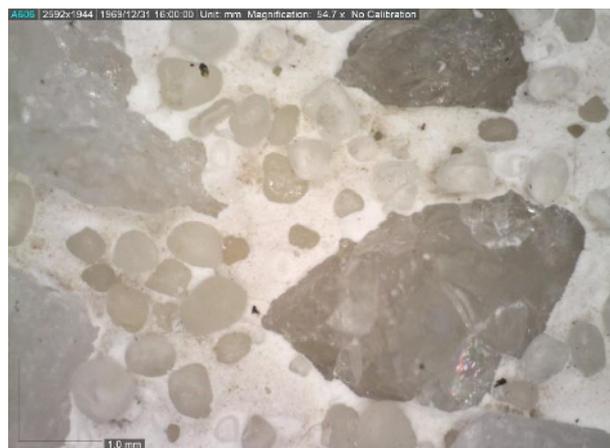
Figure 5. Digital microscope image of the original concrete *in situ*, $\approx 55x$ magnification.

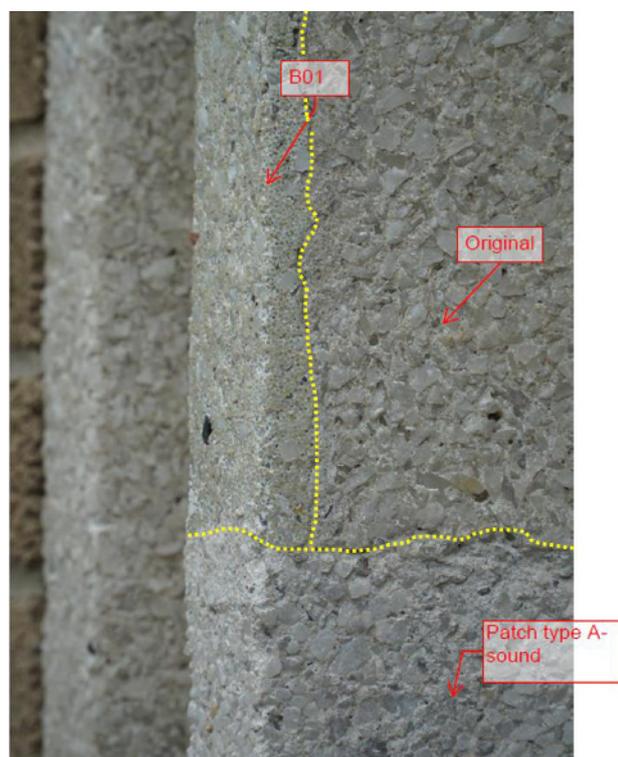
While the excess of the WPC paste is visible both under the microscope and on close visual inspection of the repairs (Figure 1, Figure 6), the campaign A repairs are still relatively young, having only been completed in 2017, and it is likely that the excess paste will erode slowly over time as part of the natural weathering process. As previously mentioned, when the interface between the materials within the core hole was examined, it was barely perceptible as the two materials had such a good visual match.

Campaign B repairs showed fair aesthetic and technical performances. The colour and profile of the repairs were close to the original, but the texture looked very different on close inspection. The difference in texture was due to a larger proportion of fine round aggregates exposed on the surface, while the original concrete has a larger proportion of angled medium sized aggregates. These repairs had irregular edges and did not extend behind the reinforcement. One of these repairs sounded hollow and showed a few linear cracks around the border, but no sign of imminent failure. Based on a visual assessment, it is most likely that the repairs from campaign B were hand-applied mortar repairs, and the positioning of the aggregates suggests they were likely post applied by pressing into the surface of the repair as it set. As a result, these repairs have a much smoother surface texture that does not match the original concrete.

Figure 6. Intersection of repair B01, the original concrete, and a repair from campaign A.

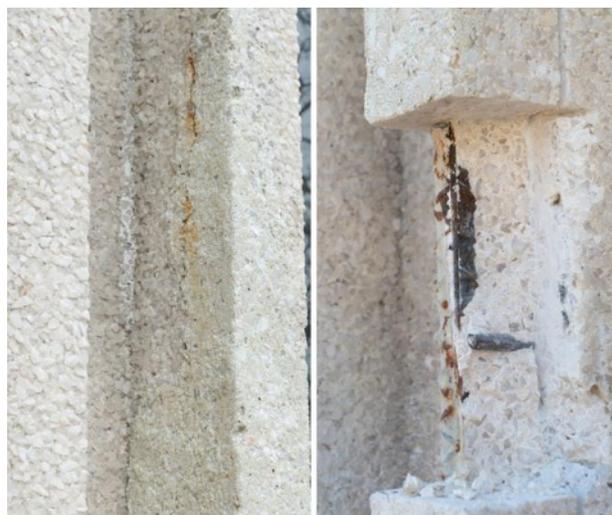
B01, which showed minor cracks and had delamination detected by sounding in 2019, showed more prominent cracking in 2021. One crack of particular concern, located in the top portion of the repair, progressed onto the original concrete, and was accompanied by small rust deposits.

Careful removal of this repair revealed a feathered edge and confirmed that the repair did not extend behind the reinforcement, and that corrosion was occurring.

Figure 7. Repair B01 showing significant cracking and rust staining from reinforcement corrosion (right) and the reinforcement following removal of the de-bonded repair (left).

It also exposed the reinforcement, revealing it had been coated during repair. However, this coating was only applied to the front face of the reinforcement – not the full circumference of the bar – and it was clear that it had been applied carelessly as it was also found on the substrate around the reinforcement.

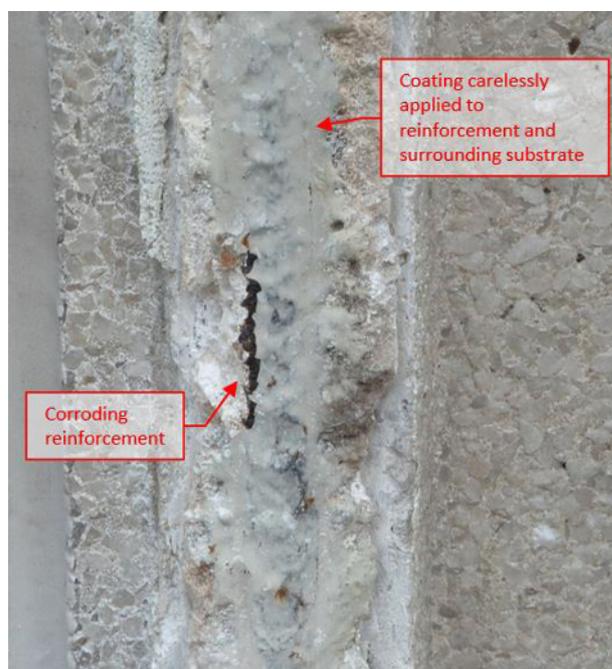
B03 showed similar conditions as in 2019 – it was sound, with no visible signs of deterioration. However, an inspection opening revealed initial stages of reinforcement corrosion. As with B01, repair B03 also had the same careless application of a coating on the reinforcement, feathered edges, and insufficient depth to reach behind the reinforcement (Figure 8). As such, it is unlikely that the reinforcement was sufficiently cleaned during the repair process.

Figure 8. Inspection opening of repair B03 showing poorly applied coating to reinforcement and ongoing corrosion.

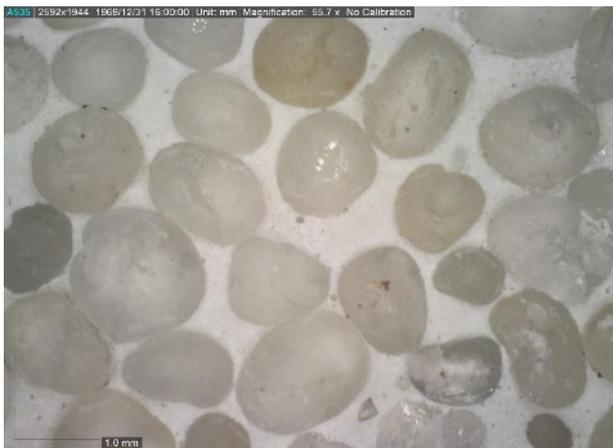
From an aesthetic perspective, the repairs from this campaign had mixed performance. On one hand, the colorimetric data shows that, when both the repair and the original are dry, these repairs were the closest in colour to the original – though even an unexperienced observer would be able to tell the difference in colour. When viewed under the digital microscope (Figure 9), the use of WPC is clearly visible and shape and colour of the fine aggregates seem similar. However, the fine aggregate in the repairs is noticeably larger than in the original. Additionally, the application of the aggregates to the surface, which was likely done during the setting of the repair, has resulted in a high concentration of the fine aggregates sitting on top of the surface, rather than being exposed from the surface. These repairs also lack any exposed coarse aggregates and this has led to a significant difference in texture between the repairs from campaign B and the original concrete.

Figure 9. Digital microscope image of repair B03 *in situ*, $\approx 55x$ magnification.

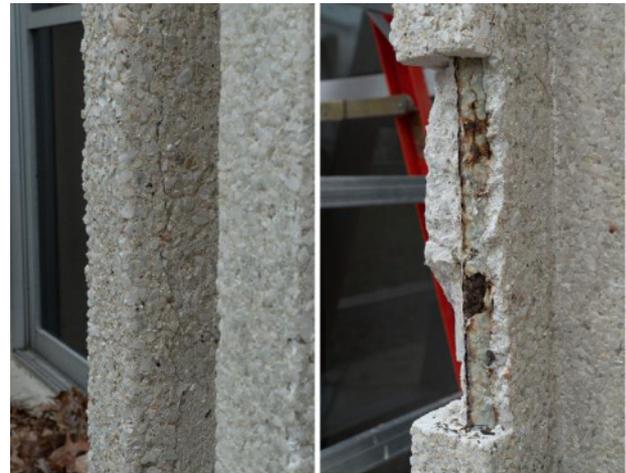
Repair C01 showed visible signs of deterioration, which had not been detected in 2019. Linear cracks were present on the front and right side of the repair running parallel to the reinforcement and sounding of the repair detected

delamination. An inspection opening confirmed that the repair was deep enough to reach behind the reinforcement, and it was revealed that the reinforcement had been coated but, despite this, reinforcement corrosion was ongoing.

Figure 10. Repair C01 showing significant cracking of the repair (left) and the reinforcement following removal of the failed repair (right).

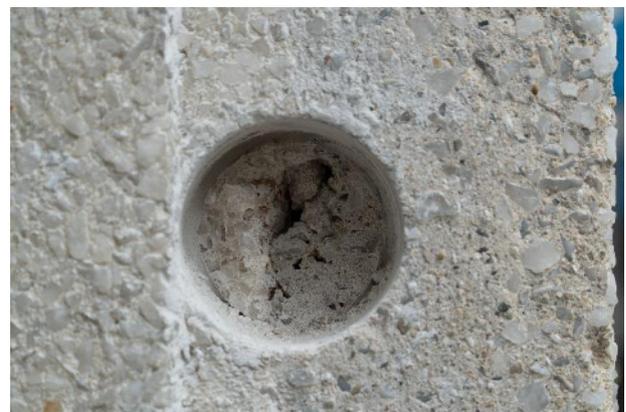
Removal of core samples on the border between repair and original concrete revealed poor consolidation of the repair material and large voids at the interface with the substrate. While laboratory and petrographic analyses of the core samples have yet to be completed, phenolphthalein solution applied *in situ* to the core hole and inspection opening suggests that the repair material may be entirely carbonated, and this is likely to be the main cause of reinforcement corrosion in repair C01.

Figure 11. Core at bond line of repair C01 and original substrate.

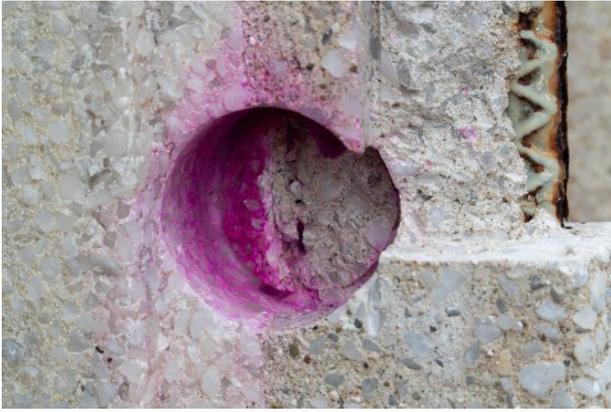
Figure 12. Core at bond line of repair C01 and original substrate following the application of phenolphthalein solution.

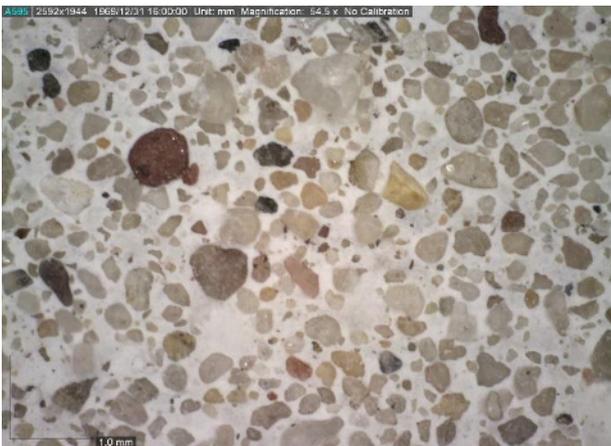
As previously mentioned, it was noted during the initial visual inspection that the colour of C01 did not match the colour of the original, but the repair had similar texture, profile, and exposed aggregates. Colorimetric measurements (Table 1) taken on site confirm a significant difference in colour between the repair and the surrounding substrate. In this case, the colorimetric measurements confirmed visual observations: C01 was a much poorer colour match than any of the repairs surveyed from the A or B repair campaigns.

Due to the colour of the matrix, it was initially assumed that ordinary Portland cement (OPC) had been used instead of WPC, and that this was the cause of the colour difference. However, images taken on site with a digital microscope suggest this is not the case – the cement paste appears to be WPC. The microscope images reveal the matrix binds a high proportion of very fine angular aggregates, some of which are considerably darker than that used in the original concrete. When viewed from a distance, this gives the illusion that the cement paste is darker than it actually is.

Figure 13. Digital microscope image of repair C01 *in situ*, $\approx 55x$ magnification.
