# Performance evaluation of patch repairs on historic concrete structures (PEPS): Preliminary results from a selection of French case studies.

**Abstract.** Within the frame of the international research project PEPS, 'Performance Evaluation of Patch Repairs on Historic Concrete Structures (PEPS)', dedicated to the durability of patch repairs in the context of culturally significant structure, a series of repaired monuments was examined in detail. Thus, the operational phases of the project are composed of *in situ* tests and laboratory analysis on samples performed on a selection of representative historic concrete structures in the three countries who are partners in the project: United States of America, United Kingdom and France. In this paper, cases studies and some results obtained on three of the five French sites will be presented: Le Raincy church built by Auguste Perret between 1920 and 1924, and Rezé housing unit and Jaoul houses built by Le Corbusier respectively in 1955 and in 1953. The assessment methodology followed is the one developed between the three institutions partners on the PEPS project: the Getty Conservation Institute (GCI), Historic England (HE) and Labo

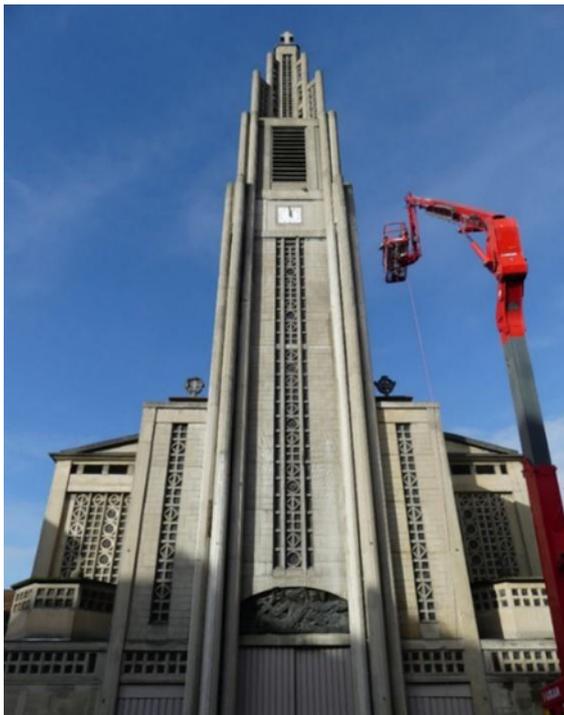
**Figure 1** Notre-Dame du Raincy church, first examinations of the bell tower

In Notre-Dame du Raincy church, the first on-site observations revealed that the 1991 repairs were very well conserved. Only a few of them showed debonding or cracks at the interface with the original concrete. However, the adjacent concrete showed numerous spalls at the interface (Fig 4 ). In addition, the patch repairs did not match with the colour and texture of the ancient concrete, and were highly visible.

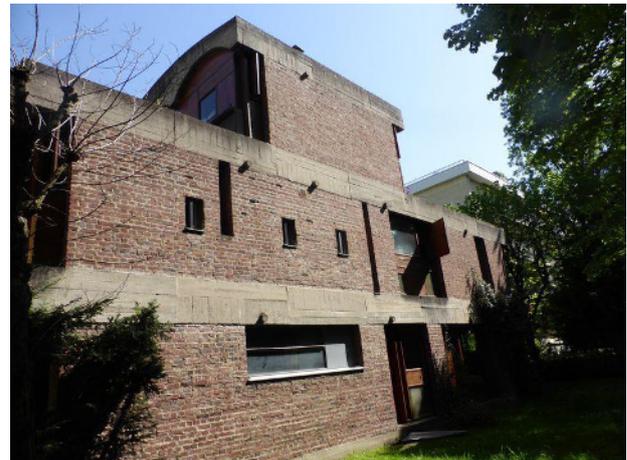
**Fig. 2** The Jaoul houses in Neuilly-sur-Seine, view of the B House.

For the Jaoul Houses, the aesthetic matching was almost perfect. The repairs could be distinguished when carefully observed, as they were slightly thicker than the adjacent ancient concrete. Although most of the repairs were still in place, detailed patch observations revealed numerous dislocations, cracks, and spalls, mainly located on the repairs and very occasionally on the adjacent ancient concrete. The evaluation of the cover depth showed low and heterogeneous cover depths (from 25 to 55 mm for the A House). The superficial hardness measured with a rebound hammer was higher for the original adjacent concrete than for the patch repair, whereas there was no difference in the scratch tests. Hydrophobic treatment was not revealed by water spraying.

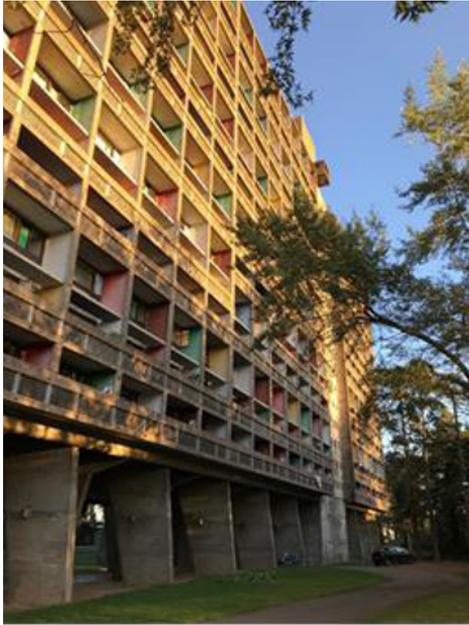
**Fig. 3** East facade of the Rezé housing unit. Pilotis and loggias.

On Rezé housing unit, the first observations of the 1995 repairs evidenced numerous degradations. Spalling, delamination, cracks, in the repair, at the interface, or in the adjacent ancient concrete were recurrently observed on the pilotis. The aesthetic performance was not good either, with very different textures and colours from those of the ancient concrete (Fig. ). The cover depth was very heterogeneous, and sometimes very low, from 10 to 65 mm. The ancient concrete in the adjacent area was harder than the finishing of the repaired areas, according to rebound hammer and scratch tests.

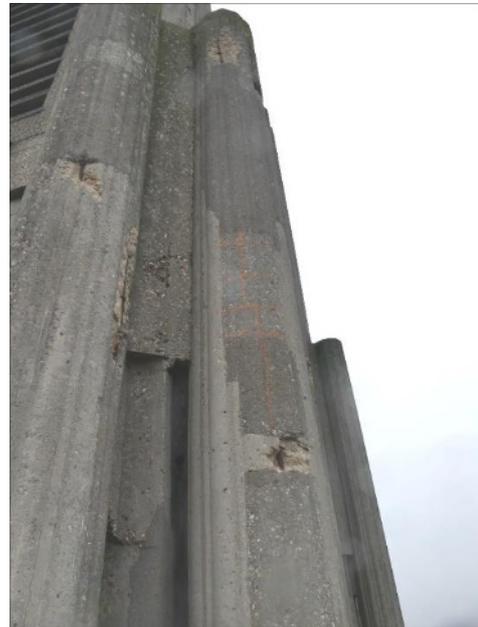
**Fig. 4** Notre-Dame de la Consolation church in Le Raincy, View of the area around patch 5, with a spalling in the ancient concrete (light area) adjacent to the repairs (slightly darker areas).

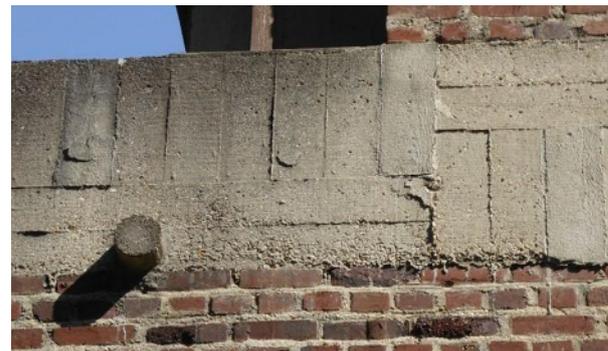
**Fig. 5.** The Jaoul houses in Neuilly-sur-Seine, spalling on a patch repair (second wood framework vertically from the left) and on the concrete, view of the B House.

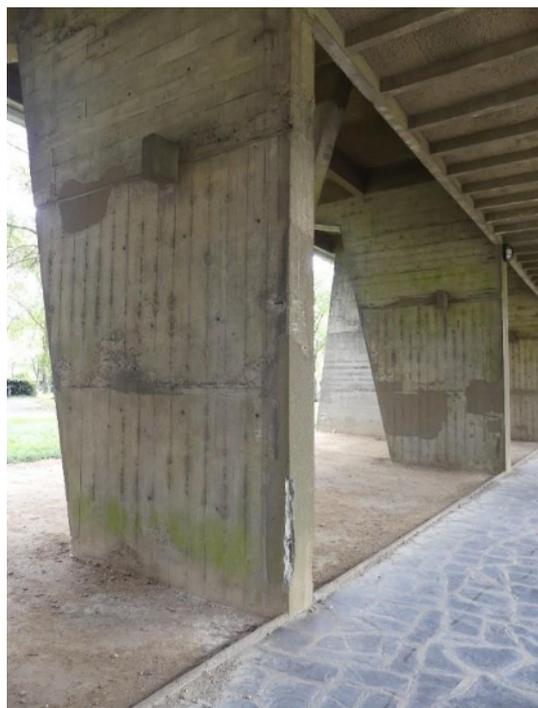
**Fig. 6** Rezé housing unit. V-shaped pile with spalling in the edge repair of the patch repaired area.

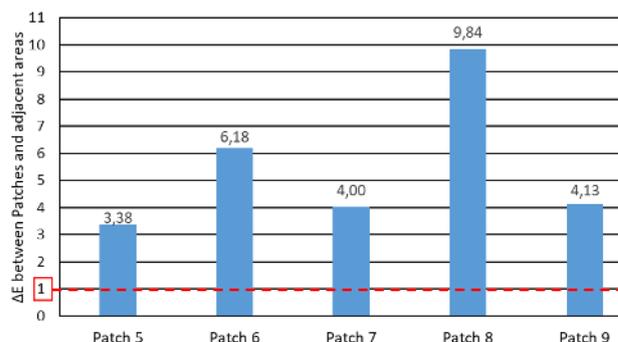
For Rezé housing unit (Fig. 1), when considering a  $\Delta E$  of 1 for colour differentiation perceptible by the human eye, all patch repairs showed significant colour differences with the adjacent ancient concrete, with very heterogeneous values, varying between 3.38 and 9.84.

**Fig. 7.**  $\Delta E$  between the patch repairs and the concrete in the adjacent area according to the patch reference in Rezé housing unit.

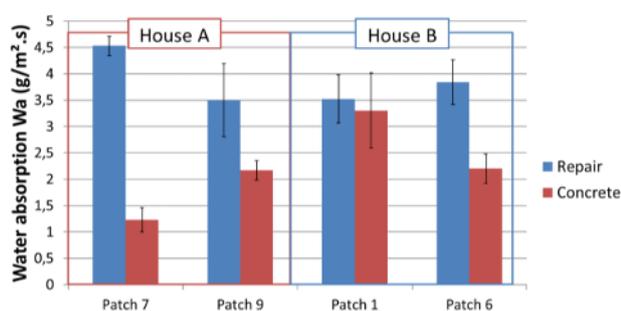
In Jaoul houses, significant differences were noted between the patch repairs and the adjacent ancient concrete for three of the four patch repairs investigated (Fig. ), with values ranging between 3.5 and 4.5  $g/m^2.s$  for the repair and between 1.2 and 3.3  $g/m^2.s$  for the ancient concrete.

**Fig. 8.** Contact sponge water absorption test results for several patch repairs of Jaoul houses A and B, both on the repaired zones (blue) and on the ancient concrete (red).

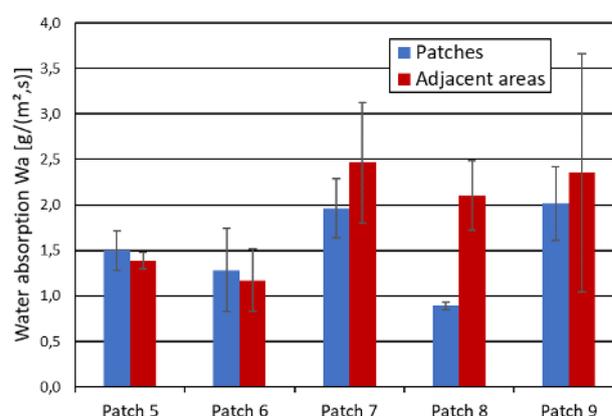
For Rezé Housing unit, water absorption values for the repaired areas varied between 1  $g/m^2.s$  and 2  $g/m^2.s$ , while for the ancient adjacent concrete they ranged between 1.2  $g/m^2.s$  and 2.4  $g/m^2.s$ . It is to be noted that the results were very scattered, with high standard deviations, so that no clear differences between the patches and the adjacent ancient concrete could be evidenced except for one patch (Fig. ). The latest (Patch 8) was significantly less absorbent than the adjacent ancient concrete. To explain this dispersion of results it is important to underline that water absorption can be very affected by micro cracking or surface faults even if the tests are performed on apparently sound zones.

**Fig. 9.** Contact sponge water absorption test results for several patch repairs of Rez  housing unit, on both the repaired zones (blue) and on the original concrete (red).

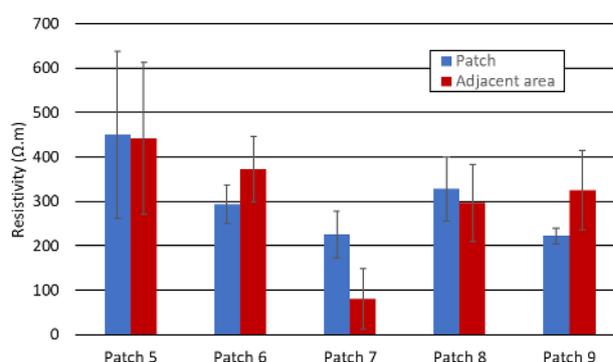
The resistivity measurements were performed using the Wenner method with a Resipod<sup>®</sup> and are gathered in Figure Fig. . Except for the adjacent ancient concrete of patch 7, all the resistivity values ranged between 200 and 450  $\Omega.m$ , which according to the RILEM Recommendation [10], can be considered as high and representative of a negligible risk of corrosion. As the standard deviations are noticeable, except for patch 7 whose resistivity is significantly lower than that of the adjacent concrete, no clear difference could be evidenced between the repair material and the ancient concrete. For patch 7, the resistivity measured in the adjacent concrete is indicative of a high risk of corrosion (<100  $\Omega.m$ ).

**Fig. 10.** Resistivity assessed with a Resipod<sup>®</sup> on five patch repairs of Rezé housing unit. Measurements were performed in the repair material (blue) and in the ancient concrete in adjacent areas (red).

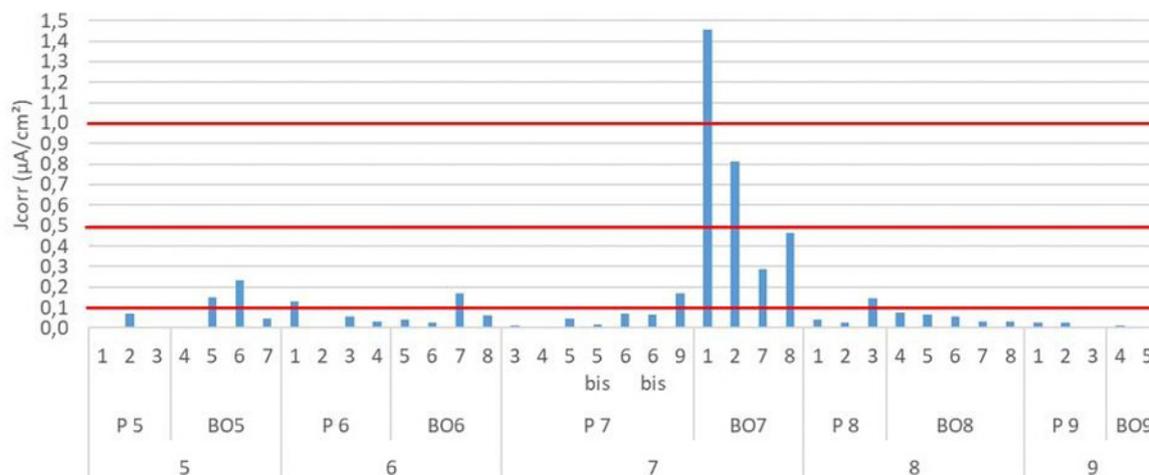
For most of the patches, corrosion current densities under 0.1  $\mu A.cm^2$  were measured, which correspond to negligible corrosion rates according to the RILEM Recommendation [12]. For patches 6, 7 and 8, three measured values were slightly above the 0.1  $\mu A.cm^2$  threshold corresponding to a low corrosion rate.

In the concrete areas adjacent to the patches, the corrosion current densities generally varied from 0.007  $\mu A.cm^2$  to 0.234  $\mu A.cm^2$ , with an average value of 0.07  $\mu A.cm^2$ . These values correspond to negligible (under 0.1  $\mu A.cm^2$ ) to low corrosion rates (between 0.1  $\mu A.cm^2$  and 0.5  $\mu A.cm^2$ ) according to the RILEM Recommendation [12]. But for patch 7, in line with the resistivity results, the corrosion seems more active in the concrete area adjacent to the patch, with values higher than 0.5  $\mu A.cm^2$ .

**Fig. 11.** Corrosion current density measured on the patch repairs of Rezé housing unit (P= Patch, BO= adjacent Original Concrete). The red lines indicate the RILEM thresholds for corrosion rates (0-0.1µA/cm<sup>2</sup> = negligible corrosion, 0.1-0.5µA/cm<sup>2</sup> = low corrosion, 0.5-1µA/cm<sup>2</sup> = moderate corrosion, >1µA/cm<sup>2</sup>= high corrosion).

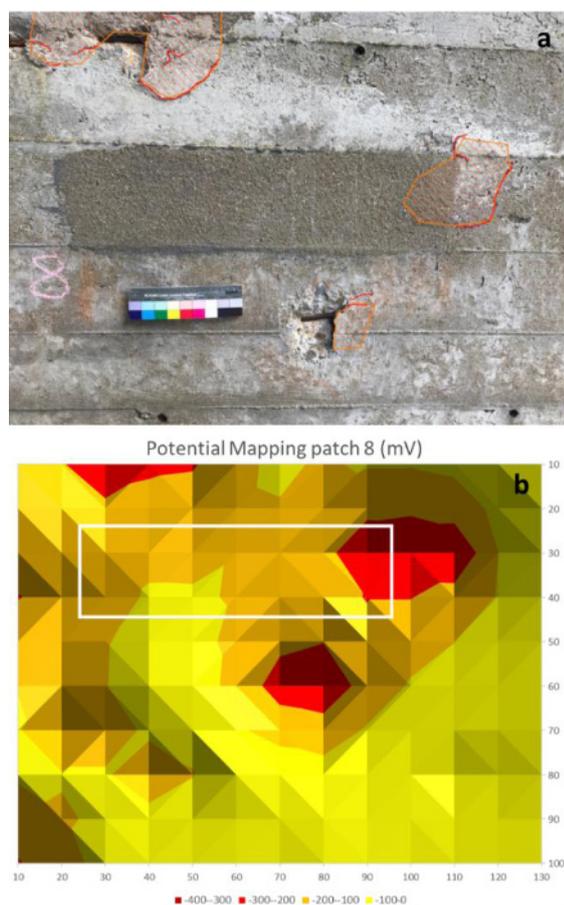
noticeable gradients should be researched to identify zones presenting high corrosion probability. The degradation and potential mapping for patch 8 are gathered in Figure Fig. . The potential map of patch 8 (Fig. b) shows a fairly high gradient in its upper right corner,

which corresponds to visibly developing spalling due to the swelling of the corroding reinforcement underneath. High gradients were also evidenced in the adjacent concrete, in correlation with spalling and cracking of the concrete.

**Fig. 12.** The decay (a) and potential mapping (b) of patch 8, of Rezé housing unit. In the degradation mapping, the cracks are represented in red and the delamination in orange. The most electronegative potentials (mV vs Cu/CuSO<sub>4</sub> reference electrode) appear in red in the map. The contours of the patch are highlighted in bold white lines on the potential map.

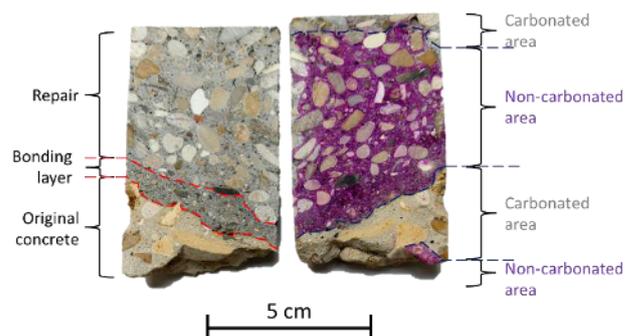
The inspection procedure has not yet been carried out for Notre-Dame du Raincy church due to accessibility issues (no scaffolding), but they will be performed in May 2022. However, cores could be sampled from a basket and evidenced repair thicknesses up to 8 cm, with a double layer (Fig. ). The colour difference between the original concrete and the repair materials could be very well distinguished. Differences in aggregate size were also noticed.

**Fig. 13.** Core of patch repair 1 in Notre-Dame du Raincy church.

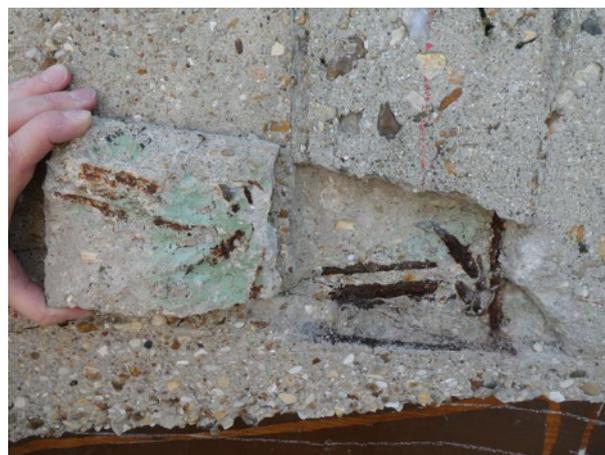
In Jaoul houses, the repair thicknesses were lower (2-3cm). The repairs were single layered, with brushless steels, and the presence of a green layer on the surface of the steel and sometimes on the concrete too. This green layer probably corresponds to a passivating product (Fig. ).

**Fig. 14.** Inspection of a patch repair in Jaoul houses.

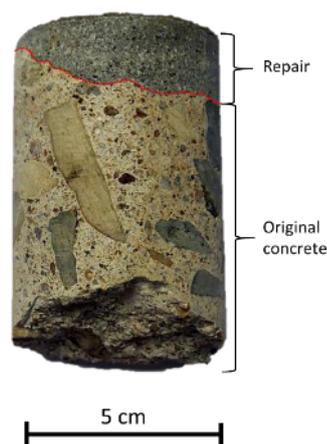
At Rezé Housing unit, inspection and sampling showed that the repair thicknesses were also very low, less than 2 cm (Fig. ). The repair was double-layered, with a mortar applied in limited areas around the reinforcement, and a thin coating covering both repaired and unrepaired areas.

**Fig. 15.** Core of patch repair 9 on Rezé housing unit.
