# Rehabilitation and Repair of Concrete Overlays

Dan King<sup>1,\*</sup> and Peter Taylor<sup>1</sup>

<sup>1</sup>National Concrete Pavement Technology Center, Iowa State University, Ames, Iowa, USA

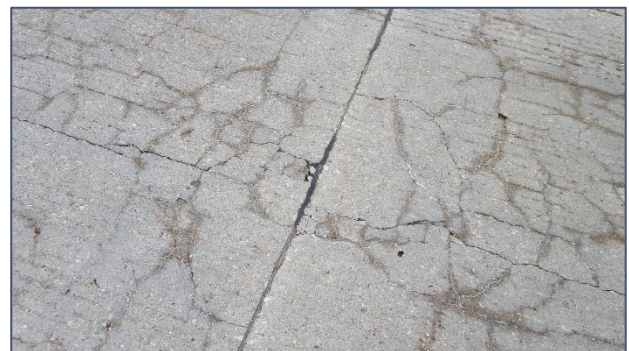
Two concrete overlays in Iowa with early age durability distresses are pictured in Figures 1 and 2. In Figure 1, map-cracking alongside a transverse joint suggests issues with either aggregate durability (D-cracking) or reactivity (ASR). In Figure 2, spalling of the transverse joints and at the joint intersections indicates that they have remained saturated due either to poor drainage or a poor-quality mix and were damaged during freeze-thaw cycles.

**Fig. 1.** Map-cracking at transverse joint.

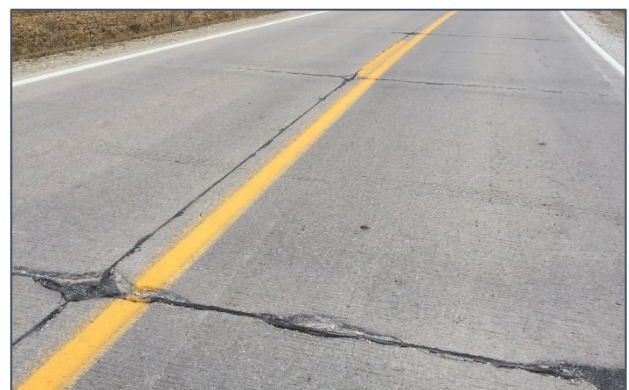
**Fig. 2.** Spalling of transverse joint and at joint intersections.

The best method for addressing joint spalling, such as the example shown in Figure 2, depends on the severity of distress and overlay thickness. When distress is limited to the upper half of the overlay, partial-depth repairs can successfully restore the pavement surrounding the joint. Partial-depth repairs are good options in thicker unbonded overlays, but in practice they may not be feasible for thinner bonded overlays, (e.g. 100 mm) where it may be difficult to limit repairs to the top 50 mm. Thinner overlays also tend to have a significantly greater saw cut joint length due to shorter slab designs [2]. If spalling is present in a large number of joints, partial-depth repairs may be cost-prohibitive. Partial-depth patches may be constructed with conventional concrete mixtures or with rapid-set materials.

In bonded overlays, or when distress extends below half the thickness of any overlay, full-depth patching and slab replacement of the total thickness of the overlay are the best methods to repair joint spalling. For thinner overlays, milling out the overlay at an affected area and inlaying with new concrete may also be viable [10].

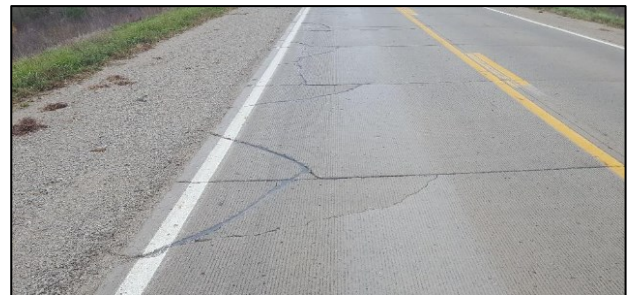
If joint spacing in these thin overlays is too large, cracking may result from shrinkage stresses or from a loss of support due to curling and warping [10]. Transverse, longitudinal, and/or corner cracking may all develop depending on the overlay design and loading configuration. An example of longitudinal and corner cracking on a COC-U overlay where excessive joint spacing was suspected is shown in Figure 3.

**Fig. 3.** Early age cracking on a COC-U overlay [5].

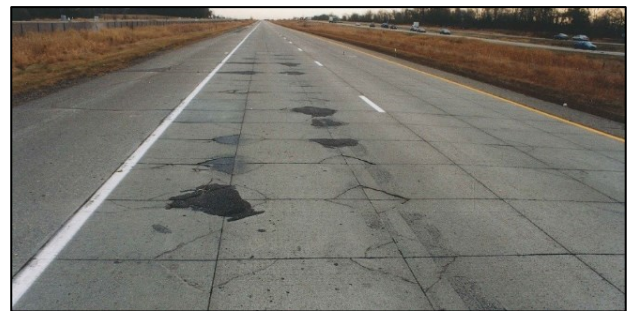
Cracking may also occur if joints fall in the wheel path. In such a case, high stresses can develop at free/unsupported slab corners, especially if there are no dowel or tie bars in the overlay, leading to corner cracking like that shown in Figure 4 [11].

**Fig. 4.** Cracking on a COA-B overlay with longitudinal joints in the wheel path [11].

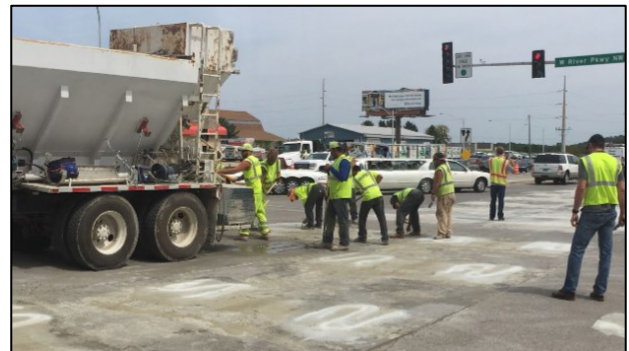
**Fig. 5.** Crew performing dowel bar retrofit on a COA-U pavement section in Minnesota [12].

While its application may be limited to overlays at least 150 mm thick, dowel bar retrofit (DBR) has been used to successfully restore load transfer to a faulted COA-U overlay in Minnesota, pictured in Figure 5 [12]. This overlay was 165 mm thick and developed faulting within just a few years due to heavy traffic loads. To accommodate the thinner slab, dowels were smaller (25 mm) than those typically used for retrofitting full-depth concrete pavements (30 to 40 mm) to ensure adequate cover. Like most DBR projects, the surface was diamond ground at the end to restore smoothness.

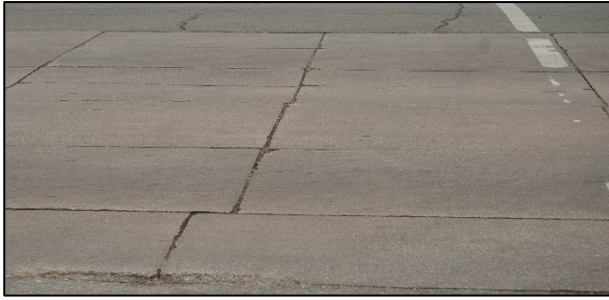
One unique distress type found in concrete overlays is panel movement, also referred to as panel migration, sliding, shifting, or joint misalignment. Panel movement describes the phenomenon when portions of the concrete overlay begin to move independently from the surrounding system. Panel movement is observed when saw cut joints that were placed monolithically across the pavement slab come out of alignment with each other. An example is pictured in Figure 6.

**Fig. 6.** Panel movement with transverse joints coming out of alignment with each other across several rows of panels [7].

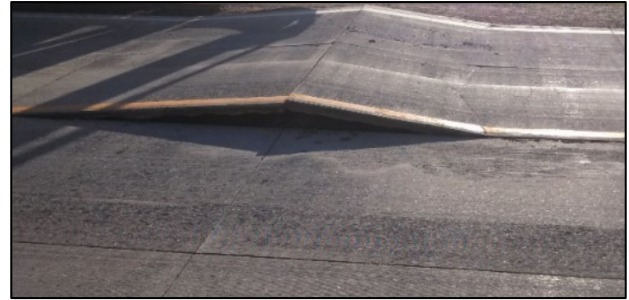
**Fig. 7.** Buckling in a COA-U overlay [10].

Buckling within the overlay generally needs to be repaired immediately after it occurs since it can pose a significant hazard to traffic. Panels at the affected site are removed and replaced to the depth of the overlay.

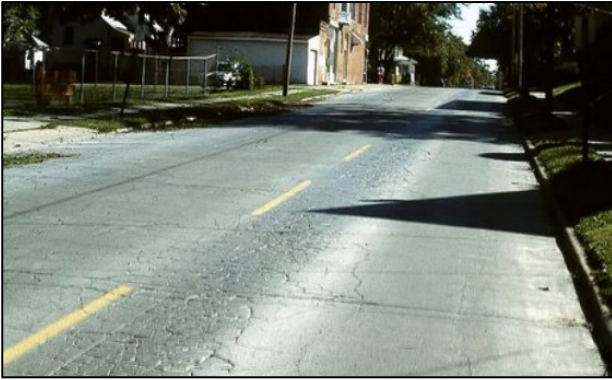
Since very thin overlay surfaces can be left carrying significant traffic loadings if debonding occurs, cracking usually develops very quickly. An example of fatigue cracking that developed after delamination at the bond interface in a COC-B overlay is pictured in Figure 8.

**Fig. 8.** Cracking after debonding of a COC-B overlay [10].

Localized instances of debonding will often lead to slabs with multiple cracks, requiring full-depth patching/slab replacement as discussed in section 4.2.2. Widespread debonding that leads to fatigue cracking like in Figure 8 will require major rehabilitation or reconstruction, which is discussed in section 5.

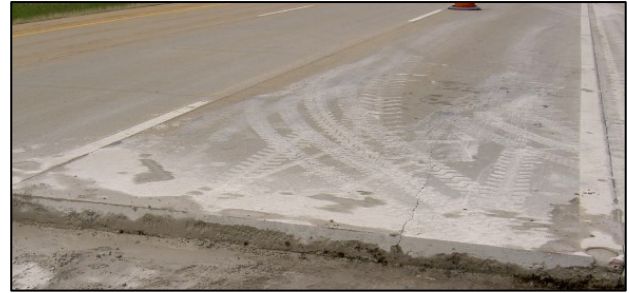
Stripping within an existing asphalt pavement or within the asphalt interlayer of a COC-U leads to a loss of support underneath the concrete overlay [10]. As discussed in section 4.2.1, loss of support in the underlying layer can lead to all types of slab cracking depending on the load condition and location of the stripping/erosion. Stripping of asphalt may also play a role in faulting, as discussed in section 4.3.1. An example of longitudinal cracking in a COC-U overlay caused by stripping within the interlayer is pictured in Figure 9.

**Fig. 9.** Stripping of an asphalt interlayer (exposed in the foreground) leading to longitudinal cracking in COC-U [10].

Stripping that leads to a loss of support and cracking in the overlay requires full-depth slab replacement. In these instances, pavement removal must continue to sufficient depth to remove all deteriorated material underneath the overlay. In a COC-U overlay, the interlayer may be re-established with a geotextile in lieu of new HMA.

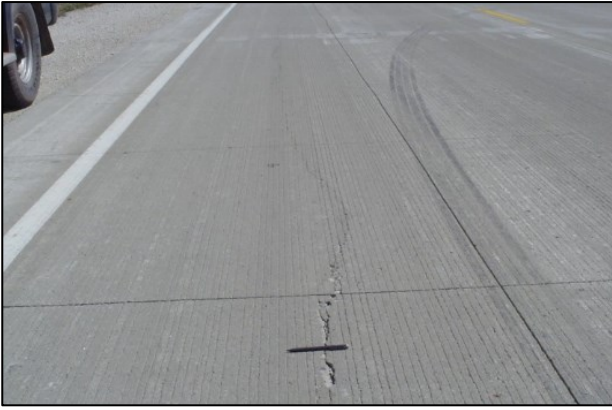
On these widened concrete overlays, longitudinal cracking has sometimes been observed to develop in the outer wheel path or paved shoulder. An example of this type of cracking is pictured in Figure 10. Cracking in the wheel path is sometimes isolated to individual slabs or may run continuously through a series of panels.

This cracking frequently appears to be caused by heaving underneath the shoulder and/or widening unit. In many of these cases, the cross slope has been observed to decrease between the crown and outside of the travel lane when it was designed to be constant, indicating that the edge of the pavement is rising. This movement may lead to cracking if the pavement is not tied properly at the joint between the mainline and widening/shoulder.

**Fig. 10.** Longitudinal cracking in the outer wheel path on a concrete overlay with an integral widening unit [11].

When these cracks first appear, they are usually not severe and do not immediately impact pavement performance. Non-working cracks may be routed and sealed. However, as the overlay ages and continues to carry traffic, these cracks can spall and cause deterioration at joint intersections. In these cases, full-depth patching should be performed to the original depth of the overlay to preserve pavement condition and prevent distresses from becoming disruptive.

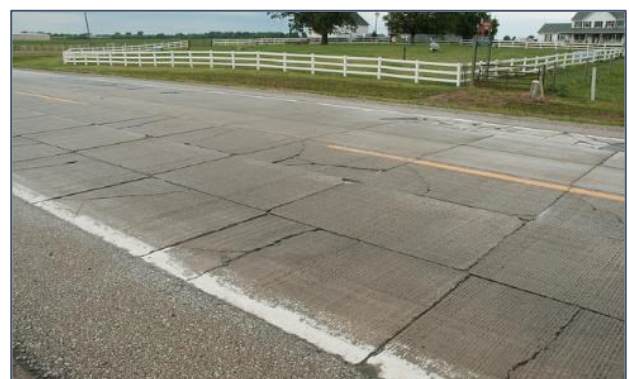
**Fig. 11.** Example of concrete overlay condition with 26.3% slabs cracked and significant fatigue damage [7].

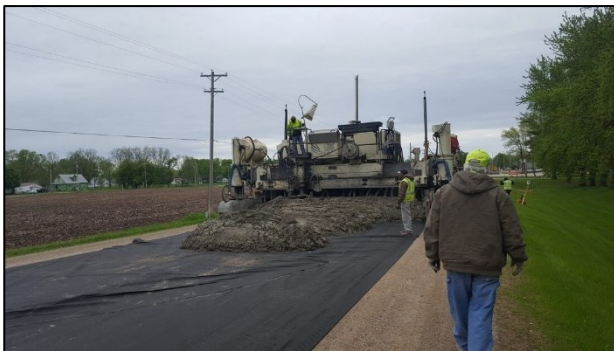
An example of a 36-year old COA-U overlay in Iowa that received a second concrete overlay (now COC-U) is pictured in Figure 12. A geotextile interlayer was used to separate the old concrete overlay from the new overlay.

**Fig. 12.** Construction of a new COC-U overlay in Iowa over an existing COA-U overlay.
