The Factors Affecting Building Damage in Balitata Village Due to 7.2 Magnitude Earthquake

Endah Harisun^{1*}, Hery Purnomo², Haryati³

^{1,2,3} Architecture Department, Faculty of Engineering, Universitas Khairun, Ternate, Indonesia,

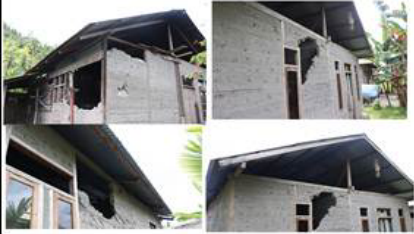
The earthquake caused the first house damage, and the building the walls collapsed due to construction errors at home. The reason is that the wall support column is made of 5/10 lumber, so the column cannot hold the wall load. Another possibility is mixed of certain bricks that do not comply with the standard 1:4 or 1:5 mixtures of cement and sand.
2
