# Improving the safety indicators of Ukrainian railways: a study of the longitudinal stability of the railway track

## 2 An example of a transportation event in which there was a loss of longitudinal stability of a jointless track

### 2.1 Characteristics of the track section at the rolling stock derailment

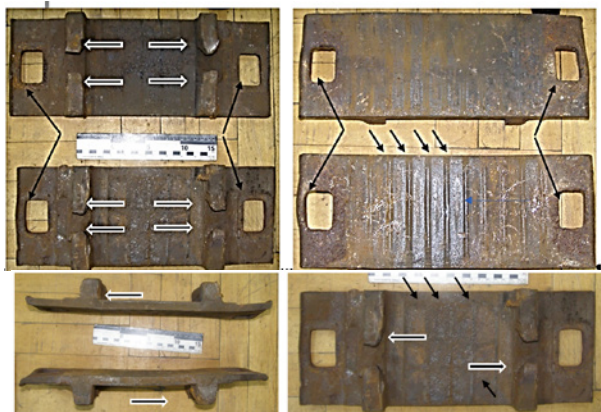
Fig. 1. Metal substrates from the train derailment area

As can be seen from these photographs, these intermediate fasteners show signs of longitudinal movement (bending) of the rail plates.

The jaws of the metal gasket under the bolt heads are deformed by torsional forces (Fig. 1; shown by double arrows). The metal gaskets are deformed in plan (Fig. 1).

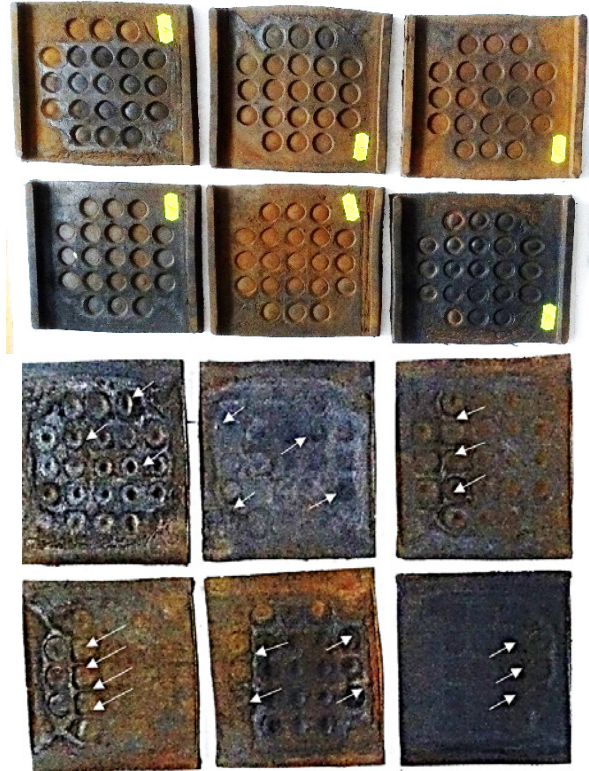
Fig. 2. Underrail gaskets from the area where the derailment occurred

Both the front and back sides of the under-rail gaskets (Fig. 2) show signs of long-term operation in conjunction with the rail sole: material displacement, undiscovered cracks, material wear in the area of the recesses, and uneven fit to the rail sole plane.

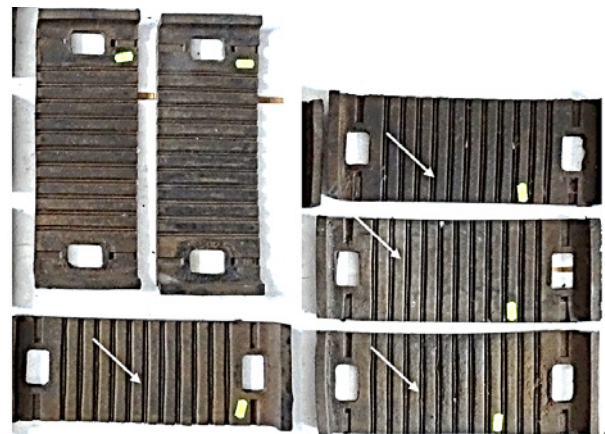
Fig. 3. Trench gaskets from the area where the derailment occurred

During the research, it was found that at the point of derailment, under-rail gaskets with markings that did not meet the requirements of the regulatory documents in force in the railway transport of Ukraine for this type of rail fastening were in use [2, 3]. In other words, the issue of the quality of these gaskets can be considered relevant in this case.

The absence of under-rail gaskets in the derailment area (up to 27 %) reduced the longitudinal stability of rail plates, since according to DSTU [2], under-rail gaskets are intended, among other things, to increase the longitudinal stability of rail plates.

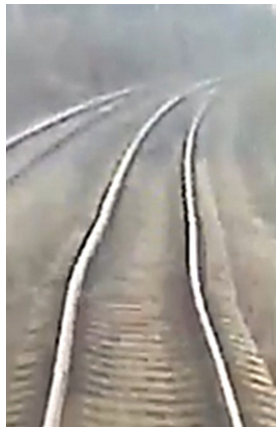
Figure 4 shows a freeze frame of the driver's cab video, which shows a clear deviation in the position of the rail strands in the plan at the derailment point, which can be classified as a "corner in the plan".

Fig. 4. Location of the rolling stock derailment

This is where the derailment occurred. The first to derail was the 1st wheelset of the 4th car of the train to the left. It should be noted that approximately 50 m before the visualised fault, the driver applied external braking.

The study found that the cause of the rolling stock derailment was the displacement of the rail and fuel grid, i.e., a change in the position of the track in the plan view, which occurred under the simultaneous influence of longitudinal temperature compression forces and rolling stock forces.
