Analysis of causes of damage to masonry walls in the historic barrack No. B-115 in the former KL Auschwitz II – Birkenau camp

*Krzysztof Gromysz*¹, *Łukasz Szoblik*^{2*}, *Zofia Drabczyk*² and *Agnieszka Tanistra-Różanowska*²

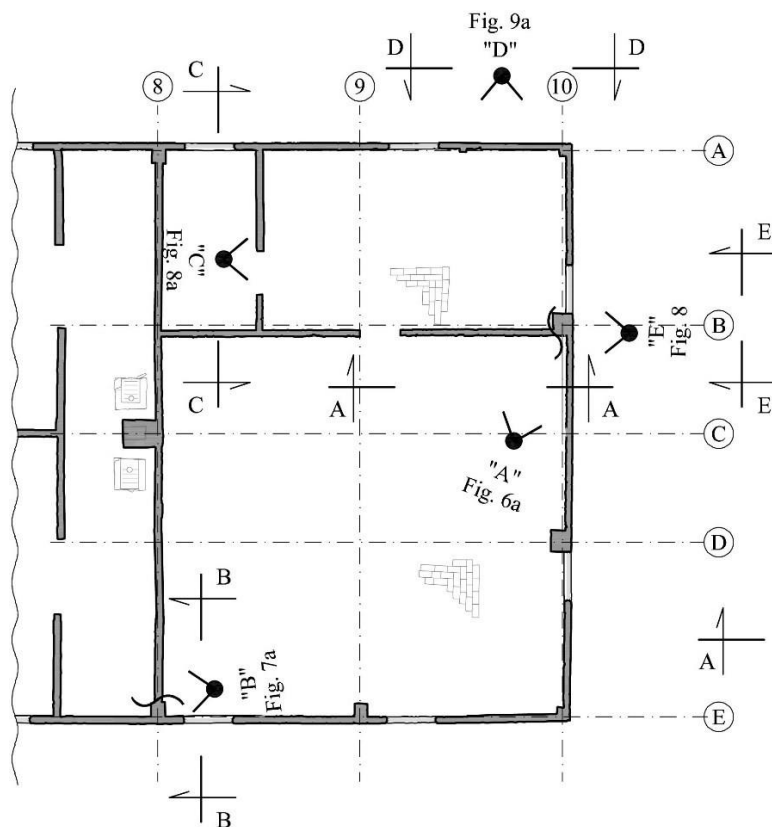
Fig. 5. Position of damage marked as “A”, “B”, “C”, “D”, and “E”.

The barrack B-115 is in poor condition, like the majority of brick barracks in sector BI, and is closed to visitors. There are many damaged structural and non-structural components. Specifically, there are cracks and walls breaking apart with a width of up to 79 mm, and the walls and roof elements are deteriorated. The position of five representative types of damage to the walls of this barrack, marked as "A", "B", "C", "D", and "E", is shown in Fig. 5. The aforementioned types of damage and the analysis of their causes are described below.

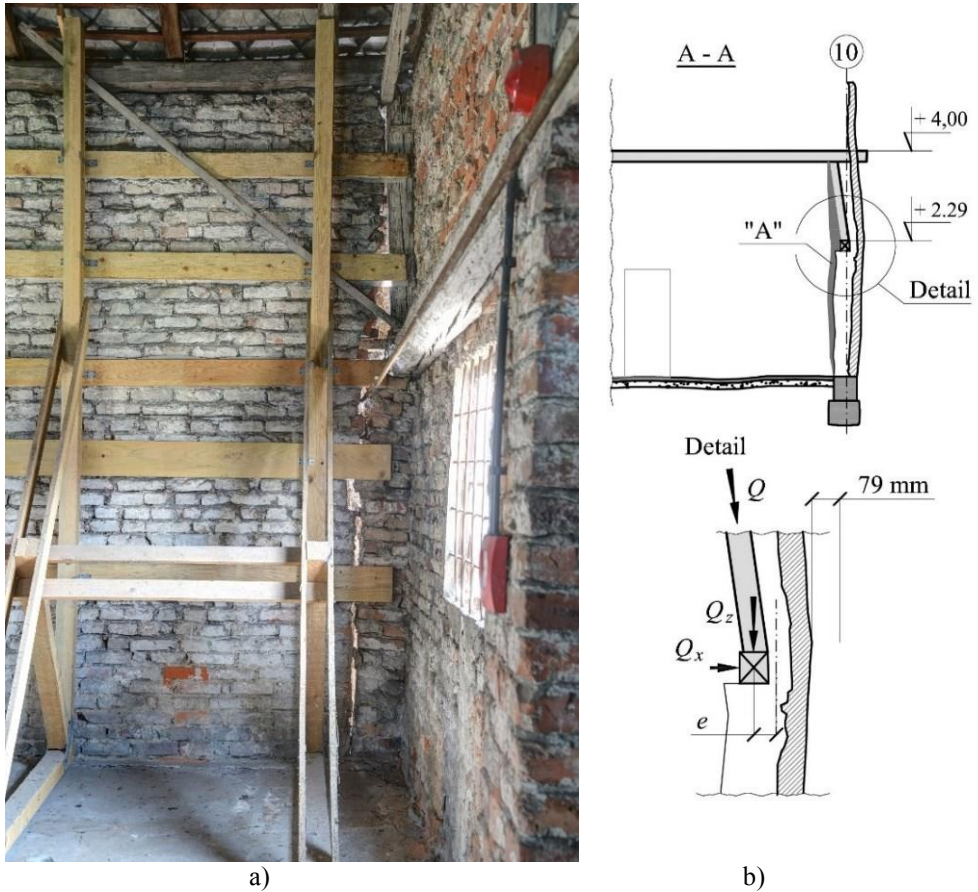
The most serious damage was found in the front walls, which were deformed and detached from the lateral walls. An example of such damage (damage "A", Fig. 6a) occurred at the connection between the walls in axes 10 and B. The connection between these walls is extended by the pilaster, which supports the column that acts as the outer support for the timber purlin in the roof structure. This column transmits the load to the pilaster through the horizontal beam (bottom chord) at the level of +2.29 m. Debonding was found between the pilaster and the wall in axis B. The widest debonding is approximately 80 mm at the level of +2.29 m, which is 2/5 the height of the wall from the support on the masonry foundation. The gable wall in axis 10 is deformed. This wall is bowed in the shape of an arch segment. The net deflection of the bowing is 79 mm and is at the level of the bottom chord. Debonding is observed along the entire height of the gable wall. The gradual deformation of the wall poses a risk to its structural instability. To prevent further degradation, the wall was protected with a timber retaining structure (Fig. 2b) built on the outside.

The original cause of damage "A" is the applied construction, in which a column of the roof structure transmits the eccentric load "e" to the wall in axis 10 (Fig. 6b). As a result, the gable wall is loaded with bending moment. Tensile stresses are observed in the horizontal mortar joints of this wall, on its outer side. They cause cracks and significantly reduce the wall stiffness. Consequently, the walls are deformed and the inclination of the column of the roof structure is changed. As a result, the horizontal force Q_x is generated and acts perpendicular to the plane of the gable wall. This load results in greater deformation of the system and accelerates the reduction of the pilaster stiffness. In this situation, the connection between the pilaster and the wall in axis B is responsible for balancing the force Q_x . However, this connection did not have sufficient load-carrying capacity and was destroyed. The resulting crack propagates from the place where the force Q_x is applied to the bottom of the front wall and its top edge, but the crack disappears in these places. This is because the wall is neither displaced at the level of the support on the foundations nor at the top edges, where it is supported by elements of the roof structure - purlins and roof battens. However, the front wall has been considerably deformed at its half-height and is currently protected against structural instability with the temporary retaining structure.

It should be emphasized that similar damage is observed in another gable wall in axis A and front walls in the majority of brick barracks in sector BI on the premises of the museum.

Fig. 6. Damage “A” in the place of connection between the walls in the axes 10 and B: (a) photo of the damage as shown in Fig. 5, (b) the mechanism of damage occurrence.

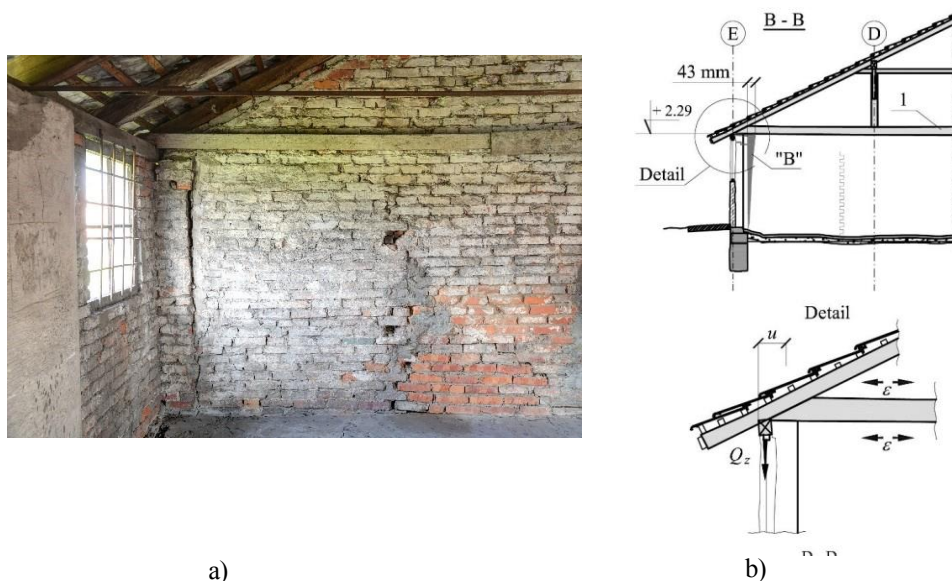
The second specific damage observed in the barrack is cracking in the connections between the lateral inside walls and external longitudinal walls. An example of such damage, marked as “B,” is shown in Fig. 7a. The characteristic of this damage is that the crack's widest point, measuring 43 mm, is at the level of the support of the wall plate on the masonry at +2.29 m. Additionally, this crack fades near the brick foundation of the wall. The external wall is deflected from the vertical plane, but no significant bowing has been observed.

The cause of damage “B” is the impact of the roof structure on the longitudinal wall. Sections of elements of the roof system are small, and concrete tiles impose a significant load. As a result, the elements of the roof system, particularly the collar and rafter ties, are deformed. This deformation is marked as “ ε ” (Fig. 7b). At the same time, the long wall of the barrack, supported on the foundation and not effectively connected with other walls, cannot respond to this deformation. Consequently, the longitudinal wall rotates on the foundation and is deflected from the vertical plane (marked as “ u ” in Fig. 7b). The lack of significant inflection of the wall is caused by the vertical reaction (Q_z) transmitted from the roof. Due to this reaction, compressive stresses are observed in all bed joints.

Fig. 7. Damage “B” to the walls: (a) photo of the damage as shown in Fig. 5, (b) the mechanism of damage occurrence; 1 – collar beam.

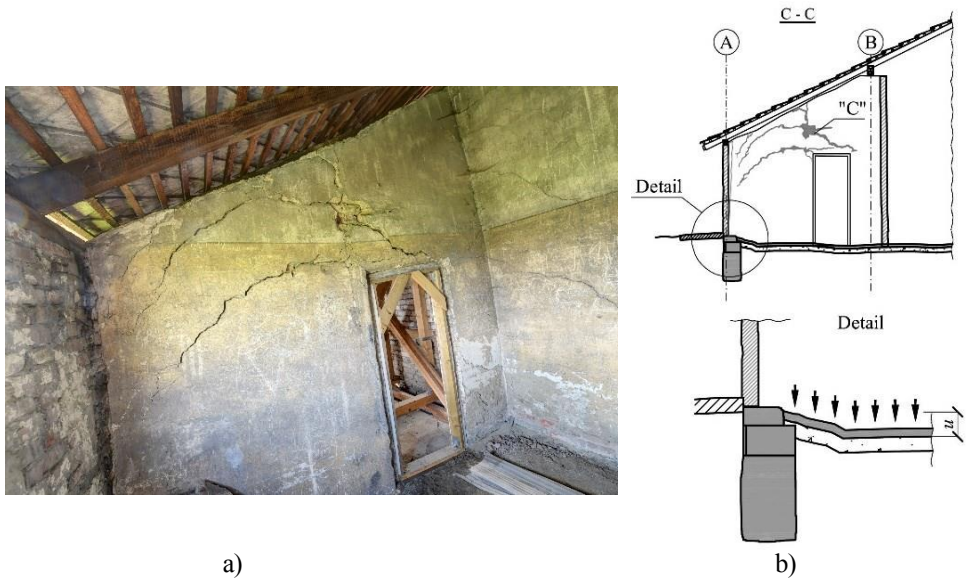
Very extensive damage, marked as "C", is on the lateral wall located between axes A and B (Fig. 8a). This damage is composed of cracks that run through the entire thickness of the wall and are arranged in a convex-shaped arch. The widest cracks, up to 10 mm, are in the middle of the wall between axes A and B. These cracks, which run towards the longitudinal walls in axes A and B, become narrower and eventually disappear in these walls. Crack "C" runs along joints and rarely goes through bricks.

To analyze the causes of this damage, the wall system in barrack B-115 was compared with the system of longitudinal walls in other barracks. This comparison indicated that originally this wall was shorter, approximately 2 m high, and served as the dividing wall between bunks. There were no foundations below the walls separating the bunks, which were placed directly on the floors. When this part of the barrack’s function changed, the existing wall was extended to separate rooms. As a result, the floor was heavily loaded, causing it to deflect. Consequently, a system of stresses was created in the wall, and the paths of the main stresses σ_2 overlapped with the direction of the observed cracks. Thus, the cracks are perpendicular to the main stresses σ_1 . The wall material has almost zero tensile strength and cannot absorb the stresses σ_1 . That is why a specific arrangement of cracks is observed, which can be described as the effect of crack bridging. The fading of cracks near axes A and B indicates that there are foundations below these walls, providing support for both the analyzed lateral wall and the longitudinal walls.

Fig. 8. Damage “C” to the wall between the axes A and B: (a) photo of the damage as shown in Fig. 5, (b) the mechanism of damage occurrence

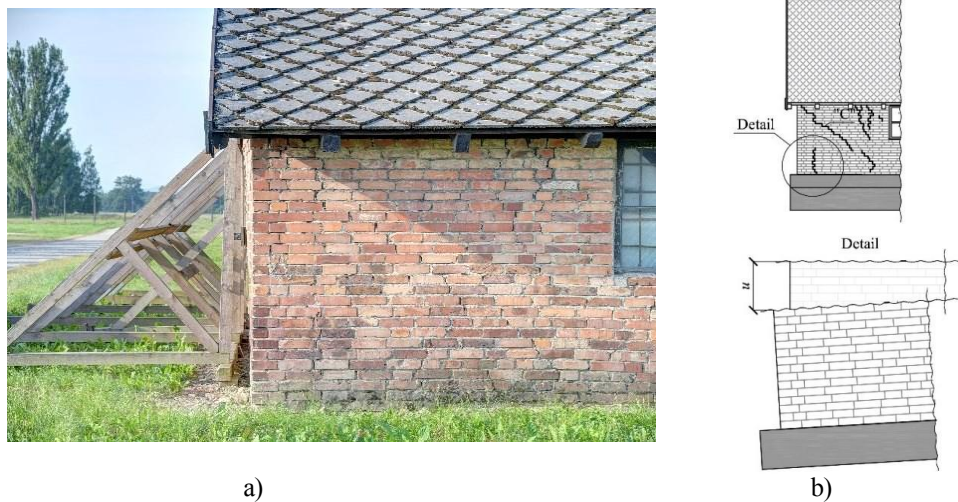
Another damage observed in the barrack wall includes cracks with a width of up to 3 mm in the longitudinal wall, near the north-eastern corner (the damage "D" – Fig. 9a). The resultant direction of the crack path is at an angle of approximately 45 degrees, while the cracks propagate in the bed and head joints and do not go through individual bricks. Visual examination of this fragment of the barrack reveals that the walls at the north-eastern corner have been partially repaired, and the described damage reoccurs. It is the result of lowering this corner of the building, which is caused by two factors acting simultaneously. The first factor includes deformation of bricks in the bottom part of the masonry, which is in contact with the ground. These parts of the wall show the most serious signs of degradation, which are caused by the lack of efficient drainage of runoff water collecting around the barrack. The lack of a gutter system and drainage of runoff water outside the barrack plan amplifies this effect. Moreover, capillary rise of water expands the area of damp wall. It is particularly noticeable on the northern exterior wall of the barrack. Moisture retained in the wall during lower temperatures causes thawing of bricks and their degradation, which increases the degradation of this part of the wall as a result of transmitted vertical loads. In addition, the damp part of the wall creates good conditions for the growth of moss and lichen that increase deterioration. The second probable reason for lowering the north-eastern corner of the wall is less favourable conditions of foundations of this part of the barrack.

Fig. 9. Damage “D” to the wall in the axis A: (a) photo of the damage as shown in Fig. 5, (b) the mechanism of damage occurrence.

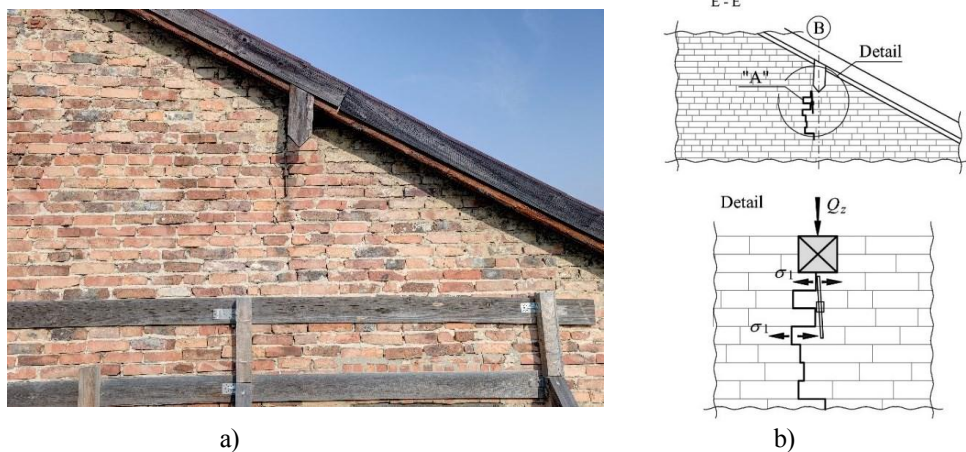
The last analyzed damage to the walls of the barrack B-115 includes cracks with a narrow width of up to 0.3 mm propagating in the gable walls, below the support for purlins (damage "E" – Fig. 10a). Probably the following mechanism is responsible for the occurrence of this type of damage. Originally, the whole reaction of purlins was taken by timber columns placed on pilasters. However, the columns were subjected to degradation over time due to corrosion and rheological deformations. The force in the columns was decreasing, and the force transmitted through the purlin directly to the front wall was increasing. The wall response to the load Q_2 was accompanied by main horizontal stresses σ_1 acting on the wall (Fig. 10b). The wall is cracked as it has limited capacity for taking tensile stresses. These cracks are perpendicular to stresses σ_1 , which means they are vertical cracks.

Fig. 10. Damage “E” to the wall in the axis 10: (a) photo of the damage as shown in Fig. 5, (b) the mechanism of damage occurrence.
