# Structural analysis and damage assessment of a fortified church – A case study: The Evangelical Church of Apos, Sibiu County

Porumb Ana-Maria<sup>1\*</sup> and Petruse Diana Eva Larisa<sup>1</sup>

<sup>1</sup>Polytechnic University of Timișoara, Piata Victoriei 2, Timișoara 300006, Romania

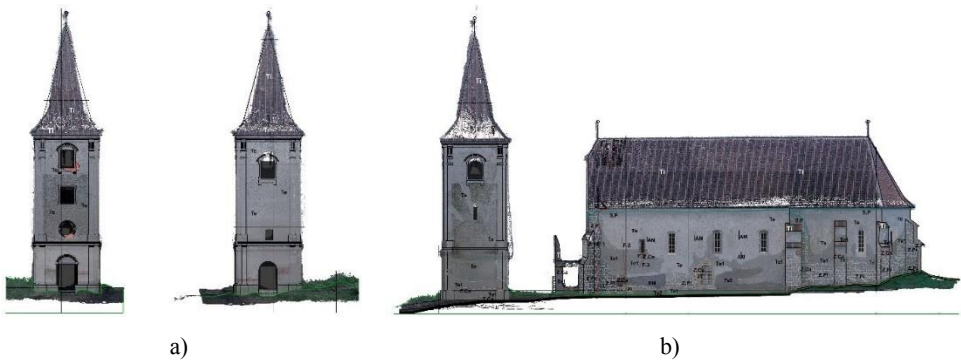
**Fig. 3.** (a) Bell tower – western and eastern facades, (b) Bell tower and church – south façade.

1. Degradations affecting the whole structural integrity, as shown in Fig. 3 and Fig. 4, caused by the appearance of cracks due to differential settlements and lack of cooperation between structural elements, as well as degradation of the layers' structure due to the influence of atmospheric factors such as meteoric and capillary waters, UV rays, and wind action, which together caused discoloration, crusts caused by the presence of salts, peeling, detachment of plaster and its grinding. Mechanical degradations resulted from the detachment of buttresses from the walls, as well as due to the sliding of the terrain towards the south after the demolition of the fortified enclosure wall. Also, in the case of brick masonry, two types of damages are distinguished: pronounced cracks indicating massive displacements of masonry and/or smaller but numerous cracks indicating masonry disintegration. In the case of the Apoş Ensemble, differential settlements combined with prolonged states of high humidity levels led to the disintegration of the load-bearing masonry. Also, seismic activity can be considered one of the factors contributing to the occurrence of damages, but these damages are difficult to identify given the current state of the

construction. Thus, both hypotheses can be considered determinant factors in the structural degradation process, but the most visible one is the uneven settling of the terrain.

2. Degradations caused by human factors and execution defects, as shown in Fig. 3 and Fig. 4 - transformations, maintenance defects, lack of protection against capillary and meteoric water, thermal bridges, wind action, lack of maintenance of vegetation in the proximal area. A series of interventions are noted that are not compliant with the use of cement mortar during repairs in the 1960s, at the base of the walls, with the aim of restoring the deteriorated plaster due to moisture infiltration from the soil, thus, the cement mortar has produced additional chemical degradation, making the masonry brittle. Another area that has undergone numerous alterations is the main access arcade, being the most frequently used mobile element of the building. Some of the degradations may be due to the technological process used at that time for these materials, due to the presence of defects, from the protection of the materials used to chemical, physical, or biochemical factors. Masonry made from inferior quality, unburned or incompletely burned bricks, with inclusions, having large, uneven, and unfilled joints with mortar, has been subjected to degradation. The use of dusty bricks and the use of inadequate quality mortar favoured the creation of a masonry with low resistance. The realization of subsequent interventions, on the occasion of making gaps, slots, or piercings in masonry, contributed directly to the progressive decaying state of the buildings in question.

3. Physicochemical degradations, as shown in Fig. 3 and Fig. 4 (The legend can be found in Fig. 5) - internal causes, such as composition defects or defects in crystalline cohesion, external causes of human origin and design and execution defects were distinguished.
