Recent methods of visualization used in the diagnosis and consolidation of historic structures

Olariu Gigi^{1*} and *Nemet Florin Marius*¹

¹Polytechnic University of Timișoara, Piata Victoriei 2, Timișoara 300006, Romania

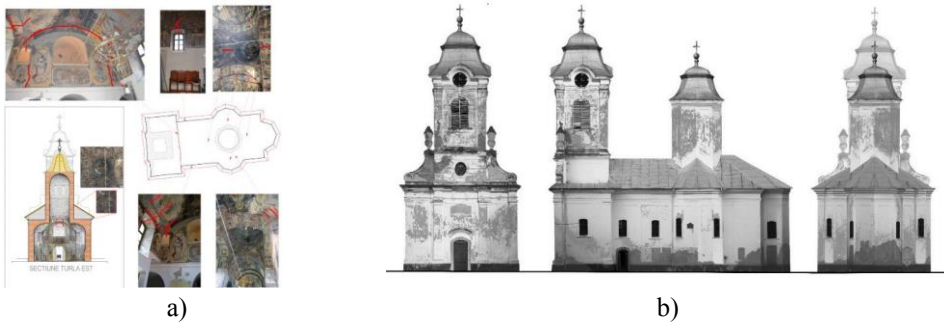
Fig. 2. (a) Cracks and degradation caused by differential settlements, (b) Deteriorations on the facades of Bezdin Monastery Church captured through 3D laser scanning

On the exterior, the main deteriorations are found in the cornice area, caused by the progressive degradation of the roofing, as well as the water drainage system - gutters and downspouts. Additionally, there are also deteriorations at the level of the finishes, mainly caused by capillary water, as well as previous interventions made with cement-based mortars.

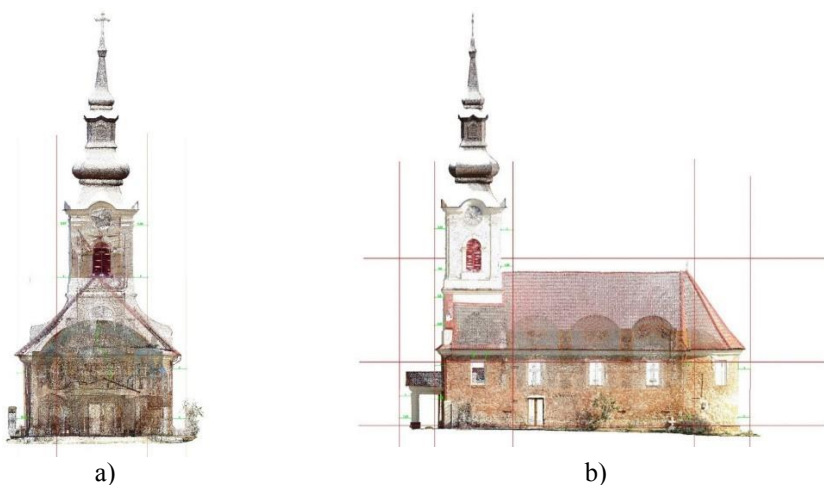
Through the analysis of the point cloud and the creation of vertical lines at a distance of one meter from each corner, the following differences were obtained: The lower left side measures 0.96 meters, while the upper left side measures 1 meter; the lower left side of the tower measures 1 meter, while the upper left side of the tower measures 0.97 meters; the lower right side measures 1 meter, while the upper right side measures 1 meter; the lower right side of the tower measures 1 meter, while the upper right side of the tower measures 1.03 meters. Additionally, there is a visible crack in the pediment area, with a length of 3.92 meters, starting from the corner of the window opening and continuing to the portico area. Preliminary conclusion: there is an outward displacement of the upper part of the building's masonry on the left side façade, as well as a displacement towards the right of the tower without major structural damage, (see Fig. 3a).

On the vertical axis, the following measurements were obtained (see Fig. 3b): Left side lower area = 1.02 m, left side upper area = 1 m; left side lower area of the tower = 0.90 m, left side upper area of the tower = 0.91 m; right side lower area = 1 m, right side upper area = 1 m; right side lower area of the tower = 1.02 m, right side upper area of the tower = 1 m.

Fig. 3. (a) The main façade of the church, (b) The right lateral façade of the church.

Additionally, there are visible external cracks, approximately 0.7 m in length, on the façade, starting from the corners of the void and extending to the cornice area. Preliminary

conclusion: there are no major structural damages. The upper masonry in the main facade has shifted inward. In the choir area, the masonry on the rear facade does not show any displacement.

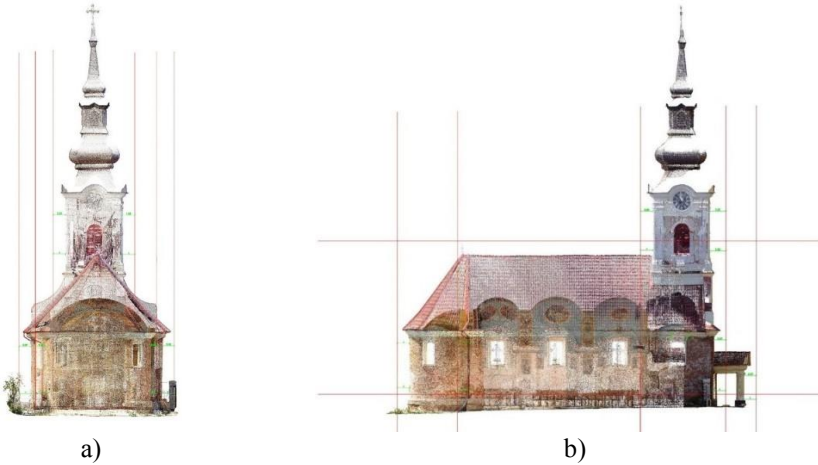
On the vertical axis, the following measurements were obtained (see Fig. 4. (a)): Left side lower area = 1 m, left side upper area = 0.97 m; left side lower area of the tower = 1 m, left side upper area of the tower = 1.01 m; right side lower area = 1 m, right side upper area = 0.92 m; right side lower area of the tower = 1 m, right side upper area of the tower = 1.02 m. Preliminary conclusion: there are no major structural damages. The upper masonry on the left side of the lateral façade has shifted outward.

On the vertical, the following measurements can be found (see Fig. 4 (b)): the left side of the lower zone is 1 m, the left side of the upper zone is 1 m, the left side of the tower's lower zone is 1 m, the left side of the tower's upper zone is 0.99 m, the right side of the lower zone is 1 m, the right side of the upper zone is 0.97 m, the right side of the tower's lower zone is 1.33 m, the right side of the tower's upper zone is 1.33 m. There are cracks present near the window opening, starting from its corners and continuing towards the cornice, with a length of approximately 0.70 m. Preliminary conclusion: There are no major structural damages. There is an outward displacement of the masonry in the upper zone of the main facade and at the upper part of the porch.

Fig. 4. (a) The back façade of the church, (b) The left lateral façade of the church.

After analysis, it is evident that the heritage object is in a good state of preservation, with the main affected areas being the front façade, as well as the right and left lateral facades, due to the presence of visible exterior cracks that may affect the structural integrity of the church. These cracks extend from the corners of some openings to the cornice, with lengths of approximately 70 cm, and up to 3.92 m in the area of the pediment in the front façade.

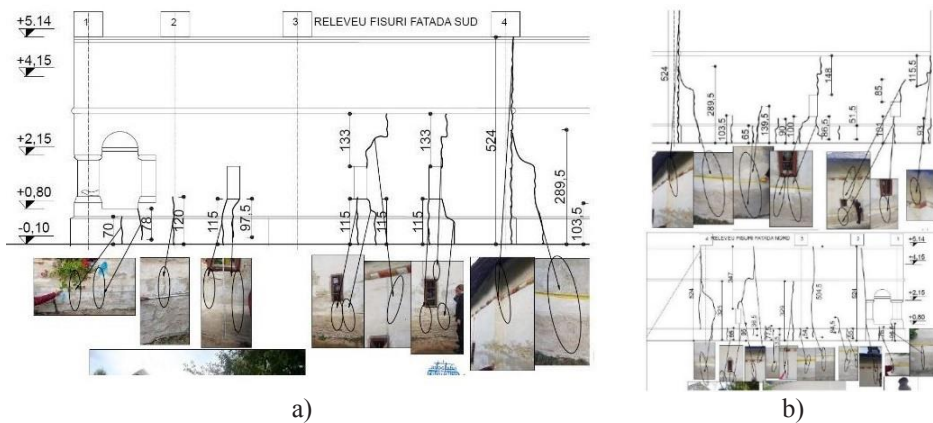
The first observation regarding the causes of structural damage concerns the damage to the masonry and plaster caused by the combined action of rising capillary water and freeze-thaw cycles. The second component that contributed to the present damage is represented by seismic action. From observations on the case at hand, the presence of a longitudinal crack was found, starting from the porch area and continuing towards the altar area, with a tendency to separate the entire building into two fragments. Also, the presence of a set of transverse cracks is noted, located in the weakened sections of window openings, niches, and doors, as well as cracks in the masonry elements, especially at the arch keys in the masonry, continued towards the window and door openings.

In the area of the facades, detachments were identified between the transverse walls and the lateral faces, as well as inclined cracks at the corners of the openings, appearing as a consequence of dynamic actions. A series of cracks are represented in Fig. 7 (a) and (b). Also, cracks were identified at the level of the vaults made of masonry in the attic area.

Fig. 7. (a) Cracks – South façade, (b) Cracks – North façade.

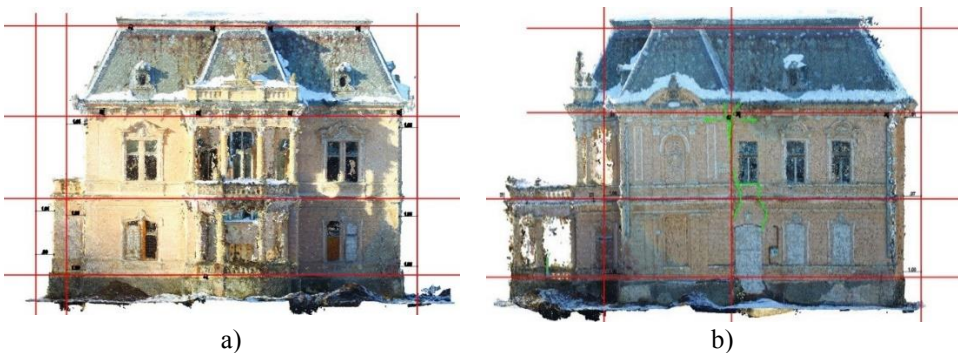
By analyzing each façade individually, information can be extracted as follows. By analysing the point cloud and drawing horizontal and vertical lines one meter away from each corner, the following differences can be observed: On the vertical axis, the following differences can be found (see Fig. 10 (a)). The eastern side has a difference of 1 m from the base to the floor above the ground floor, and another 1m from the floor above the ground floor to the floor above the first floor; the western side has a difference of 1 m from the base to the floor above the ground floor, and 1.04 m from the floor above the ground floor to the floor above the first floor. The preliminary conclusion illustrates an inward displacement of the upper part of the building's masonry. On the horizontal axis, the following differences can be found: The floor line in the central area (balcony area) shows a settlement of 21 cm; the floor line above the first floor shows that the settlement is maintained both at the balcony level and at the central wall level; the floor line above the ground floor shows a repeating settlement in the central attic area, partially covering the balcony. The preliminary conclusion is the presence of uneven settlement in the central area of the building.

On the vertical axis, the following differences can be observed (see Fig. 10 b): Left side base = 1 m, floor above ground floor = 1 m, floor above first floor = 0.89 m. Preliminary conclusion: there is a displacement of the masonry at the upper part of 2 cm. In the central area of the facade, a double-directional cracking zone is highlighted, one towards the left, with a distance of 7 cm at the upper part, and the other towards the right with 9 cm. Preliminary conclusion: the building is cracked in two different directions with a total differential settlement of 16 cm. Right side base = 1 m; Floor above ground floor = 0.97 m; Floor above first floor = 0.91 m. Preliminary conclusion: there is an outward displacement of the entire wall, increasing from the base to the upper part by 9 cm. On the horizontal axis, the following differences can be observed: The floor line is skewed. The floor line above the ground floor shows a settlement in the balcony area with a drop of 5 cm. The floor line above the first floor shows differences from the central area, with a drop of the floor towards the right by 7 cm. Preliminary conclusion: there is a settlement on the corner on the right of 9 cm, and a settlement of the terrace on the left side of 5 cm.

Fig. 10. (a) The main façade, (b) The right lateral façade.

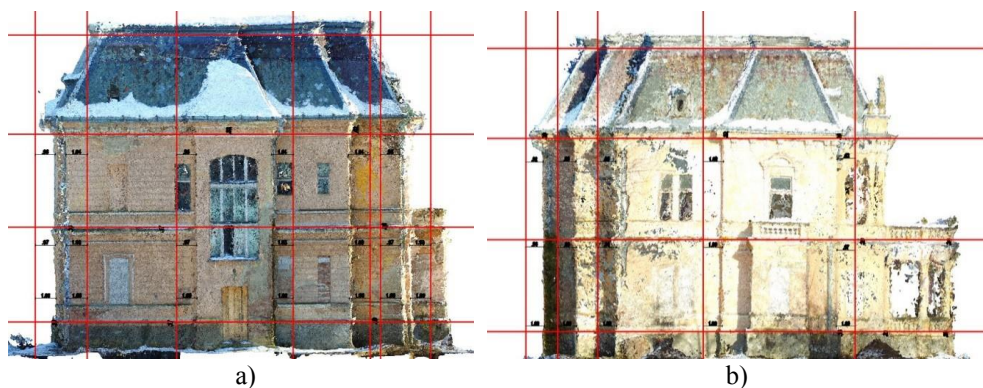
On the vertical, the following differences can be found (Fig. 11 (a)): Left side at the base = 1 m, floor above ground level = 0.97 m, floor above first level = 0.96 m. Preliminary conclusion: there is a displacement of the masonry at the top by 4 cm, towards the left. On the vertical, in the central area, the following differences can be found: At the base = 1 m, floor above ground level = 0.97 m (left), and 1.03 m (right); Floor above first level = 0.96 m (left), and 1.04 m (right). Preliminary conclusion: there is a displacement of the masonry at the top by 4 cm, towards the left. Right side at the base = 1 m, floor above ground level = 0.97 m, floor above first level = 0.96 m. Preliminary conclusion: there is a displacement of the masonry at the top by 4 cm, towards the left. On the horizontal, the following differences can be found: The floor line slopes to the left with a difference of 7 cm; The floor above ground level shows a sag of 7 cm towards the left. The floor above first level shows a drop towards the left of 7 cm. Preliminary conclusion: settlement on the corner to the right of 7-8 cm.

On the vertical plane, the following differences can be observed (Fig. 11 (b)): Left base side = 1 m, floor above ground floor = 0.96 - 0.98 m, floor above first floor = 0.92 - 0.95 m. Preliminary conclusion: there is an upward displacement of the masonry of between 5 and 8 cm, towards the left. On the vertical plane, in the central area, the following differences appear: At the base = 1 m, floor above ground floor = 1.03 m; Floor above first floor = 1.08 m. Preliminary conclusion: there is an upward displacement of the masonry of 8 cm towards the left. Right base side = 1 m, floor above ground floor = 0.97 m, floor above first floor = 0.92 m. Preliminary conclusion: there is an upward displacement of the masonry of 8 cm towards the right. On the horizontal plane, there are the following differences: The floor line slopes towards the right with a difference of 10 cm; The floor line above the ground floor shows a settlement of 4 cm towards the right. The floor line above the first floor shows a fall towards the right of 18 cm. Preliminary conclusion: settling on the corner on the right of 14 cm.

Fig. 11. (a) The back façade, (b) The left lateral façade.

In conclusion, the building has significant structural damage, with major cracks and fractures in the joint areas, mainly due to differential settlements. In the area of the attic and the cornice, there are cracks in the masonry, as well as cracks at the level of the basement vaults, cracks in the brick arch on the ground floor that supports the staircase. Deterioration is also present on the facades, where the plaster shows significant damage, and on the portions where it is missing, its absence has caused partial erosion of the mortar from the joints.
