Common issues regarding the churches of Banat

Abstract. Banat is a south-western region of Romania in which all villages contain orthodox churches. The churches in question were constructed during the end of the 18th century – beginning of the 19th. It is important mentioning that the religious activity was uninterrupted during this time. The churches are located in the following villages: Poganesti, Voiteg, Zgribesti, Balint, Sanmihaiu Roman, Hezeris, Unip, Capat, Saravale, Hodoni, Igris, Babsa, Ficatari, jebel, Visma, Cadar, Hodos, Olosag. The aim of the study is to identify the primary issues, deteriorations, which became apparent with time and present during evaluation and identifying the cause of this. The observations were made during 2022-2023. The majority of the orthodox churches from Banat consist of a central area (*naos*), sometimes accompanied by transepts on both sides, a sanctuary in the eastern part and a bell tower in the western part. The primary structural degradation consists of cracks in the walls, the arches and domes. The causes of all this are unequal leaning of the walls, uneven weight exerted by the structure, foundations with insufficient width and depth

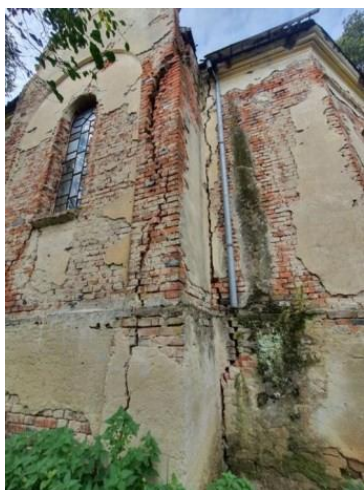
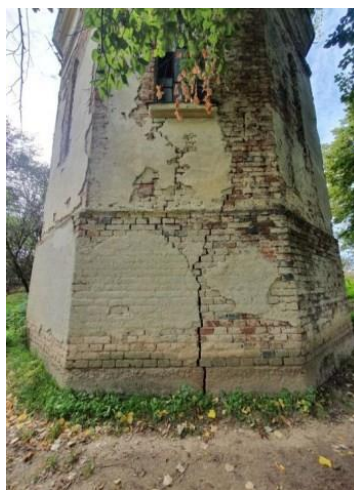
Cracks or fissures can appear in the foundation. They continue to extend towards the upper levels of the building. Structural walls, in addition to cracks and fissures, may also have deterioration of the bricks and joints between them, reducing the horizontal section. (Fig. 8-9)

Fig. 8. “Vizma” Orthodox Church.

Fig. 9. “Vizma” Orthodox Church.

In the case of cracks in the walls, they will be "stitched" with metal clips inserted in the joints of the masonry.

Then the area is covered with hydraulic lime reinforced with a metal mesh. [6] (Fig. 17).

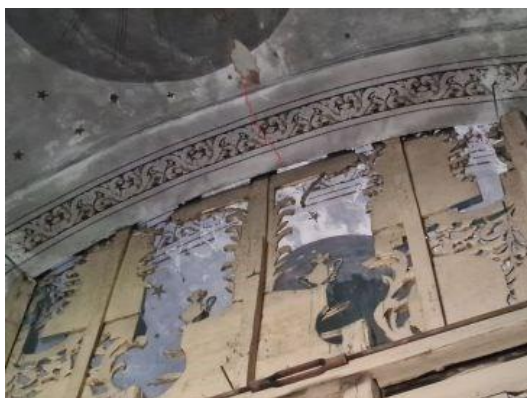
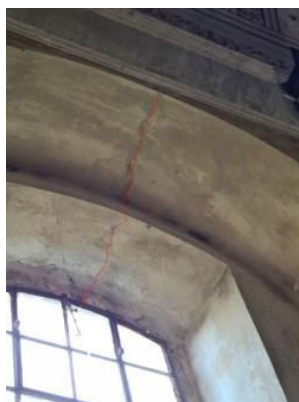
The masonry arches present cracks in the middle of the bottom area with disruption of the masonry continuity. They may even have dislocations and falling of brick. The area above the window gap frequently shows cracks. (Fig. 10-11)

Fig. 10. “Saravale” Orthodox Church.

Fig. 11. “Saravale” Orthodox Church.

Solution 1: it is proposed to install a tie at births to take the stretching forces and stop the advancement of cracks. It should be remembered that the longitudinal arches marking the lateral apses initially had metal straps, which meant that the arches did not show structural degradation (Fig. 16).

Solution 2: Drilling at the top of the spring (through the bridge), introducing metal reinforcement and filling with hydraulic mortar. The reinforcements introduced must be perpendicular to the crack direction in order to take over the tensile forces. Fig. 16. [5]

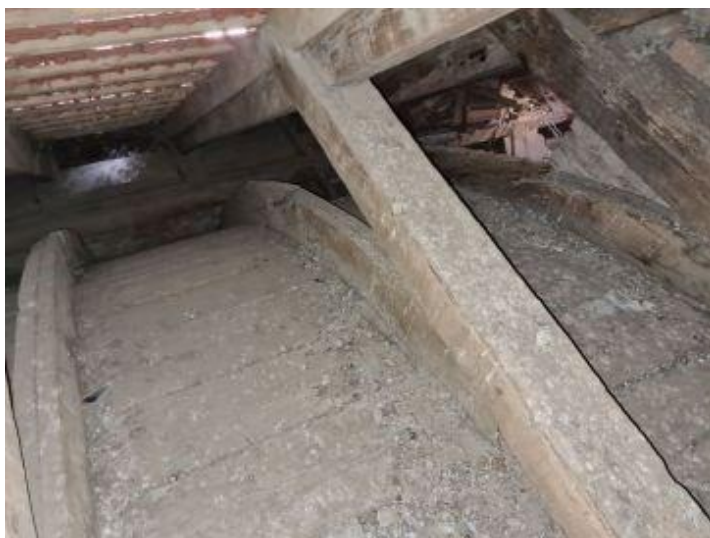
Fig. 12. “Saravale” Orthodox Church.

The wooden vaults may have splintering, decay. The roof wood may have decayed ends, the wooden elements may be cracked, rotten or even broken (Fig. 12).

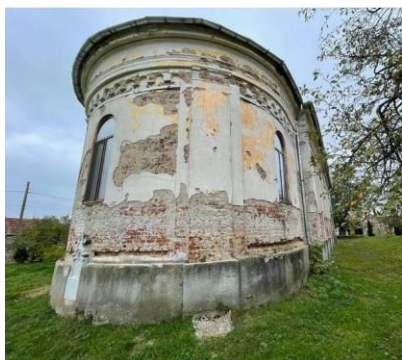
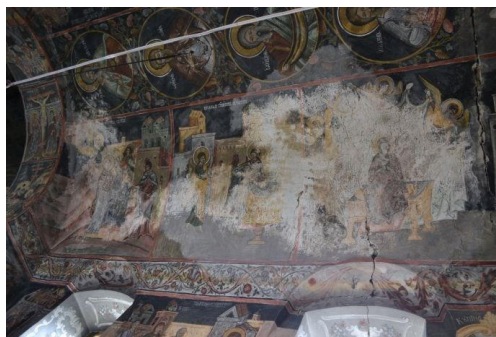
These are: detachments from the plaster, exfoliation, degradation of the painting (Fig. 13, 14).

Fig. 13. “Babsa” Orthodox Church.

Fig. 14. “Bezdin” Orthodox Church.
