# Conservation, consolidation and restoration of the Holy Annunciation Church, Vatasesti village, region of Oltenia, Romania - Architectural and structural particularities

**Abstract.** The present article discusses the process of architectural and structural diagnosis of a late 18th century, brick masonry built, Christian church located in Vătășești village, Vâlcea county, Romania, presenting the particularities discovered. The church is dedicated to Saint John the Baptist and The Holy Annunciation and it is listed under the LMI code (List of historical monuments of Romania) VL-II-m-B-09968. Its registration in the list of historical monuments inscribed in the National Cultural Heritage of Romania was realized especially thanks to its original byzantine style mural paintings (frescoes) still left almost intact on the interior walls, the only serious damage made to it being found on the paintings once found on the outside walls. In order to properly conserve, consolidate and restore the vernacular monument, the process of diagnosis had to include research and investigations of various and complementary areas such as 3D scanning using laser scan technology, the archaeological repor

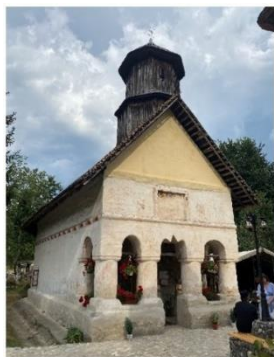
**Fig. 6.** West façade.

The general shape of the roof was modified in the past with the addition of a bell-tower above the portico. This unfortunate choice led to the damaging of the paintings on the west façade, the paintings showing daily village life scenes.

Due to the reshaping of the roof, the unique scenes painted on the outside wall of the portico were washed away by rain.

Still, you may identify silhouettes of trees, hills and people on the façade, but the scenes are lost forever.

1. The restoration of the original volumetric configuration of the roof, with the overhang present on every façade and the removal of the bell-tower in order to preserve the remains of the outside paintings is the only volumetric change that the architectural project [6] proposed.

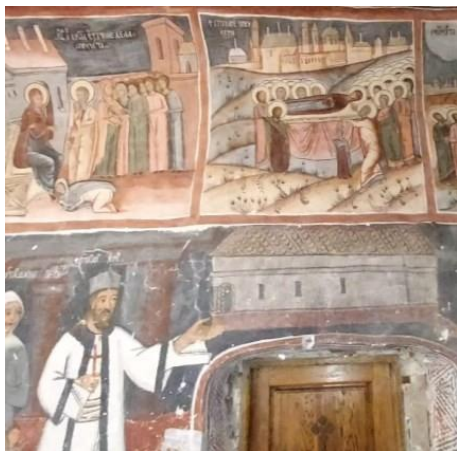
**Fig. 9.** Detail of the western wall of the narthex.

As Fig. 9 shows, depicted on the western wall of the narthex are the founders with their families holding a model of this church, a very important piece in the restoration process puzzle. Comparing the original painted image with the present state of the monument we concluded that the roof was badly changed and needed restorative interventions according to the original appearance.

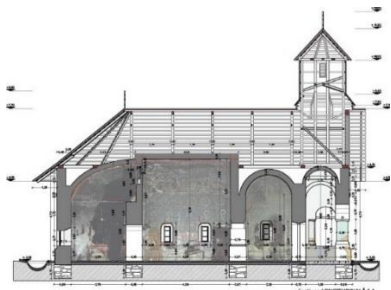
**Fig. 12.** Longitudinal section of the church.

Particularities shown by the surveys were the lack of perpendicularity and parallelism of the walls and the lack of symmetry of the church by the central axe on the East-West direction. The building is not splittable in two equal parts, with the north side being narrower than the south side.

A very important discovery was the slight leaning of the building towards the south-east intersection of the altar apse and the naos, where the most important structural cracks were found.

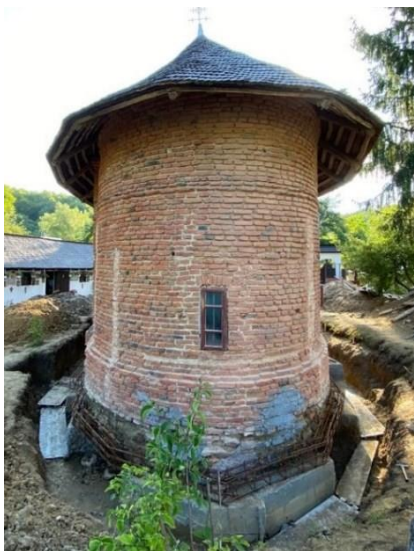
**Fig. 15.** Underbuilding works phase.

The general quality of the foundations was discovered to be very poor in terms of techniques and depth. They only reach between a minimum of 60 to 70 centimetres of depth, while in the region the conventional freezing depth is of 1 meter. This allows water to freeze underneath the rock boulders causing displacements of the soil under the foundations, hence the small cracks that randomly appear and have no structural correspondent. Technically, the foundations were built of rock boulders and lime mortar, a problem being the fact that due to humidity the mortar was washed away.

1. In order to reduce the differential settlements of the foundations and to increase their volume so the efforts can be better received by the natural ground, underbuilding works (Fig. 15) were projected. Another reason for the underbuilding approach was the consolidation of the link between walls and foundations.

2. Having seen the condition of the boulder masonry of the foundation, first of all they had to be injected with a new mortar of hydraulic lime in order to glue the boulders back and prevent them from falling apart when digging underneath.

3. Above the underpinnings our team projected a concrete beam that goes around the church, in order to keep the foundations together.
4. Once the consolidation of the foundations was finished, the remaining ditches were filled with a drainage system made of different sorts of gravel and the drainage tube. Above this, the sidewalks needed to be off-set from the walls with a minimum distance of 10 centimetres, in order to allow a minimum ventilation of the infrastructure.

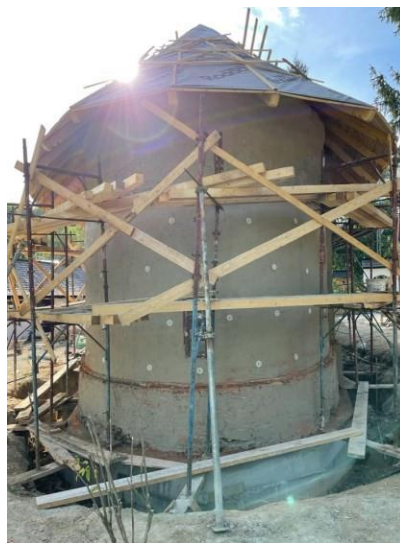
**Fig. 16.** Wall consolidation works.

The walls presented two classic categories of cracks, ones coming down from the arches and vaults to the foundations, and others upward and downward the windows and doors.

1. For the reinforcement of the walls, we used longitudinal reinforcement made of helical stainless-steel bars, with high mechanical performance, placed between the rows of masonry in order to stitch the structural elements. The bars were fixed using hydraulic lime.

3. In order to restore the structural continuity of the building, all walls besides the western façade were meshed with fiberglass and aramid nets specific for the reinforcement, improvement and anti-seismic adaptation of masonry. (Fig. 16)

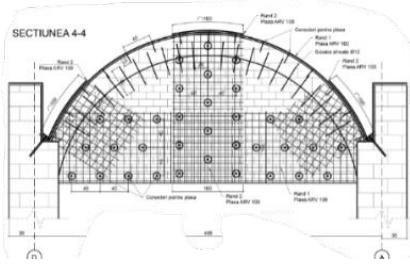
**Fig. 18.** Projected consolidation detail of the vault above the naos.

The arches and vaults in the narthex, naos and altar were cracked on the middle axe direction, due to the displacement on the walls. In the portico were no damages found, because of its small dimensions. Particularities here were found when looking at the vaults and domes from the attic of the building. Here the investigating team found out that the capstone, the keystone of the arched shapes was made by wood pickets. Due to fluctuations of humidity these pickets changed their shape and volume and this process may have generated some part of the cracks in the vaults.

This category of interventions seeks to prevent the vaults and the dome above the altar to collapse. (Fig. 18)

The interventions were implemented only on the outer surfaces, from the attic. No mural paintings were touched by the new works.
