# Repair of reinforced concrete beams using carbon fiber reinforced polymer

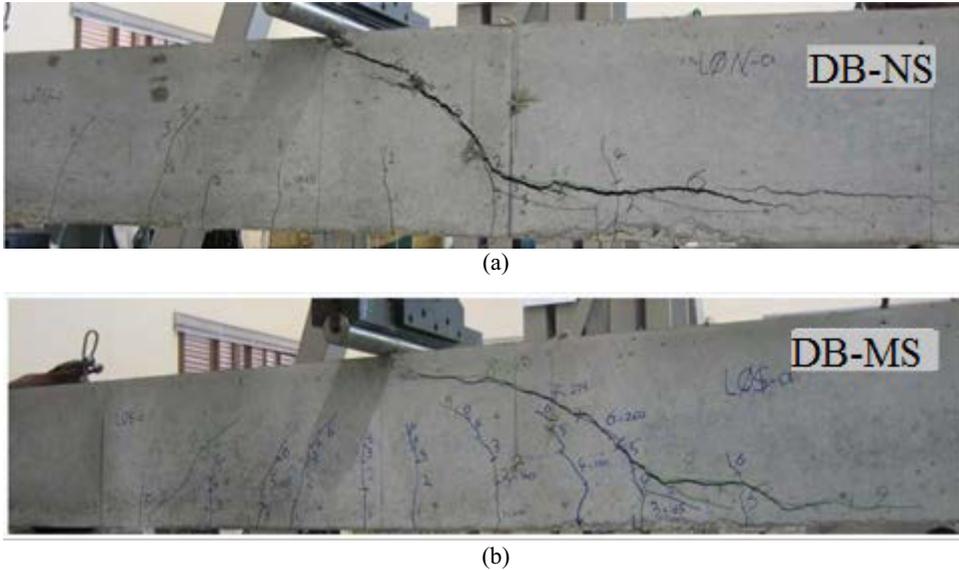
**Fig. 1.** Pre-damaged beams (source [26]), a) without stirrups, b) with minimum ratio of stirrups

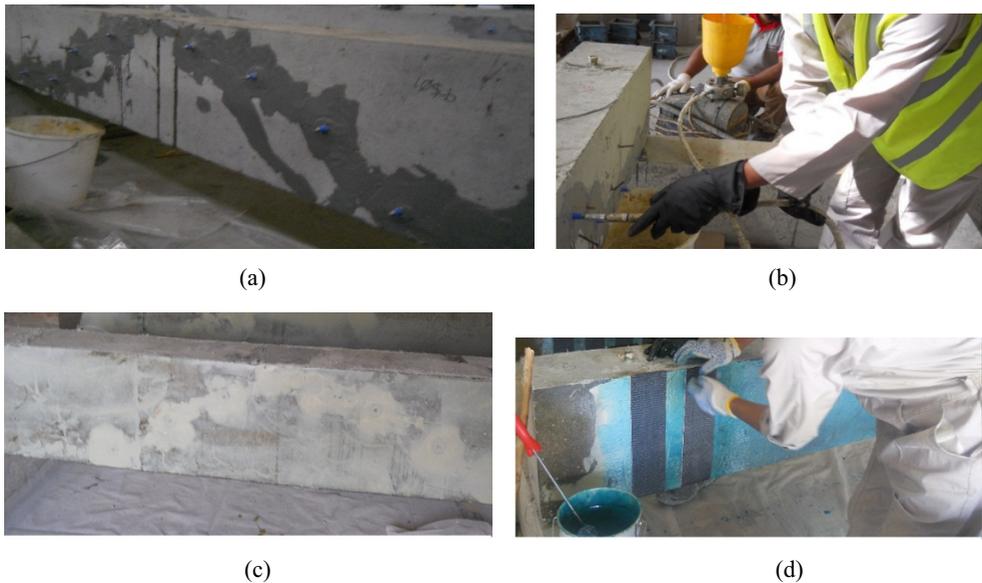
**Fig. 2 .** a) Pre-damaged beam with attached packers on the main crack, b) Injecting epoxy using pressure pump, c) Beam ready for wrapping after surface grinding and primer coat application, d) Wrapping the beam with CFRP strips using compatible encapsulation resin.

Repair process of the beams shown in Fig.2, included steps which are: cleaning the major crack with air blower, sealing the cracks and attaching the packers with an appropriate mortar (Nitomortar FC™), injecting and filling the major cracks using epoxy (Denepox™), surface grinding with diamond grinder, and surface preparation with Nitomortar™ and primer-coat (Nitowrap™), and finally hand lay-up application of U-shaped CFRP discrete strips (Nitowrap FRC 300™). It should be mentioned that before bonding CFRP strips to the specimens, the corners of the beams were chamfered to prevent stress concentration in the sharp bottom edges of the beams.

Four out of five beams were wrapped with 2 layers (2L) of EB-CFRP in U-jacketing scheme and one beam was repaired with epoxy injection only (0L). It is worth nothing that prior to bonding the CFRP strips, the pre-existing major cracks in the beams were injected with epoxy. The epoxy was injected using the specific pressure pump through the attached vessels (packers) on the surface of the specimens. The EB-CFRP strips bonded to the beams, had a width (wfrp) of 100 mm and a center to center spacing (sfrp) of 150 mm and a net spacing of 50mm as shown in Fig. 3.

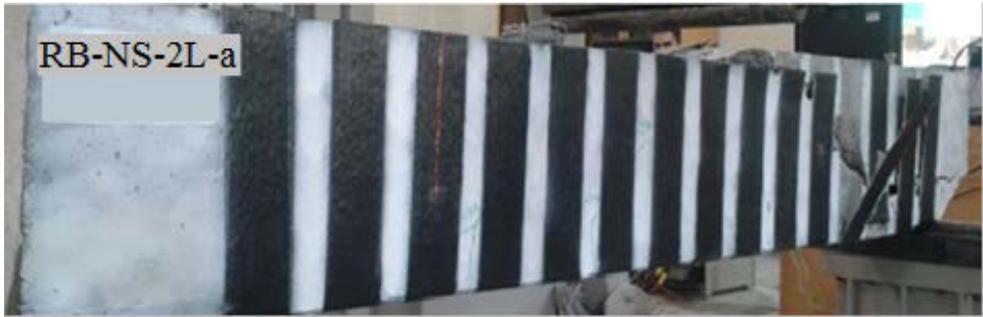
Fig. 4 shows photos of typical tested repaired specimens after failure. As can be seen in Fig.4, all specimens exhibited either full debonding or local debonding of CFRP sheets accompanied by separation of the concrete cover from the beams lateral faces. The beams without minimum stirrups failed in shear by delamination of EB-FRP followed by collapse. However, beams with minimum ratio of steel stirrups experienced a flexural failure followed by local debonding of EB-FRP. The delamination of CFRP strips in beams without stirrups, was quite sudden while in beams with minimum ratio of stirrups it was happening gradually and slower.

**Fig. 4.** Repaired beams after failure (a) without Stirrups, (b) with minimum ratio of stirrups.

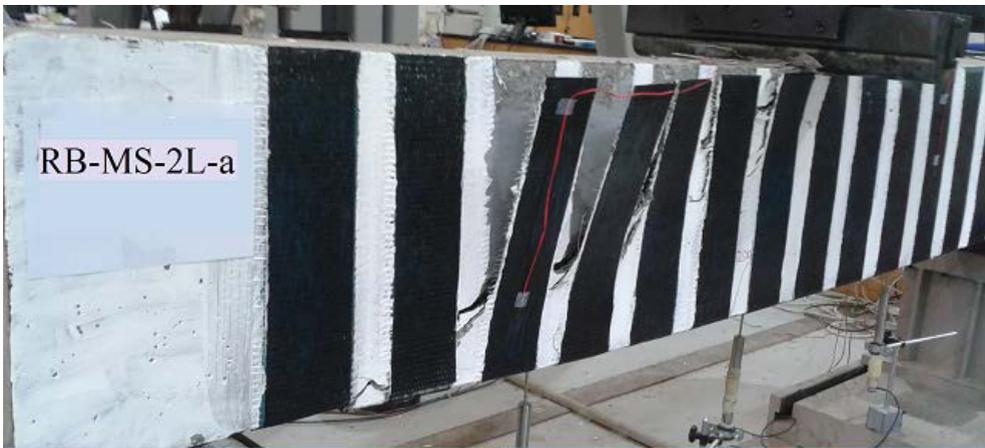
(b)

Specimen RB-MS-2L-a exhibited yielding of its longitudinal reinforcement recorded by embedded strain gauge attached to it, indicating flexural failure. As for the Specimen RB-MS-2L-b, the flexural failure was indicated by exhibiting longitudinal splitting cracks parallel to the compression zone steel reinforcement. It is worth noting that some of the repaired beams exhibited a change in the location of major shear crack after repairing. In other words, the major shear crack was switched from one shear span to the other shear span after repair of the pre-damaged beams. Furthermore, it can be seen in the photos that debonding occurred at the shear span that has experienced a wide diagonal shear crack. Whereas, the other shear span remained intact.
