# Structural changes of selected materials for glass industry after thermal loading

**Abstract.** The presented paper is focused on study and investigation of structural changes in relation to the selected materials which are exposed to the thermal loading. The given work is connected with closer investigation of such material as Dominial ZF 2 which is commonly used for production of steel moulds and components in the glass industry. Moreover, the given work is also devoted to the investigation of materials which are commercially called Toolox 33 and Toolox 44 because these materials were proposed by firm to be used as substitutive materials of Dominial ZF 2. Both of the mentioned and investigated materials have not been used in glass industry yet. Experimental procedures were proposed on the basis of the fact that the investigated materials are exposed to thermal as well as mechanical loading and they are in direct interaction with hot molten glass. After simulated thermal loading, the investigated materials were exposed to the static tensile test and by this way, it was possible to obtain samples with fracture surfaces and these fracture surfaces were evaluated in terms of chara

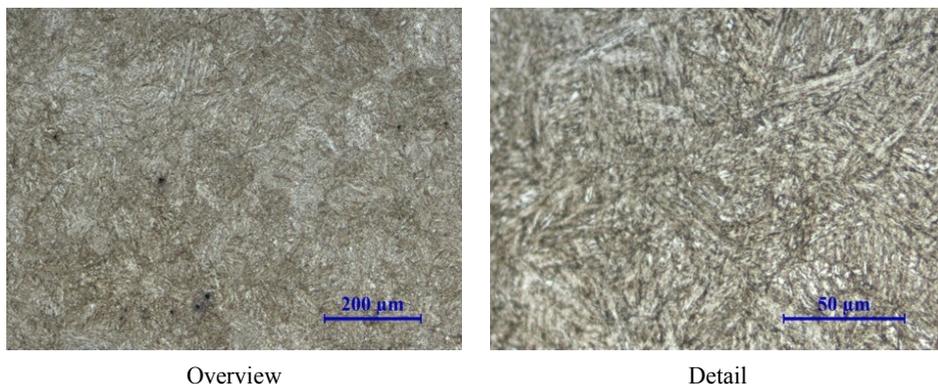
The microscopic examination of the delivered materials showed that both proposed steels had a structure consisting of lower bainite, respectively of sorbite with local occurrence of martensitic needles and residual austenite (Fig. 1, Fig. 4). The microstructure of the Dominial ZF2 steel is austenitic with the occurrence of fine carbides along the grain boundaries (Fig. 7).

**Fig. 1.** Microstructure of the as delivered Toolox 33 material – uncycled

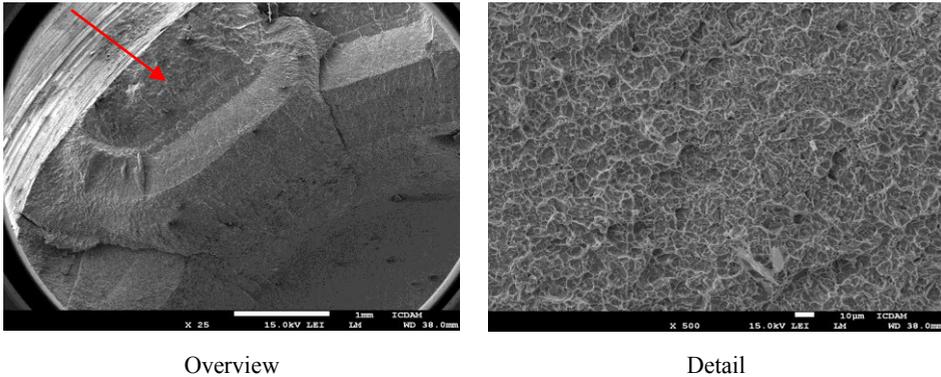
On metallographically prepared sections (Fig. 2) of the area under the fracture surface (after the heat load cycles), structural changes that characterized the fatigue process around the crack were observed. In this area, there occurred strain-stress state, which subsequently resulted in a failure. The fracture surface shows the defined locations in the structure, which are typical for the coexistence of individual phases with different ductile and strength characteristics (Fig. 3). These areas support the local concentration of microdeformation processes leading at different sites to cohesion failure (the red arrow indicates the site of initiation and the occurrence of secondary cracks).

**Fig. 3.** Fracture surface of Toolox 33 after 50 cycles

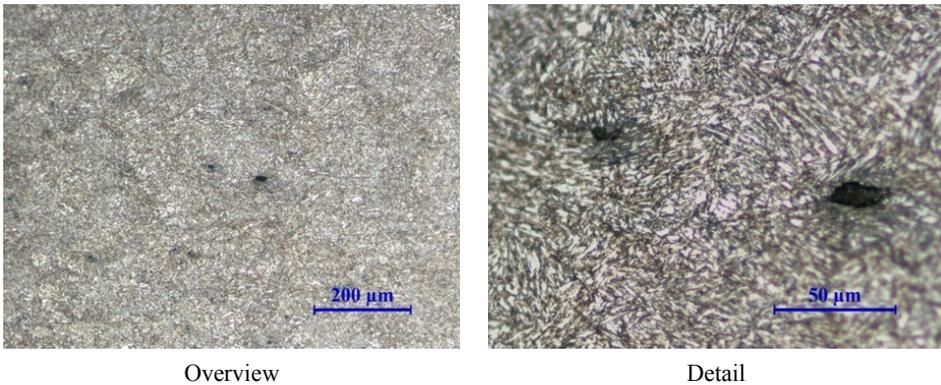
Toolox 44 has a similar microstructure (Fig.4) as Toolox 33 including the occurrence of inclusions formed due to chemical heterogeneity of the material.

**Fig. 4.** Microstructure of the as delivered Toolox 44 material – uncycled

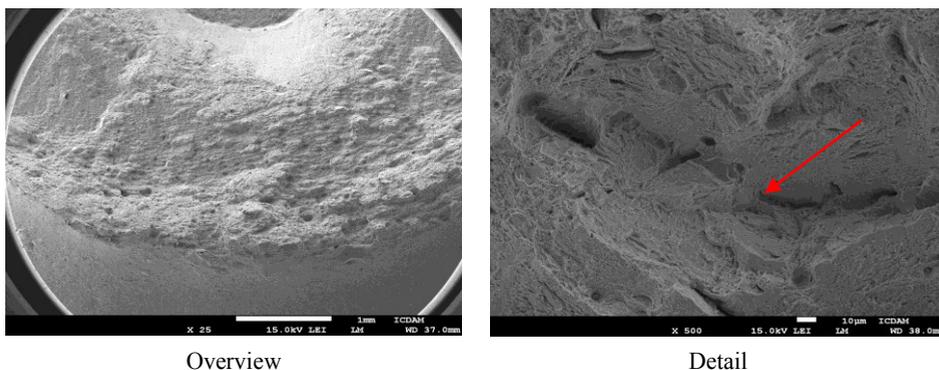
In the given case, it is a failure of the mixed nature, where ductile and fragile locations alternate in the fracture surface depending on the character of phases present in the structure (Fig. 6). The arrow point at the initiation sites of the failures.

**Fig. 6.** Fracture surface - Toolox 44, after 50 cycles

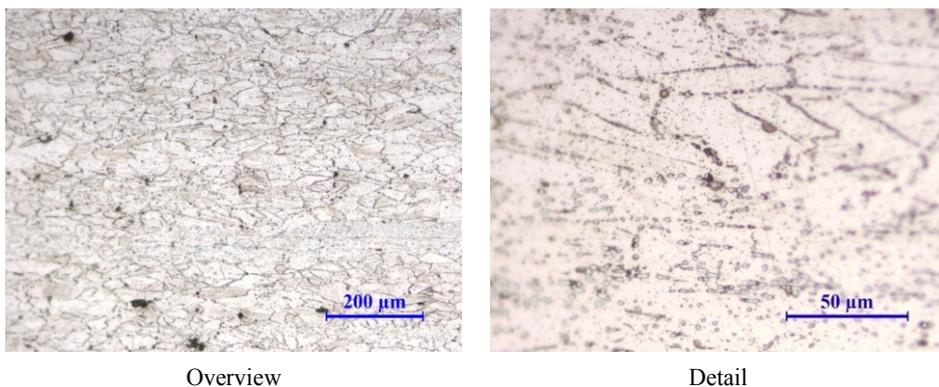
Dominial ZF2 steel is heterogeneous depending on size of austenitic grains (Fig. 7), which react to changes of deformation effects (after 50 heat load cycles) in different ways. There occurs a texture, which cease to exist in proximity of the fracture surface (Fig. 8).

**Fig. 7.** Microstructure of the base material - Dominial ZF – uncycled

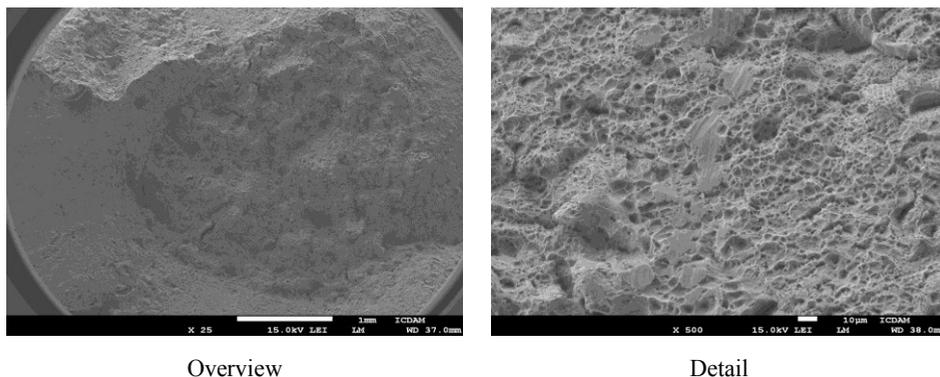
Here, it is possible to mark the failure of the Dominial ZF 2 steel as ductile with the different size of the dimples on the edge of the sample and in its core (Fig. 9).

**Fig. 9.** Fracture surface - Dominial ZF 2 – after 50 cycles
