## Spalling behaviour of nano SiO<sub>2</sub> high strength concrete at elevated temperatures

**Abstract.** The behaviour of high strength concrete exposed to high temperature and incorporating Nano SiO<sub>2</sub> and Micro SiO<sub>2</sub> is presented. An experimental programme was developed and carried out which involved testing of Nano SiO<sub>2</sub> and Micro SiO<sub>2</sub> incorporated high strength concrete specimens exposed to temperatures ranging from room temperature to 800 °C. Maximum spalling was noted in Micro + Nano silica specimens. However, the maximum strength loss and temperature induced cracking was noticed in Nano silica specimens.

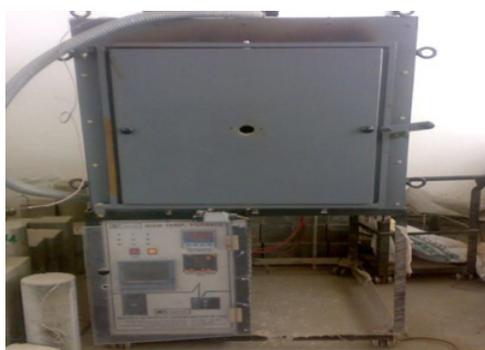
**Figure 1.** (a) Programmable muffle furnace. (b) Specimens after exposure.

The specimens were exposed to 4 different temperature regimes viz: room temperature (27 °C), 200 °C, 500 °C, and 800 °C in a programmable muffle furnace (Fig. 1). The exposure scheme of the specimens is shown in the Table 3. The average moisture content (% by mass) at the time of exposure was 2.4% in MS specimens, 2.7% in NS specimens and 3.6% in MN samples. The temperature was increased at a rate of 5 °C/min and the target temperature was maintained for 2 hours after which the specimens were allowed to cool to room temperature.

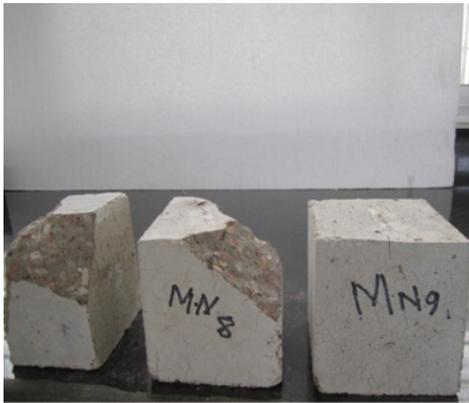
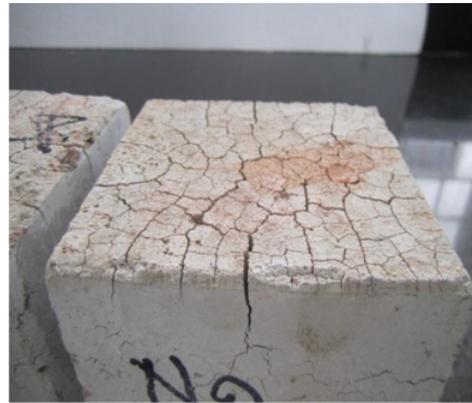
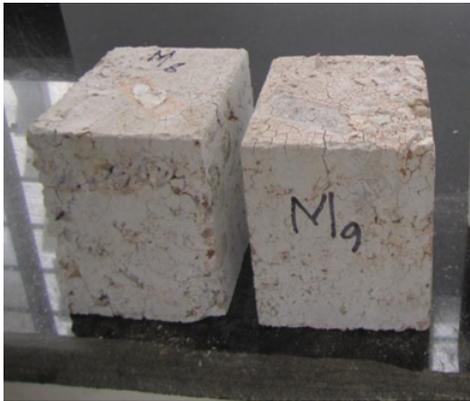
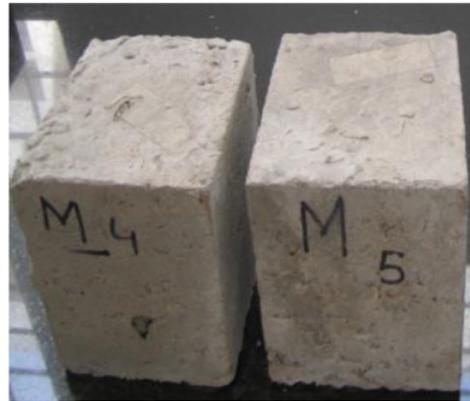
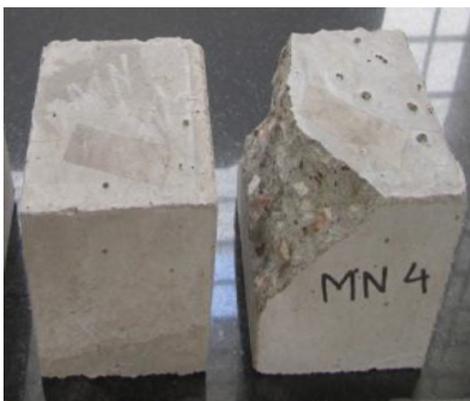
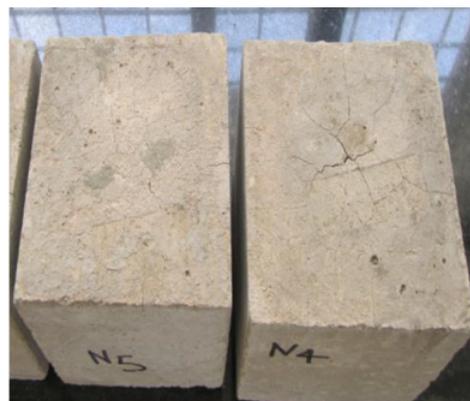
**Figure 2.** Specimens after exposure to different temperatures.

(a) MN specimens after 800 °C

(b) NS specimens after 800 °C

(b) MS specimens after 800 °C

(d) MS specimens after 500 °C

(e) MN Specimens after 500 °C

(f) NS specimens after 500 °C

The damage to the concrete after exposure to elevated temperatures was assessed on the basis of visual inspection. It usually includes visual observations of color change, cracking and the spalling of the concrete surface [9]. Figures 2(a–f) illustrate the appearance of concrete specimens after exposure to varied temperature regimes. There was no visible effect on the surface of any of the specimens, which were exposed to a temperature of 200 °C. However the specimens which were exposed to a temperature of 500 °C showed varying amounts of cracking and spalling. The Micro SiO<sub>2</sub> specimens showed some fine surface cracks, while the Nano SiO<sub>2</sub> specimens showed significant cracks. In MN specimens the cracking was quite evident and one of the specimens even spalled. The MS specimens which were exposed to 800 °C had cracks on the surface and the concrete had started to deteriorate. On the contrary in NS specimens the cracking was very extensive at 800 °C temperature and the cracks went deep into the cross section of the specimens [Fig 2(b)]. The concrete was observed to be loosely bound and the concrete chips would come out on just minor disturbance with hands. In case of MN samples the spalling took place in two of the specimens at 800 °C temperature, but the cracking was not too extensive. The results were in contradiction with what we had anticipated. It was thought that the NS samples would spall more but in the present study the MN samples spalled more. The reason could be extra dense micro structure due to the combined effect of Micro and Nano SiO<sub>2</sub> in MN samples. The particles of Nano SiO<sub>2</sub> would have filled the voids which remain after the Micro SiO<sub>2</sub> particles react with the calcium hydroxide and thus rendering the microstructure of MN specimens dense. Also the MN specimens showed greater water retention properties and this led to build up of higher pore pressure and ultimately more chances of spalling. Nevertheless the NS samples cracked extensively indicating the poor thermal behaviour of NS HSC.

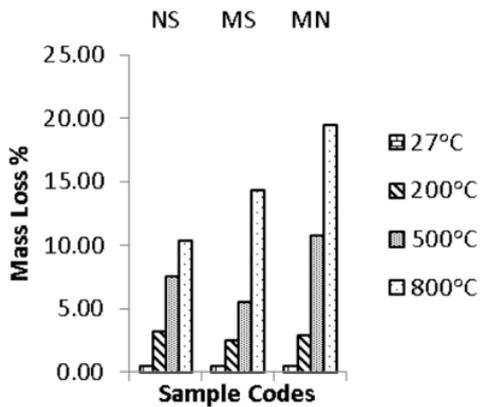
Figure 3. Mass loss at different temperatures.

The effect of elevated temperature on the weight loss of different specimens is shown in the Figure 3. In each concrete mix the losses increased with increase in temperature. These losses were about 3.17%, 7.53% and 10.4% respectively at 200 °C, 500 °C and 800 °C in NS samples. In case of MS specimens the mass loss was 2.47%, 5.47% and 14.28% respectively and in case of MN samples the loss in mass was reported as 2.88%, 10.79% and 19.45% respectively at 200 °C, 500 °C and 800 °C. The mass loss in case of MN samples was highest at all the temperatures. The mass loss was due to spalling in MN samples due to higher initial moisture content.

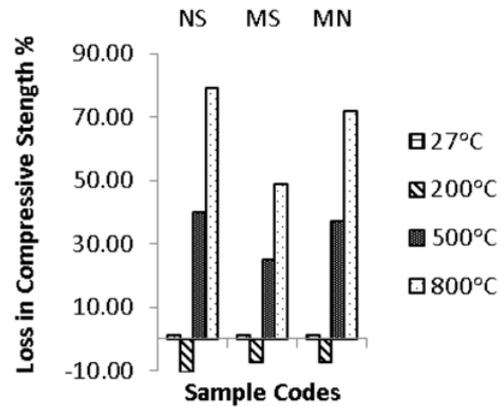
Figure 4. Variation in compressive strength loss.

Figure 4 shows the variation in loss of compressive strength of the specimens at different elevated temperatures. After exposure at 200 °C, all the specimens of different mixes showed an increase in the compressive strength, the highest (10.44%) being in NS specimens. The increase of strength in MN and MS specimens was almost same. It is to be noted that exposing the specimens to a temperature to a tune of 200 °C can increase the hydration process by producing more high-density calcium silicate hydrate and by increasing the reactivity of nanosilica, which enhances the strength [10]. Nanosilica converts more of the calcium hydroxide to calcium silicate hydrate and this process gets accelerated for the concrete exposed upto such temperature. However on further increasing the exposure temperature the specimens showed loss in compressive strength which increased on increasing the temperature to 800 °C. A loss of 79.12% was found in NS specimens, 48.63% in MS and 71.9% in MN specimens. Such behaviour can be attributed to excessive build up of vapour pressure which led to extensive cracking in NS samples. One of the peculiar behaviour of NS specimens was that during compression testing the cubes crushed into burnt powdery substance which showed very less cohesion and more like burnt clay.

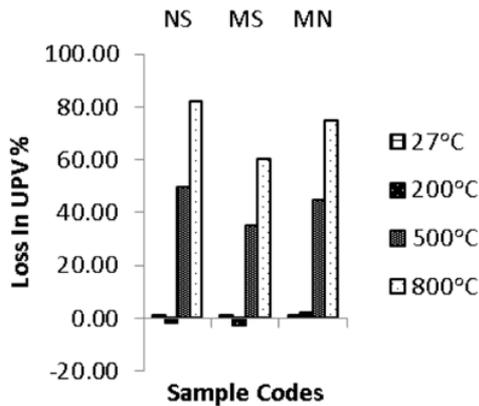
Figure 5. Loss in UPV of different specimens.

The loss in UPV as shown in Figure 5 also depicts the degradation of concrete as the exposure temperature was increased. The UPV increased upto 200 °C thereafter showing a decreasing trend with increase in temperature. Again the degradation was more in NS specimens. A loss of about 82% in UPV was measured in concrete with Nano SiO<sub>2</sub> while the MS specimens showed a loss of only 60% in UPV. In case of MN specimens the UPV loss was found to be 74.72%. Such behaviour may be again attributed to extensive cracking in NS specimens due to build up of high vapour pressure.
