## Spalling of concrete subjected to blast loading

**Abstract.** This paper presents outcomes of the blast field tests of FRC and reinforced concrete specimens, which were performed in cooperation with the Czech Army corps and Police of the Czech Republic in the military training area Boletice. The numerical evaluation of the experiments focused on the spalling of concrete subjected to blast loading started after the first set of the tests, took almost 3 years and required further small-scale experiments performed in the labs of the Czech Technical University.

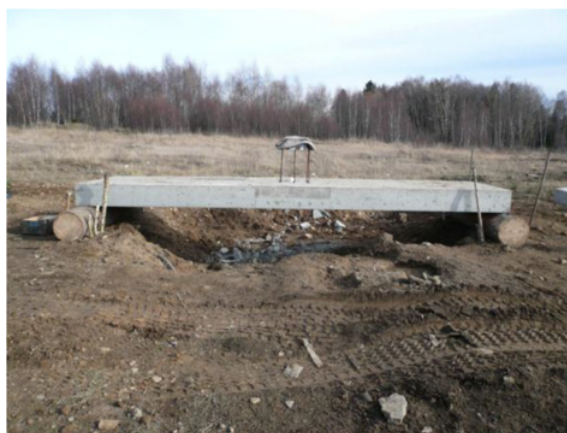
**Figure 1.** Layout of the experiment.

The slabs were placed on timber posts which were fixed in position by steel tubes. The ground under the slabs was removed; 5 m in diameter and 1 m deep excavation was prepared under the slabs so the results of the experiments would not be influenced by rebound of the pressure wave.

The 25 kg TNT charges were placed on steel “chairs” (3Ø10 mm links, 3 mm thick steel plate) in the middle of the slabs. The “chairs” provided off stand of 450 mm from the slab. This value was chosen as the most usual height of car trunk.

The charges were fired remotely by radio impulse. Layout of the experiments can be seen in Fig. 1.

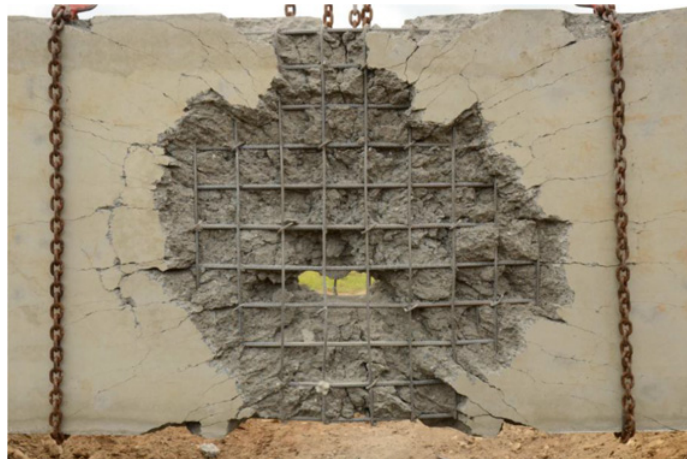
**Figure 2.** Damaged specimen No. 3 (RC) after blast – bottom view.

The specimen No. 3, C55/67, no fibers was less damaged. The area of the puncture is 0.02m<sup>2</sup>, volume 0.01m<sup>3</sup>, which represents 0.4% of the total volume of the specimen. Total volume of the damaged

concrete (puncture + spalling) is  $0.2\text{m}^3$ , which represents 7.4% of the total volume of the specimen. The area of puncture was reduced by 95% in comparison to specimen No. 1, the crushed concrete remained within the reinforcement matrix, total volume of damaged concrete was reduced by 15% in comparison to specimen No. 1. The damage to the sides was reduced by 85%. The deflection was 285 mm on the left side and 290 mm on the right side of the specimen. The shape of deflection was similar to deflection from uniformly distributed loading. The deflection was increased by 10% in comparison to specimen No. 1.

The effect of blast loading on top and bottom surfaces of the specimens can be found in Figs. 2 to 3.

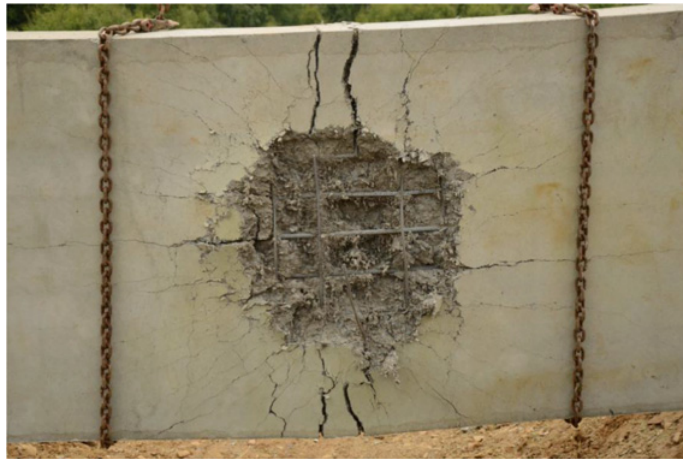
**Figure 3.** Damaged specimen No. 5 (FRC) after blast – bottom view.

The specimen No. 5, C30/37, 9 kg/m<sup>3</sup> PP fibers was less damaged. Total volume of the damaged concrete (puncture + spalling) is 0.06m<sup>3</sup>, which represents 2.2% of the total volume of the specimen. There was no puncture, the total volume of damaged concrete was reduced by 75% in comparison to specimen No. 1. The sides of specimen No. 5 were not damaged. The deflection was 255 mm on the left side and 265 mm on the right side of the specimen. The shape of deflection was similar to deflection from point loading in the mid-span of the specimen. The deflection was decreased by 16% in comparison to specimen No. 1.

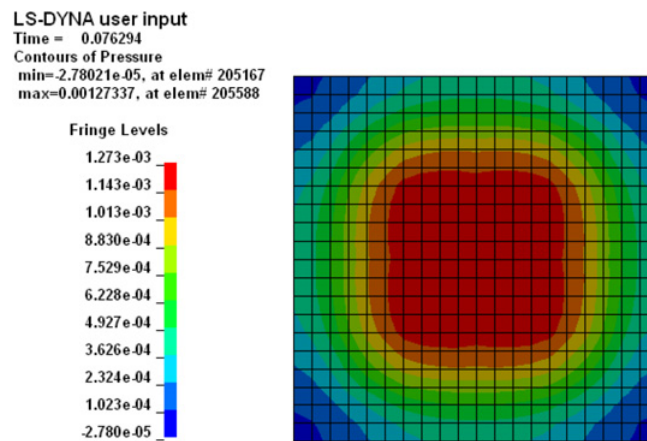
**Figure 4.** Compressive stress at the top surface of the specimen.

The compressive stress at the top surface of the specimen can cause local crushing of concrete (Fig. 4) or a shear failure of the specimen (puncture by shear-punching behavior). The pressure wave propagates further by the speed of sound in the material.

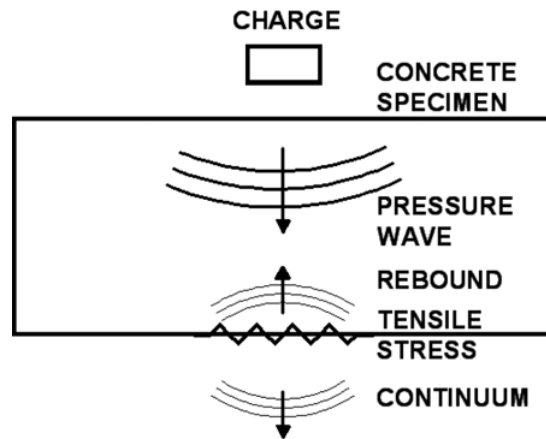
**Figure 5.** Propagation of the blast overpressure wave in a concrete specimen.

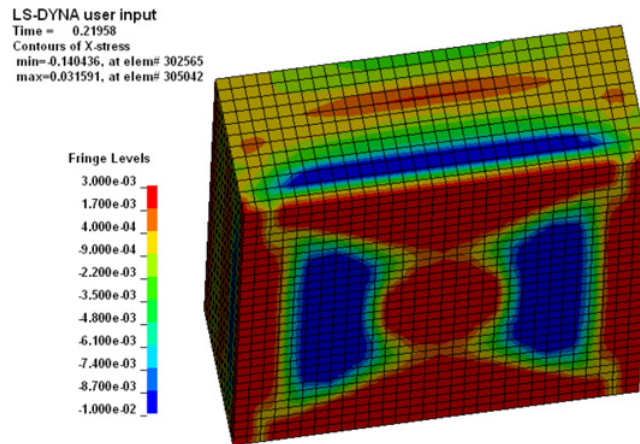
**Figure 7.** Axial stresses at the soffit of the specimen by the time the blast overpressure wave reached its soffit – No eroded elements in numerical model.

The effect of added fibers was modeled according to the approach described in [1], the principle was adapted from [3]. Figure 7 shows the resulting tensile stresses at the soffit of the FRC specimen.
