# Investigation into Common Decay of Educational Buildings in Malaysia

**Abstract.** All types of buildings will undergo decay and deterioration over a period of time. In the past few years, there have been numerous official reports in the mass media relating to building decay and failures throughout the country. Building decay and failures are becoming ordinary phenomena in the construction industry. This study is firstly intended to identify and differentiate the common building decay and failures faced by Malaysian educational buildings. Seven educational buildings in Kedah were selected as case studies. Inspections were conducted and the decay of the respective buildings was recorded. The persons in charge of the educational buildings were also interviewed and the results were used for this study as well.

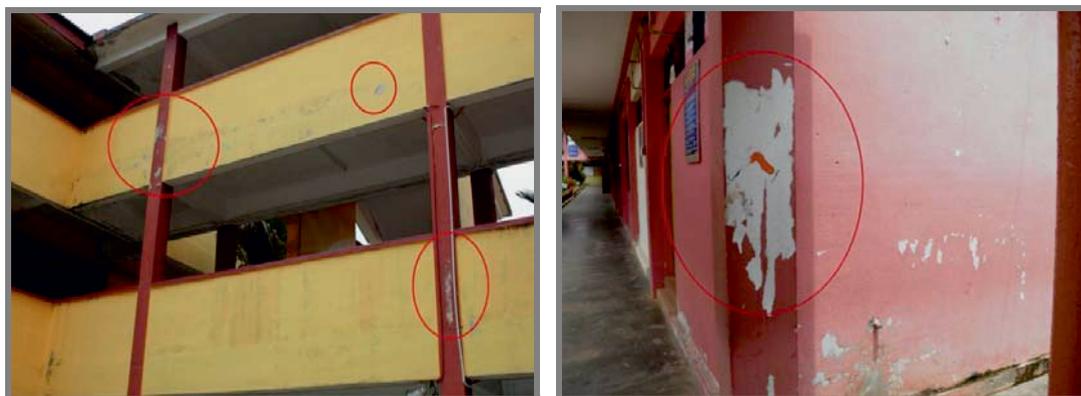
Peeling paint was the most common form of critical decay which was found on the façade of the buildings, especially on the plastered walls, ceilings, beams and columns. These components were consistently exposed to sunlight, rain, wind and dampness, resulting in peeling paint. The excessive exposure spoiled the paint surfaces and thus the surfaces had become chalky, flaked and blistered. Figure 1 shows the effect of peeling paint on the external walls and columns. The paint on the ceiling was also gradually being peeled off due to the presence of moisture. The peeled-off paint on the ceiling could be easily found on the top floors of the buildings because the rainwater had entered through the roof, as some of the roof tiles were missing or had been blown away by strong winds.

Figure 1. Peeling paint on external walls and columns

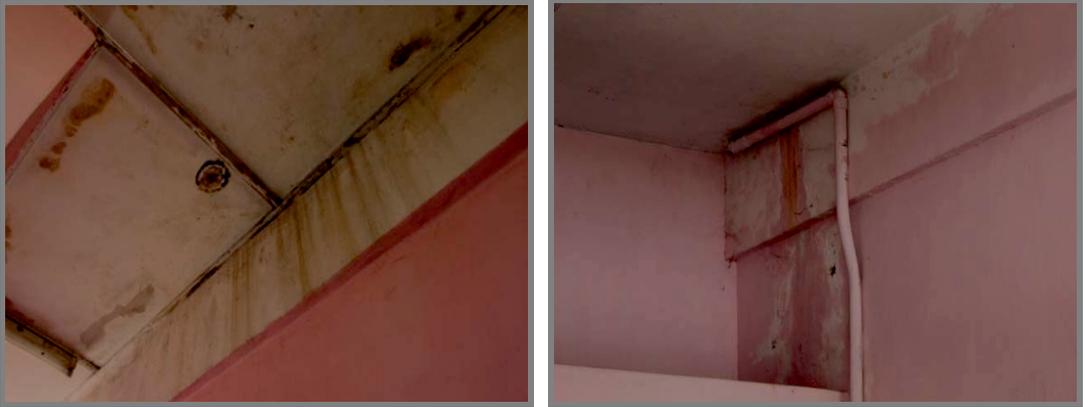
The classrooms, especially those on the top floor, were greatly affected by dampness to the ceiling where the roof tiles were missing or had been blown away by the wind. The rainwater had penetrated directly into the building itself, resulting in dampness as shown in Figure 2.

**Figure 2.** Penetrating damp on the ceiling (left) and damp caused by leaking pipe (right)

Besides, dampness can arise from unattended water caused by leaking pipes, gutters and flushes. The leaking water penetrated into the wall, resulting in horrible water stains. Over a prolonged period of dampness penetration and poor ventilation within the building, excessive moisture promoted the growth of mould on the surfaces of the walls.

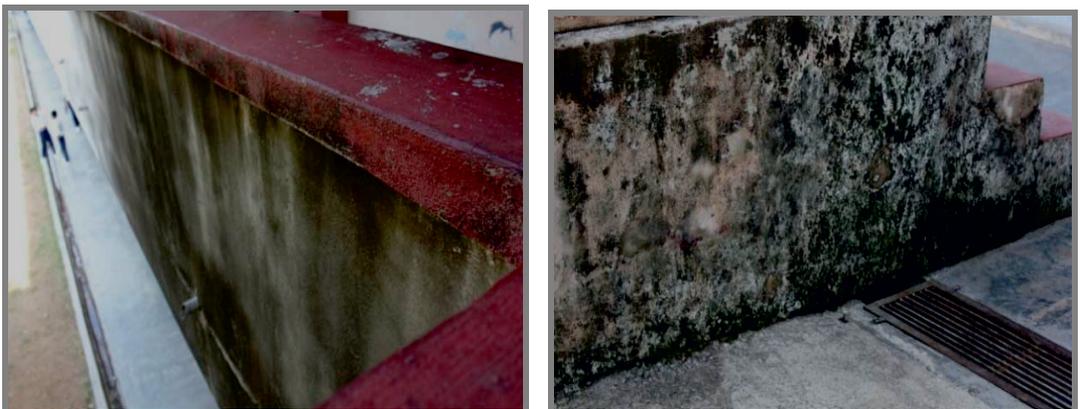
Discoloration of the paintwork was commonly found in the inspected educational buildings. The paintworks of the surfaces were either a brownish, blackish or yellowish colour. This decay is often related to the presence of dampness or biological attack. Moulds grow aggressively on the surface of paintworks when there is excessive moisture, resulting in discoloration.

A simple repainting will not solve the problem for long. Furthermore, serious discoloration will lead to structural damage and damage to the facade. Figure 3 shows a blackish discoloration of the paintwork.

**Figure 3.** Blackish discoloration of paintwork

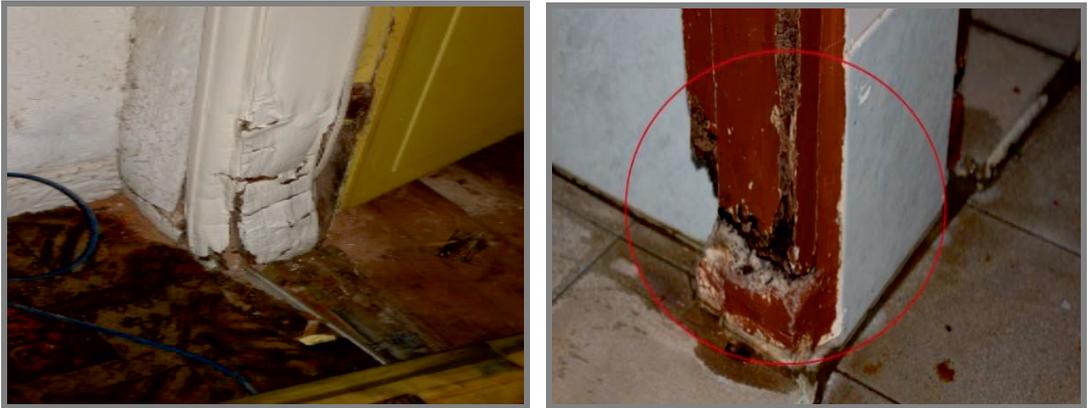
The problem of timber decay is mainly found on door frames, window frames, timber roof struts and ceiling battens. These components are exposed to moisture, which is the main critical element in the timber decay process, while some timber materials decay because of aging, e.g. ceiling battens. Figure 4 shows the timber door frames in the toilets which suffered the most deterioration because they were highly exposed to water. This type of timber decay is also known as wet rot. Wet rot is the most common type of timber decay in which the fungus feeds on the timber; the timber must be damp or wet enough for the fungus to thrive and continue the rotting process. Timber decay occurs if the timber becomes sufficiently wet, and oxygen and nutrients are present.

Figure 4. Timber decay on door frames at toilet area.

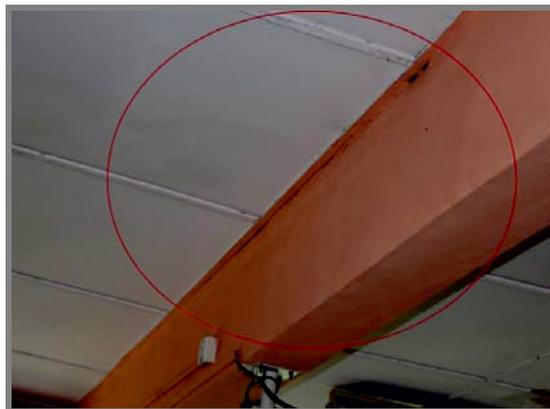
Cracks occurred on the various elements in the educational buildings such as the walls, ceilings, beams, columns and even floors. Many structural and non-structural cracks were found. Structural cracks take place in walls, beams and columns. However, non-structural cracks usually happen in plaster or other finishes with cement rendering. Cracking can be classified into a few types: vertical, horizontal, diagonal and hairline. Figure 5 shows a horizontal crack in the beam. Some parts of the inspected buildings showed serious cracks while some only showed minor cracks.

Figure 5. Horizontal crack on beam

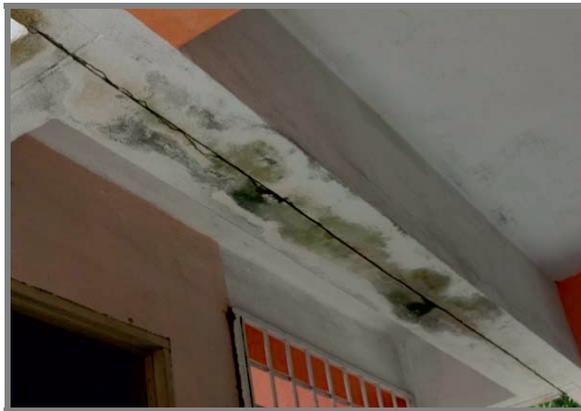
Some visible gaps were found between the elements, such as the walls, columns, beams, ceilings, door frames, etc. Figure 6 illustrates a gap that had formed at the interface between the old beam and the new beam. In fact, a new building had been connected to the original building. However, this new addition was detached from the old building, resulting in a large and visible gap. A gap was also found between the wall and the door frames. The shrinkage and expansion of the door frames (timber materials) due to atmospheric conditions may have caused the gaps. Besides door frames, other timber materials such as ceiling battens were also found to have gaps from the wall. In such circumstances, dampness may penetrate into the building and result in water stains. Moreover, the detachment of columns from the wall was basically caused by poor construction and workmanship.

**Figure 6:** A visible gap between the beams.

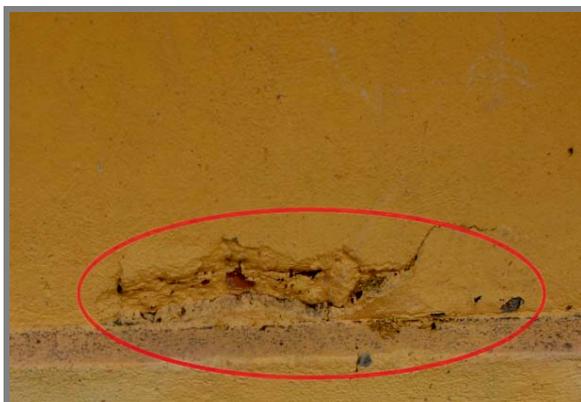
Plaster rendering was the widest used finish in the educational buildings. Most of the sections in the inspected educational buildings were finished by plaster rendering. However, the plaster renderings underwent deterioration after a period of time. Some of the plaster renderings were decayed, uneven, broken and also cracked. Figure 7 shows the broken plaster renderings. Although plaster renderings tend to deteriorate as the building gets older, many damaged plaster renderings still appeared just after the construction, mainly due to poor workmanship or low quality material.

**Figure 7.** Broken plastered renderings

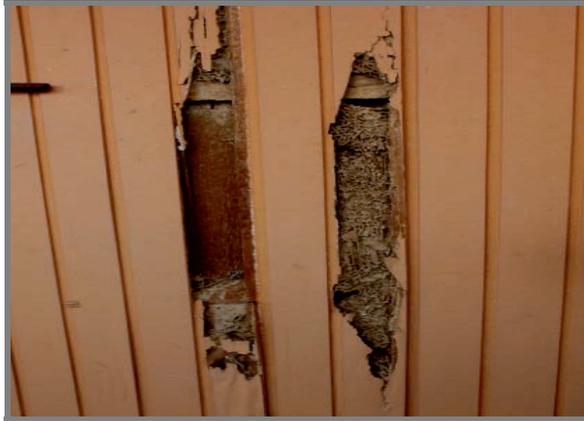
Timber deteriorates when it is exposed to water penetration and excess moisture. Termites attack damp and digestible timber. Large amounts of timber materials had been attacked by termites, causing the timber structures to become soft. These materials included timber doors, door frames, roof struts and window frames. Some of the furniture suffered from this decay as well. Figure 8 shows the effect of termite attack on the timber door.

**Figure 8.** Termite attack on door

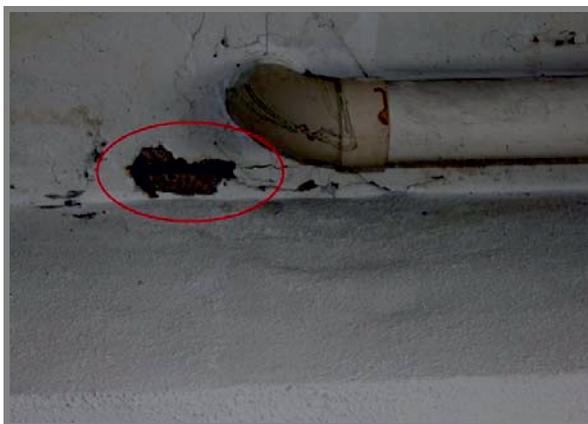
**Figure 9.** Spalling of concrete

In addition, spalling of concrete was found with its exposed reinforcement as shown in Figure 9. When the steel reinforcement eroded, the formation of rust caused a loss of bond between the steel and concrete, and this resulted in spalling. The integrity and performance of the structure can be influenced if this problem is not addressed instantly.

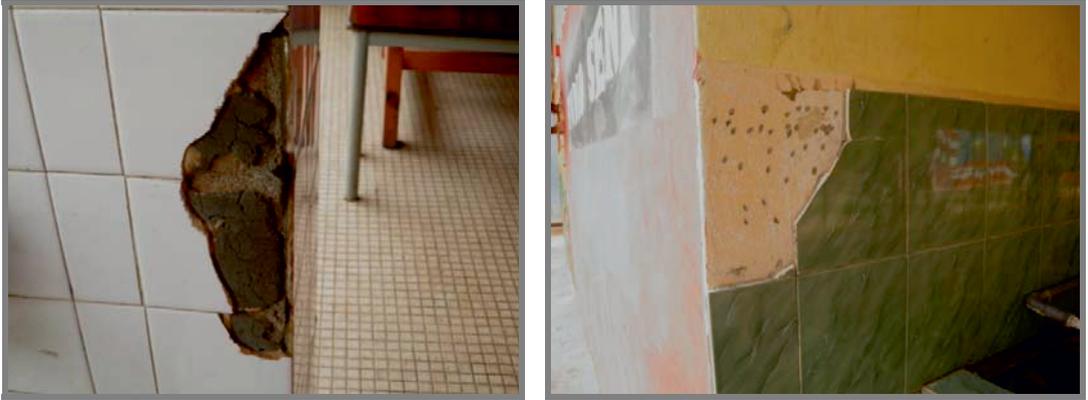
Tiles were used as finishes to the walls and floors. The types of tiles used in the inspected educational buildings were ceramic tiles and homogenous tiles. There were only certain areas where the tiles were used as finishes because most of the areas were finished by plaster renderings which were cheaper. Those areas were the offices, cafeteria, computer labs, staff's toilets and multimedia hall. The major problems found in the inspected buildings were slippage, unaligned, cracked, broken and loose tiles. Tiles will crack and break when heavy objects are dropped on them. Figure 10 shows a mixture of tiles decay found in the buildings.

**Figure 10.** Defective tiles on walls

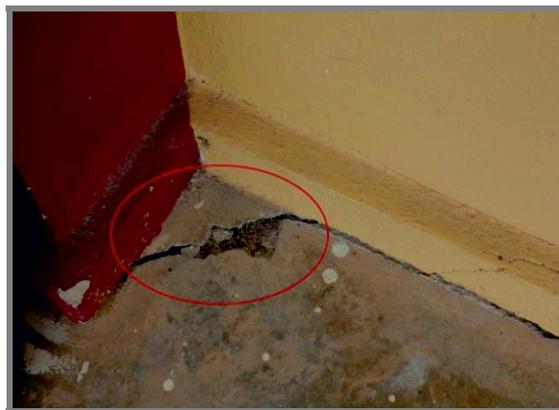
Cracks on the lower parts of the structure indicated a crisis of settlement. The gap in the cracks was large, about 10mm, as shown in Figure 11. This may be associated with the movement of the ground beneath the foundations due to the weight of the building itself. Settlement occurs where a structure is founded on varying ground conditions or foundation failures. Other possible causes of this problem are soil erosion by flowing water, changes in ground water level, uneven bearing capacities of soils and poor soil conditions.

**Figure 11.** Cracks on the lower part of the building
