Evaluation of Fire Hazard and Safety Management of Heritage Buildings in Georgetown, Penang

Abstract. Fire is a subject that is always neglected and ignored as far as heritage buildings are concerned. Unlike newly-built buildings, which are required under UBBL to undergo certain fire protection system tests, people are less likely to carry out such tests and detailed assessments for heritage buildings. Thus, this research is significant as it is aimed at accomplishing several objectives including studying the current fire emergency plan, besides identifying and assessing the possible fire hazards in heritage buildings in Penang. Several case studies were carried out at a few premises such as the Khoo Kongsi, Cheah Kongsi, Hock Teik Chen Shin Temple and the Teochew Temple with the aid of the Fire Rescue Department Malaysia (FRDM). The results obtained from this study will be discussed according to several aspects focusing on general health and safety management at the site, the fire-fighting system, fire exit routes and signage at the temples, fire hazards, and fire detection and alarm.

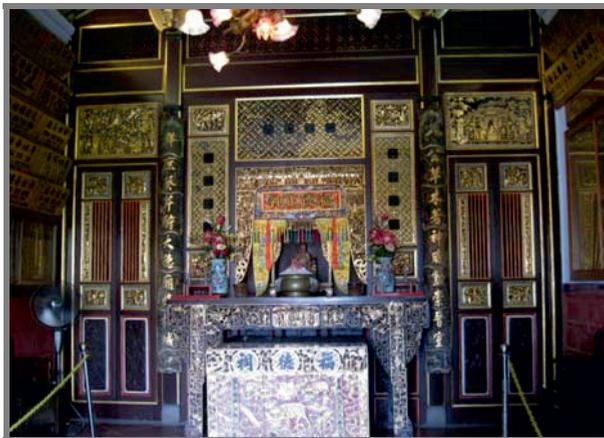
The fire hazards in the Khoo Kongsi come mainly from joss sticks. Joss sticks are used for ancestral worship. Almost 70% of the worship hall is made up of timber (Figure 1). Timber is a highly flammable building material. It can be one of the main fire hazards in the temple. There is no procedure currently to prevent the accumulation of combustible materials in the Khoo Kongsi.

Figure 1. Typical worship hall, more than 70% of which is made up of timber

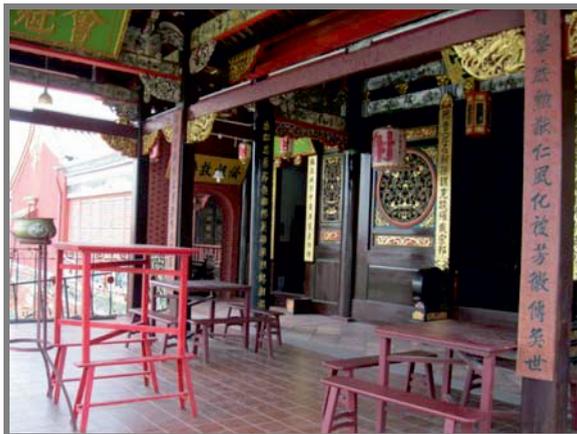
The fire hazards in the Cheah Kongsi also come from joss sticks which are used for ancestral worship. It is obvious that the building is mainly constructed from timber, which is highly flammable (Figure 2). This could be another important fire hazard element that one should be aware of. The building is not a non-smoking building, so there might be some smoking hazards from cigarettes too. The main electrical installations are inspected and are in good condition. There is no procedure currently to prevent the accumulation of combustible materials in the Cheah Kongsi.

Figure 2. Timber-made ancestral hall of the Cheah Kongsi

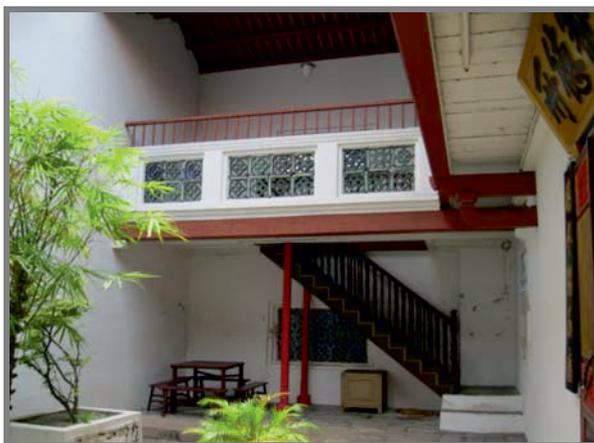
Figure 3. Staircase free from obstruction

All the registered fire extinguishers in the Cheah Kongsu are well-maintained. All the fire exit routes and the points of exit from the building are clear of obstruction, as shown in Figure 3. All the floor surfaces and stairs along the escape routes in the Cheah Kongsu are free from tripping and slipping hazards as well. No lighting is provided along the escape routes in cases of emergency. Furthermore, there is no escape route plan showing different directions to guide visitors to places of safety in the Cheah Kongsu.

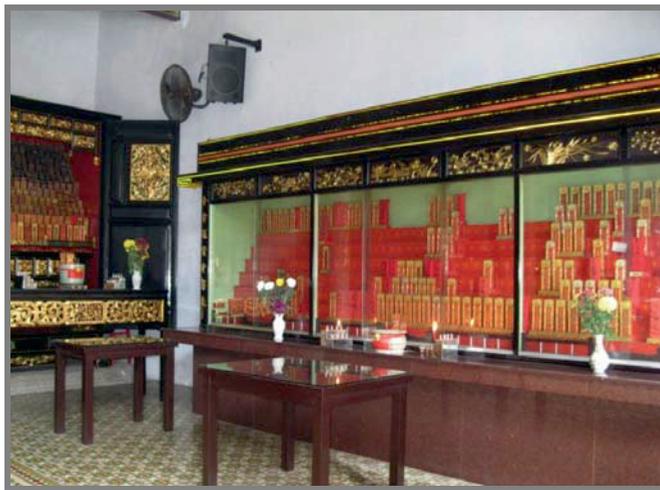
The fire hazards in the Penang Teochew Association come mainly from joss sticks. Joss sticks are used for ancestral worship. The building is made up of less timber compared to other ancestral temples. However, the worship hall is still made up of a large amount of timber, as shown in Figures 4 and Figure 5. This highly flammable building material can be one of the main fire hazards of the temple. The building is not a non-smoking building, so there might be some smoking hazards from cigarettes too.

Figure 4. The worship hall of the Teochew Association, Penang

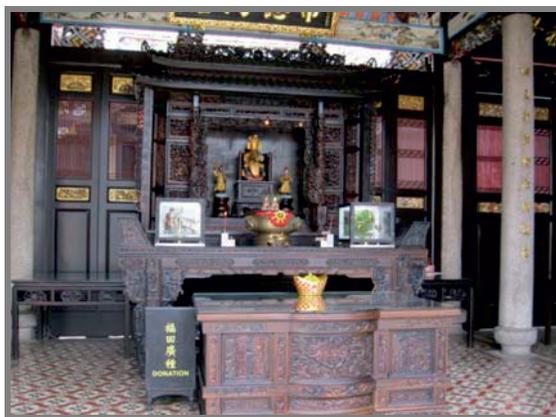
Figure 5. The worship hall of the Teochew Association, Penang

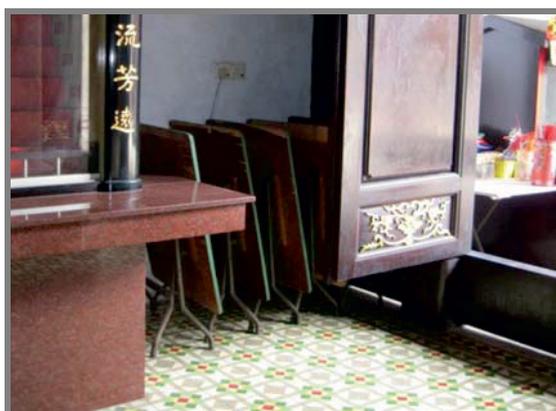
The flammable materials and substances are kept properly in a store behind the worship hall, as shown in Figure 6. It is well-organised. There are no flammable gases, explosive materials or flammable liquids / solvents in the Penang Teochew Association. There are some portable appliances and switches, which are well-guarded and securely fixed in position at a safe distance. These have been fixed away from all combustible materials. As there is a family of 6 living in the Penang Teochew Association, there will be some hot surfaces or portable heat hazards, which mainly originate from the kitchen.

Figure 6. The flammable materials and substances are kept properly in a store behind the worship hall

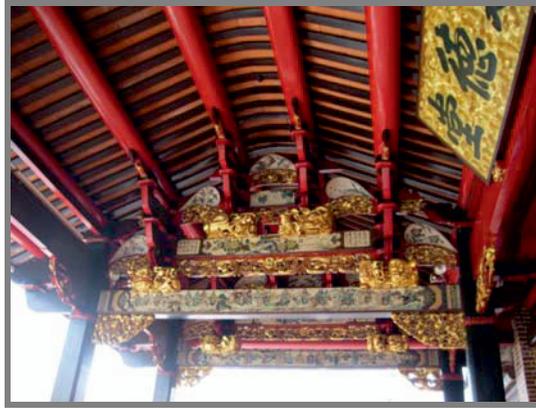
The fire hazards in the Hock Teik Cheng Sin Temple come mainly from joss sticks. Joss sticks are used for ancestral worship. The building is beautifully decorated with flammable timber-made crafts, as shown in Figure 7. The building is not a non-smoking building, so there might be some smoking hazards from cigarettes too. The main electrical installations are properly inspected and checked. However, there is no testing procedure in place for the portable electrical appliances. It would be good to carry out the electrical testing in order to help prevent electrical fires. There is no procedure currently to prevent the accumulation of combustible materials in the Hock Teik Cheng Sin Temple.

Figure 7. Timber-made crafts in the Hock Teik Cheng Sin Temple

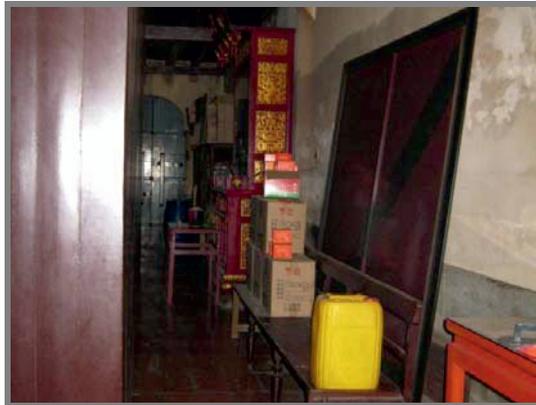
The flammable materials and substances are not well-kept, as shown in Figure 8. It is less organized as compared to other clan houses. The materials for worship are placed along the corridor. However, there are no flammable gases, explosive materials or flammable solvents in the Hock Teik Cheng Sin Temple. There are some well-guarded portable appliances and switches, which are securely fixed away from all combustible materials. There are no hot surfaces or portable heat-hazards in the Hock Teik Cheng Sin Temple. The clan house is not occupied by anyone, thus there are no fire hazards from the kitchen.

Figure 8. The flammable materials and substances are not well-kept
