Fire Risk Assessment of Adaptive Re-Use of Historic Shop Houses for Sleeping Accommodations in Malaysia

Abstract. Heritage buildings were generally constructed without regard for fire risks or the requirements for fire protection, as are obligatory in new constructions. When a heritage building undergoes a change to its original function, improvements to the building's fire safety are necessary to meet the needs of possible increases in occupancy loads and to account for fire risks related to the new usage. This research focuses on fire safety risks, fire protection and safety systems as well as the rules and regulations that an adaptive reuse heritage shop house is bound to when transitioning to a sleeping accommodation, which, in this case, means becoming a hotel. In this research, six heritage shop houses were chosen as case studies. The objectives of this research were to evaluate current fire emergency plans as well as to identify and assess possible fire hazards created by adaptive reuse of heritage shop houses to sleeping accommodations in Penang through a series of observations and interviews. The results of the research show that most of the buildings were provided with i

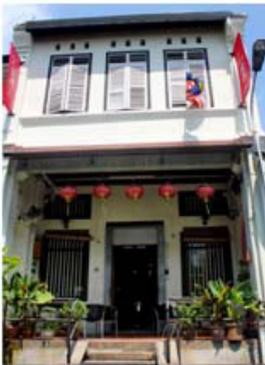
Fig. 2: Red Inn Heritage

(1) Red Inn Heritage (Fig. 2)

Red Inn Heritage is a two storey shop house located at 15 Love Lane. The architectural style of the building is Early Straits Eclectic. It was built around 1880s-1920s and started operating as a hotel in 2011. The building has a total area of ± 644m² and provides 34 guest rooms.

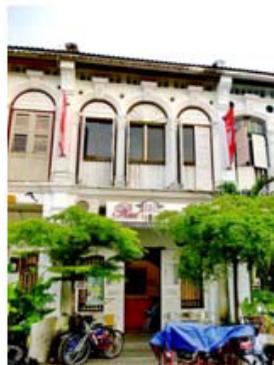
Fig. 3: Red Inn Penang

(2) Red Inn Penang (Fig. 3)

This two storey building is of a Late Straits Eclectic style and was built around 1910s-1930s. It is located at 55 Love Lane and started as a hotel in 2010, offering 13 guest rooms with a shared bathroom. Red Inn Penang is adjacent to Lebuhr Klang at the rear side and to other guesthouses on either side. The total area of this building is ± 156m².

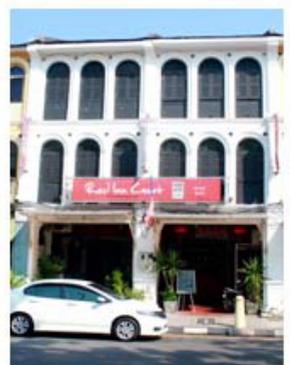
Fig. 4: Red Inn Court

(3) Red Inn Court (Fig. 4)

Red Inn Court is a three storey building which is located on Masjid Kapitan Keling Street and is adjacent to a motor's shop on the right side. The owner inherited this building from relatives who formerly used it as a residence. There are 11 guest rooms in the Red Inn Court with a total building area of $\pm 108\text{m}^2$.

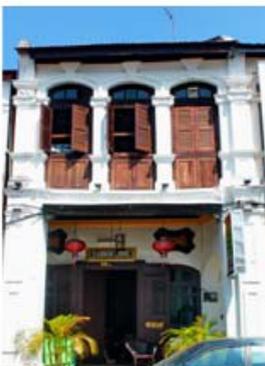
Fig. 5: Rainbow Lodge 2

(4) Rainbow Lodge 2 (Fig. 5)

Rainbow Lodge 2 is located at 98 Pintal Tali Street and is a two storey building that was built around 1910s-1930s with a Late Straits Eclectic architectural style. The building's owner still maintains the original façade and almost the entire structure of the building, which is a total area of around 120m^2 . This building has 9 guest rooms which are separated by wooden partitions.

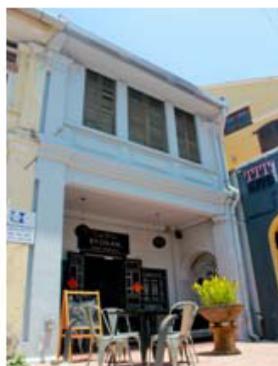
Fig. 6: Ryokan Chic Hostel

(5) Ryokan Chic Hostel (Fig. 6)

Ryokan Chic Hostel, located at 62 Muntri Street, is a three storey building with 16 guest rooms. This building has a total area of about 270m^2 and was renovated in March-April 2011 before being used as a hostel.

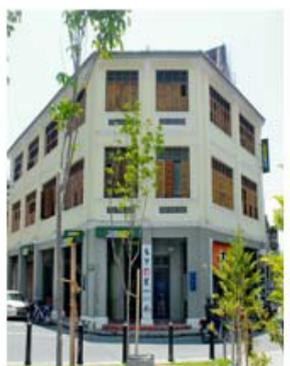
Fig. 7: Syok Hostel

(6) Syok Hostel (Fig. 7)

Syok Hostel is a three storey building located at the corner of the meeting point of Chulia Street and Leith Street. With a Southern Chinese Eclectic style, this building started operating in February 2013 after being renovated. Standing on a piece of land of about 301m^2 , this building provides 8 guest rooms with a shared bathroom. This building also rents out half of the ground floor to a Subway Restaurant.
