# Vibration Monitoring of a Large Scale Heavy Haul Railway Viaduct

**Abstract.** In South Africa, heavy haul railway transport was introduced in the mid-1970s for the Iron Ore and the Coal Export lines. In recent decades, the expansion of existing mines, new markets and the competition of iron ore- and coal-exporting countries have led owners and operators to progressively increase the capacity of the export lines. On the one hand, operational efficiencies have been improved; on the other hand, a significant increase of the rail traffic has been experienced. Thus, bridges along the export lines are now crossed by heavier and longer trains with more frequent train passages than in the past. Increasing train loading might lead to significant consequences on structures such as dynamic amplifications and reduction of service life due to fatigue. Hence dynamic assessment and monitoring of the structural condition of bridges under actual train loading are becoming more relevant to support decision making processes. The paper presents the investigations carried out on the Olifants River Viaduct, a critical structure along the Iron Ore Export Line, in order to implement a state-of-the-art

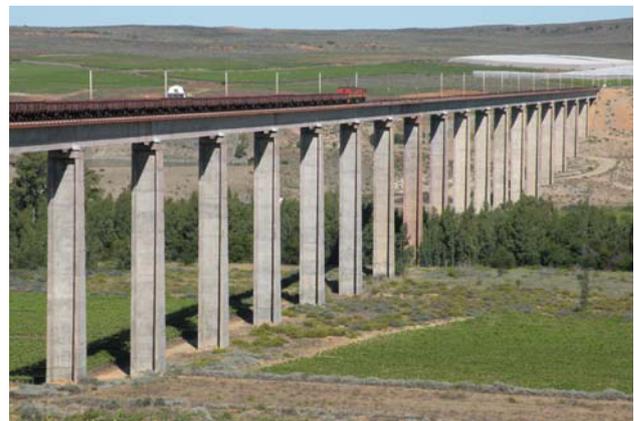
Figure 2. View of the Olifants River Viaduct.

The Olifants River Viaduct (Fig. 2) is located in an agricultural area in the Western Cape Province of SA, between the small towns Lutzville and Vredendal, about 30 km far from the Atlantic coast. It has been in operation since 1976 when the Iron Ore Export Line was inaugurated. In the following subsections, after providing a description of the viaduct, some selected results from experimental investigations carried out in July and October 2014 are presented and discussed.

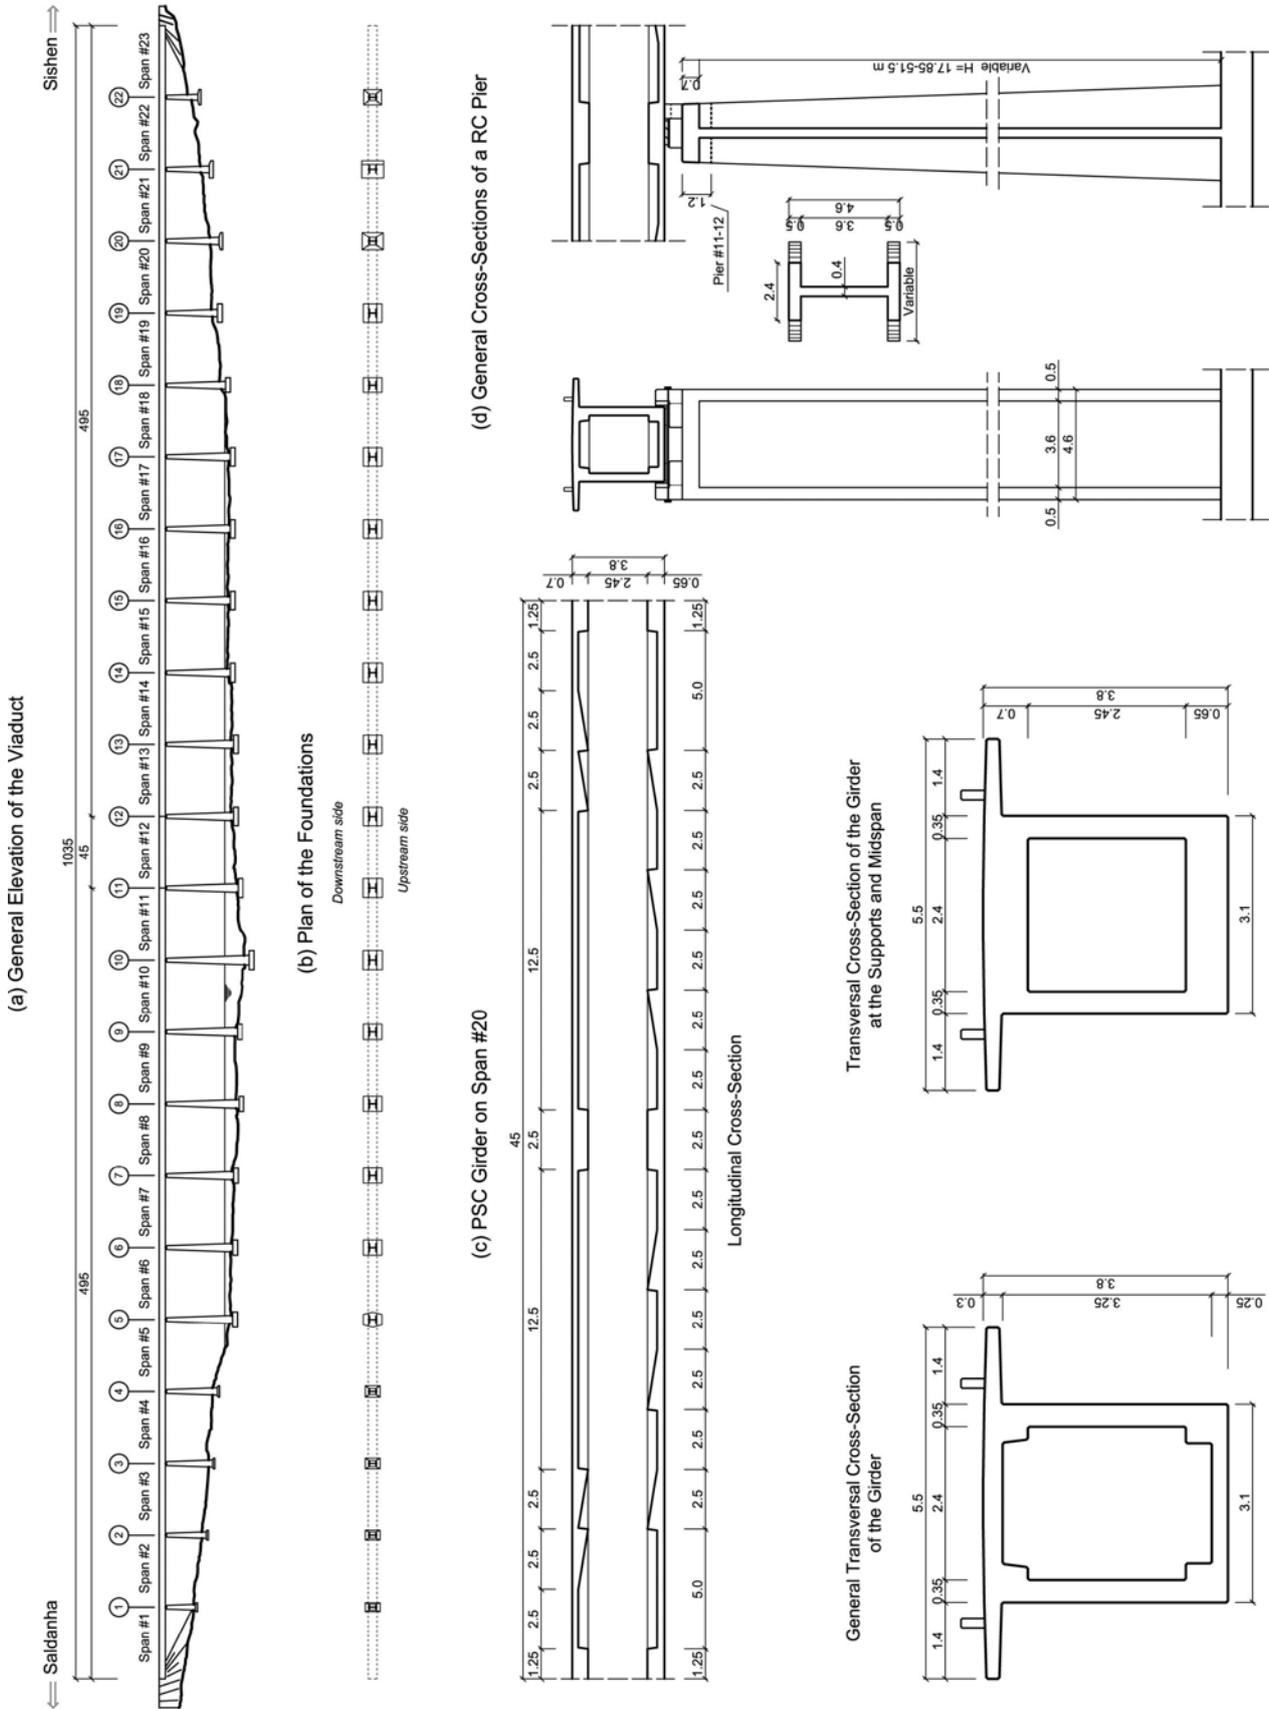
**Figure 3.** The Olifants River Viaduct: (a) general elevation; (b) plan of the foundations; (c) cross-sections of the PSC girder on span #20 and (d) cross-sections of a typical RC pier (dimensions in m).

The viaduct consists of a single box PSC girder, 1035 m long on 23 spans equally spaced, supported by 22 reinforced concrete (RC) piers 45 m apart (Fig. 3(a)). Two expansion joints are located at the piers #11-12 so that three structural independent girders result: two major girders, 495 m long, on spans #1-11 and #13-23 respectively, and a short simply supported girder, 45 m long, on span #12. The piers #1-4 and #20-22 were erected on spread footings (Fig. 3(b)) while piers #5-19, lying on the bed of the Olifants River, were built on piled foundations having a different number of piles ranging from 8 (pier #5) to 36 (pier #19).

The viaduct was built by the incremental launching erection method. Hence the cross-section of the girder is uniform along the entire viaduct. As shown in Fig. 3(c), the overall depth of the cross-section is 3.80 m, the width of the bottom flange equals 3.10 m whereas the top flange (viaduct deck) is 5.50 m wide in order to host a single ballasted track, two lateral pedestrian passages and parapets. The thickness of the bottom flange along the span is 0.25 m which becomes 0.65 m at the supports and midspan in order to accommodate the anchorages of the prestressing tendons. Similarly, the thickness of the top flange equals 0.30 m and becomes 0.70 m where anchorages are located. Finally, the vertical webs of the girder have thickness equals 0.35 m.

The three PSC girders are supported by 22 RC tapered piers having a H-type cross-section (Fig. 3(d)) where the flanges are oriented along the longitudinal direction of the viaduct. Due to the variable topography of the Olifants River Valley in which the viaduct is located, the piers have consequently a different height ranging from 17.85 m (pier #1) to 51.50 m (pier #10). The H-type cross-section has uniform overall depth of 4.60 m; the width linearly increases along the pier axis: at the pier top the width equals 2.40 m while at the bottom it ranges from 3.65 m (pier #1) to 6.00 m (pier #10). Finally, the thickness of the cross-section flanges and web equals 0.50 m and 0.40 m, respectively.

Two different types of bearings are positioned between the girders and piers: i) a reinforced neoprene bearing (RNB) at the piers #1-4, 11-12 (under the simply supported girder) and 18-22; ii) a sliding bearing (SB) at the piers #5-9, 11-12 (under the major girders) and 13-17. The RNB approximately behaves as a hinge while the SB behaves as a slider allowing for longitudinal displacements also due to the thermal effects occurring in the long girders. Finally, transversal bearings are located between the girder webs and the pier caps (Fig. 3(d)).

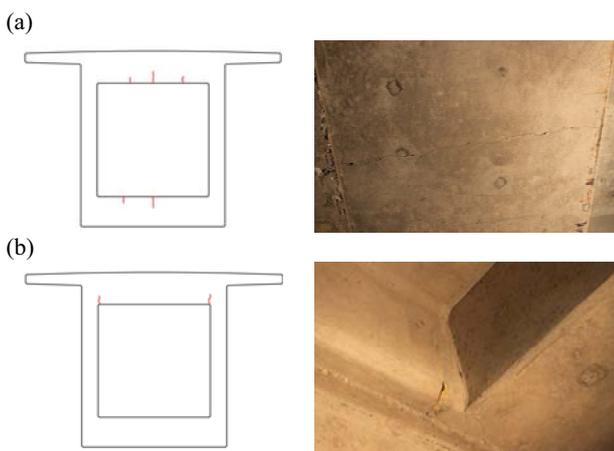
**Figure 4.** Crack phenomena detected in span#20 at (a) the supports and (b) midspan sections.

However, some significant cracking phenomena were detected inside the girder, generally in the thicker parts of the flanges. Fig. 4 summarizes the cracks in span #20: at the supports, significant longitudinal cracks were generally observed in the middle of top and bottom flanges with propagation on the entire thicker part of the flange (Fig. 4(a)); at mid-span, significant cracks generally occur at the top corners, again with propagation on the entire thicker part of the flange (Fig. 4(b)). Similar cracking phenomena were observed also in other spans of the girder so that the cracks in span #20 appear to be recurrent crack patterns.

The interpretation of the nature of cracking is generally challenging since many factors can contribute to the phenomenon. However, the lack of transversal prestressing as well as of transverse beams/diaphragms in the viaduct seems to play a significant role. In addition, a lack of transversal reinforcing steel bars in the thicker parts of the flanges at the supports was observed in the original technical drawings. Thus, when train loading and related reactions at the bearings occur, high tensile stresses arise in the top and bottom flanges, respectively, which might not properly managed by the existing steel reinforcement. In the mid-span section, stresses due to train loading and transversal effects related to the longitudinal bending behavior of the girder lead to recurrent cracking patterns as well.

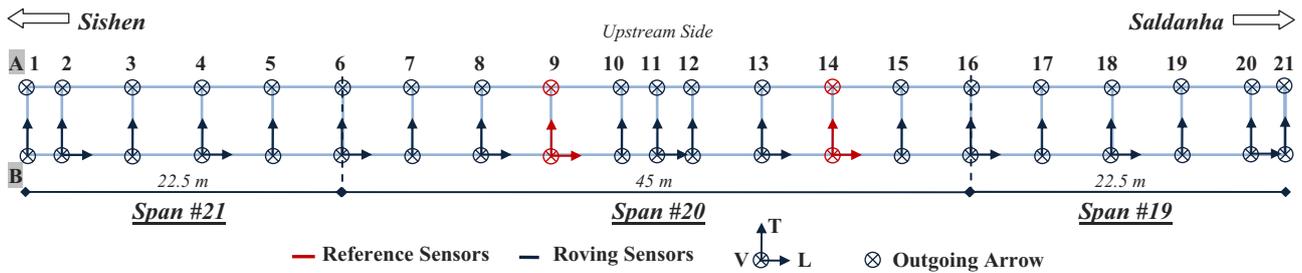
Figure 5. Dynamic test in Oct 2014: instrumented positions and directions of the sensors.

The test was performed by 8 reference sensors at cross-sections #9 and #14 and 7 roving sensors at first located at cross-sections #1-2 (Setup #1) then at cross-sections #3-4 (Setup #2) and so on for a total number of 10 setups.

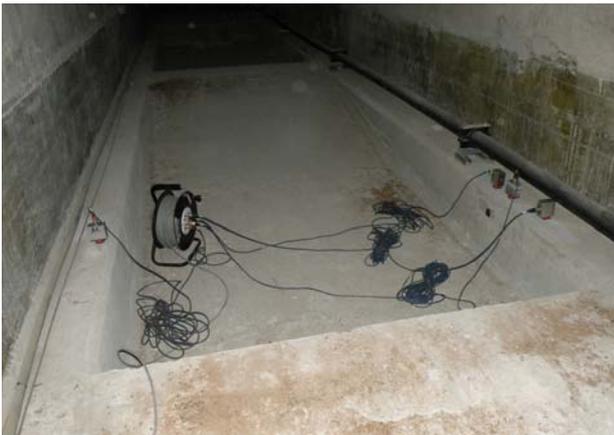
Figure 6. Dynamic test in Oct 2014: four QA-700 accelerometers deployed on the concrete girder.

In terms of equipment, 15 force-balance Honeywell Q-Flex QA-700 current output accelerometers with related cabling, a power supplier and a PC-based data acquisition (DAQ) system hosting 2 National Instruments (NI) PCI-4472B 8-channels, 24-bit resolution boards were used. DC coupling was used in recording the electric signals. The accelerometers QA-700 accelerometers were attached to the structure by using magnets on steel plates glued on the concrete surface (Fig. 6).

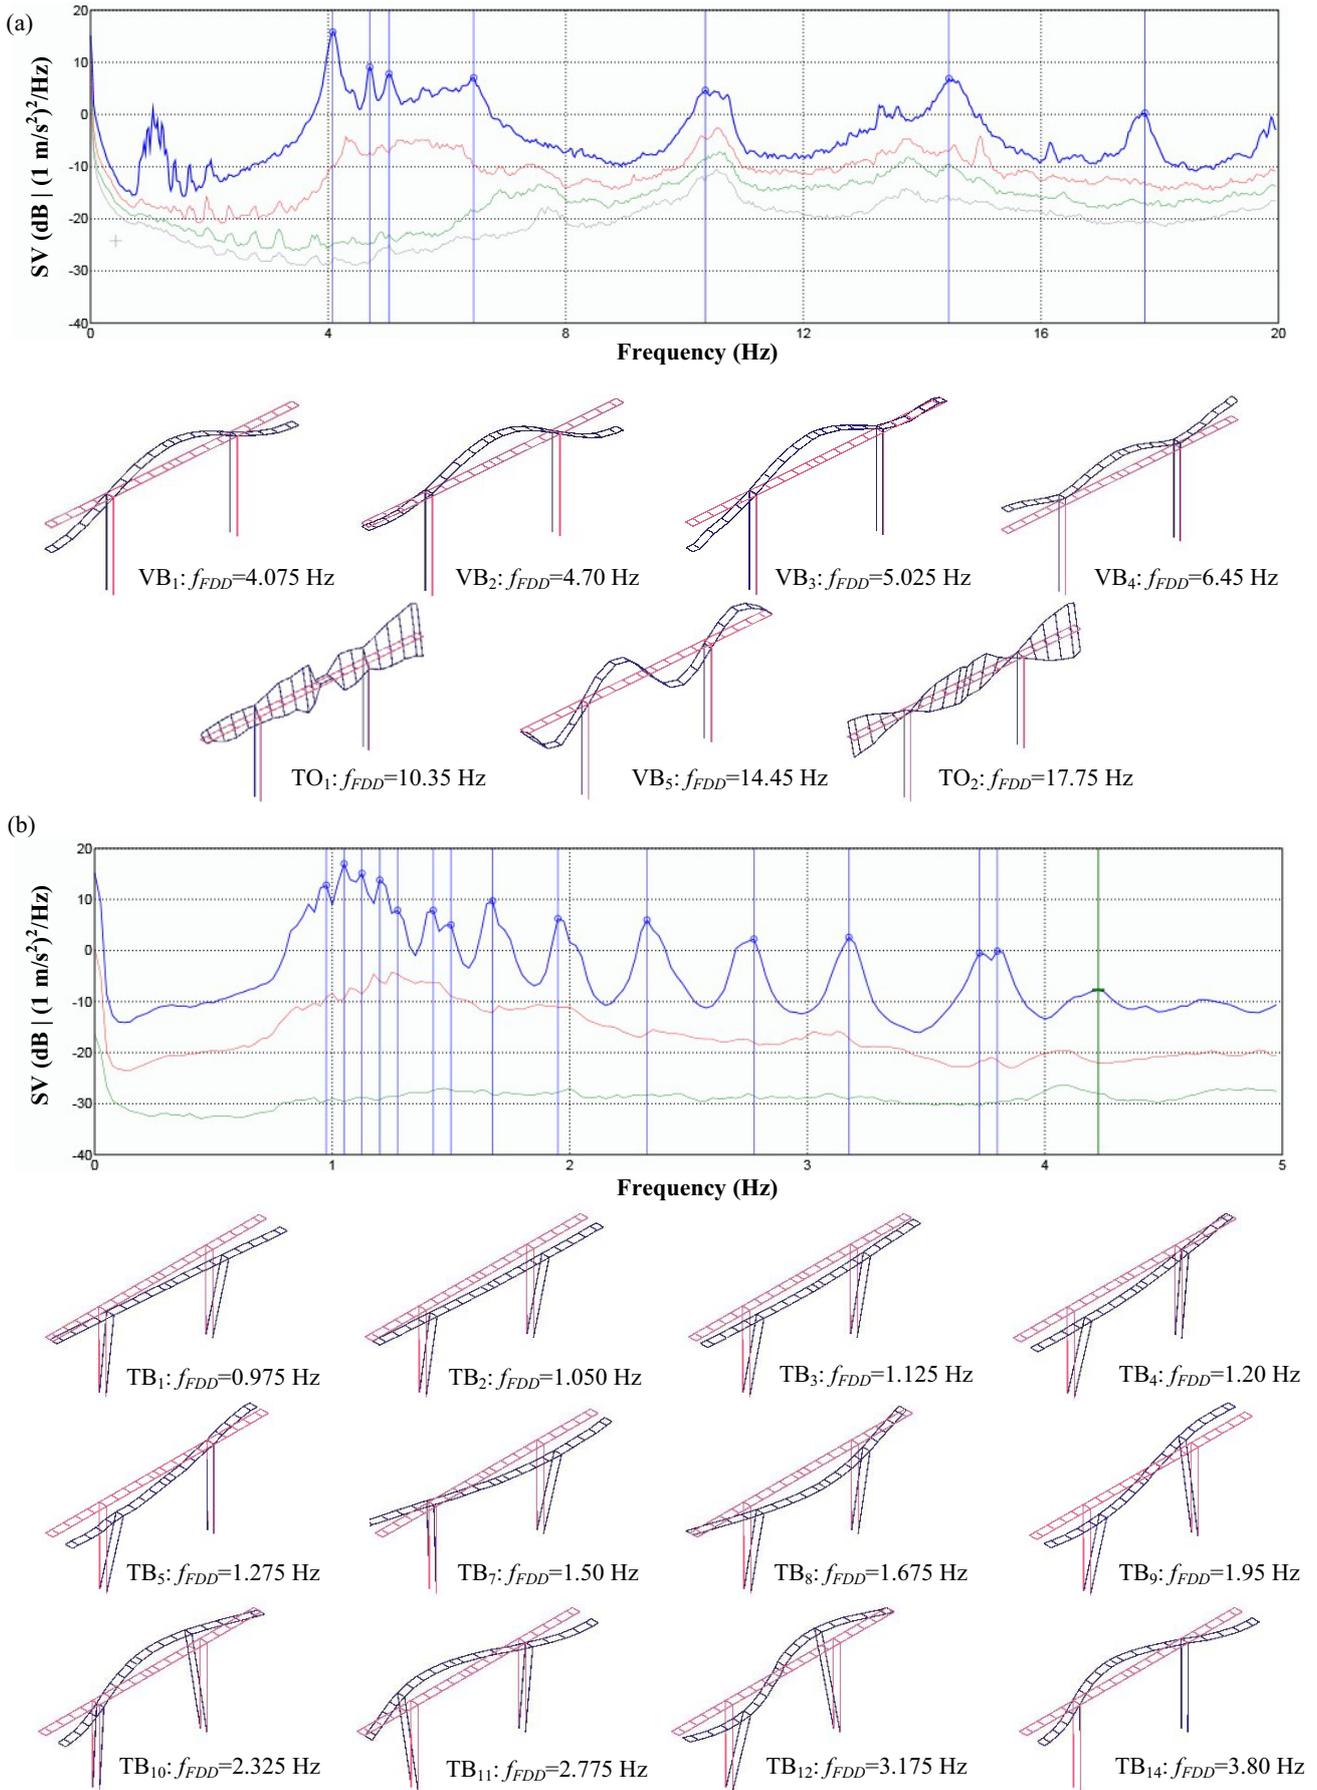
**Figure 7.** Dynamic test in Oct 2014: (a) SV lines of the vertical behavior and VB/TO modes identified in the frequency range 0-20 Hz; (b) SV lines of the transversal behavior and 12 selected TB modes identified in the frequency range 0-5 Hz.

- i) the 1<sup>st</sup> VB mode of vibration of the girder is confirmed being at 4.1 Hz;
- ii) four additional VB modes and two TO modes were identified by the FDD technique in the frequency range 0-20 Hz;

- iii) the transversal behavior of the girder is characterized by several close TB modes in the frequency range 0-5 Hz. A 1<sup>st</sup> TB mode was identified at  $f_{FDD}=0.975$  Hz. However, considering the mode shapes in Fig. 7(b) and the identified modes by the SSI-PC, the TB modes around 1 Hz (i.e. modes TB<sub>1</sub>-TB<sub>4</sub>) (see Fig. 7(b)) need a further more comprehensive investigation in order to understand if any of them is in fact related to a local vibration mode of a pier;

- iv) even though separately listed, modes TB<sub>13</sub>-TB<sub>14</sub>, identified by the FDD technique, show highly correlated mode shapes (MAC=0.99) denoting the occurrence of a single mode in those SV line peaks. That mode is identified at 3.762 Hz by the SSI-PC technique;

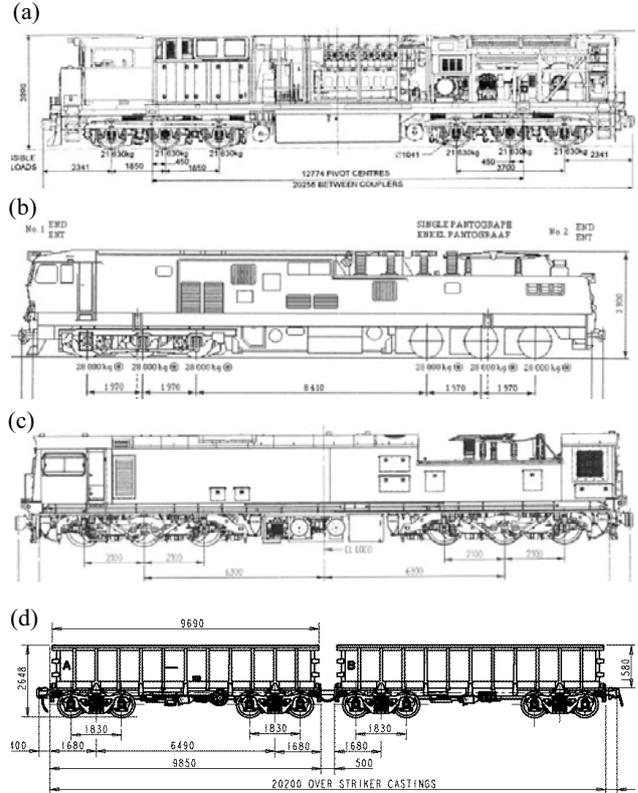
**Figure 8.** Schematic of locomotives (a) 43D - 216 kN/axle, (b) 9E - 280 kN/axle and (c) 15E - 300 kN/axle and wagon (d) CR13 - 300 kN/axle.

The three different types of locomotives 15E, 9E and 43D are illustrated in Fig. 8(a-c), respectively. Similarly, Fig. 8(d) shows an elevation of the wagon type CR13 used to transport the iron ore. The wagon CR13 has a gross weight of 200 kN (20 tonnes). When fully loaded, the wagon static weight equals 1200 kN (120 tonnes), resulting in 300 kN/axle (30 t/axle). The total length of the three rakes of wagons is approximately 3.85 km [7] which becomes 4.1 km including the locomotive consists [4]. At present the RDP train of TFR is the longest freight train in the world

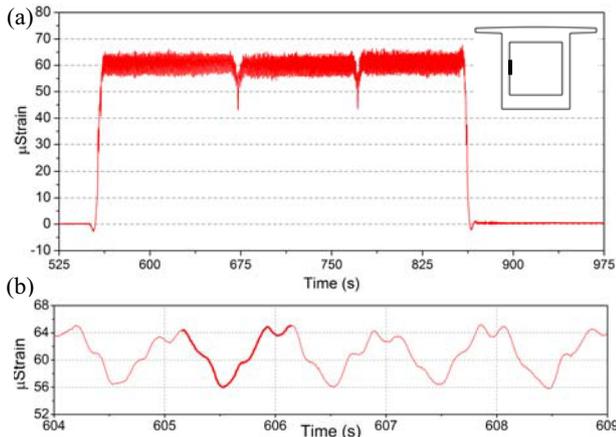
**Figure 9.** Dynamic test in Oct 2014: (a) example of strain signal due to a loaded train; (b) pseudo-periodic wagon induced signal.

In terms of strains, three resistance-based HBM SLB700A strain transducers were deployed inside the girder at the cross-section on pier #21 (see Fig. 3). Fig. 9(a) shows the strain time history recorded during the passage of a loaded train by a strain transducer vertically attached on the girder web. The strain time histories were collected with  $f_s=128$  Hz. That sampling rate was high enough to properly record the strain variation due to the RDP train; however a further test with a higher sampling rate will be performed to better describe the sequence of axle loads. Focusing on the strain time history generated by the sequence of the CR13 wagons, a pseudo-periodic strain signal was observed (Fig. 9(b)). Thus, the vibration strain time histories generally allows for: a) estimating the train speed being both the wagon size and axle distance known and assuming uniform motion of the train. In the example of Figure 9 the train speed was estimated being around 32 km/h; b) estimating the period of the pseudo-periodic signal induced by the long sequence of wagons and so the period of the train loading. As Fig. 9(b) suggests, the period of the wagon loading is generally close to 1 s; c) estimating the variation of stresses in the concrete material if an estimation of the elastic modulus of the concrete is available.

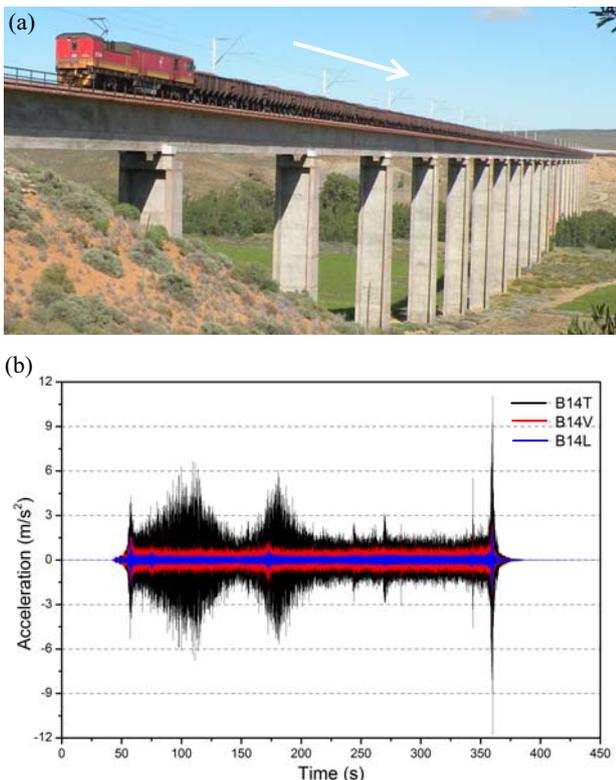
**Figure 10.** Dynamic test in Oct 2014: (a) a loaded train on the viaduct; (b) acceleration signals collected at position #B14.

The same loaded train passage was recorded in terms of acceleration with  $f_s=1024$  Hz at the four reference positions (see Fig. 5). Train signals 350 s long ( $\approx 6'$ ) were extracted and detrended. Fig. 10 shows the acceleration response as collected at the position #B14 along the V, T and L directions. Large signal amplitudes were observed in the T direction reasonably due to irregularities on train wheels and rails and generally associated to high frequency values. Table 3 summarizes RMS of the acceleration  $a_{RMS}$  and the peak acceleration  $a_p$  values of the train signals. The values are listed for both the measured and filtered signals. The latter were filtered by applying a signal filtering LabVIEW tool [13, 14] set with a low-pass Butterworth filter, frequency cutoff of 25.6 Hz for the V signals and 12.8 Hz for the T and L signals as in the estimation of  $G(f)$ . As expected, the filtered signals denote as the V response is the greatest than the ones along the T and L directions.

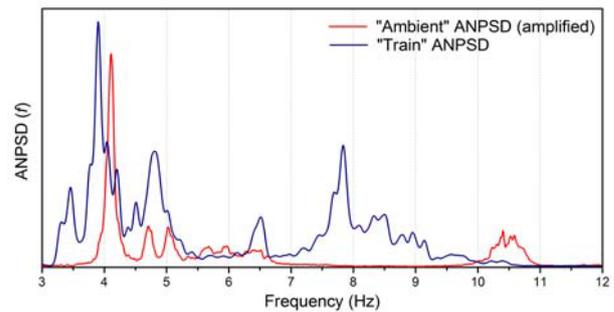
**Figure 11.** Dynamic test in Oct 2014: frequency content of the ANPSD( $f$ ) from vertical ambient vibration and train signals.

The train acceleration signals 350 s long were also analyzed to investigate frequency content and excited vibration modes during a train passage. For example, Fig. 11 shows the ANPSD( $f$ ) in the V direction in the frequency range 3-12 Hz. The plot compares the ANPSD( $f$ ) of train signals to the one computed from ambient vibration signals (depicted at a larger scale) both estimated with  $\Delta f=0.0125$  Hz. The "Ambient" ANPSD( $f$ ) was estimated from signals 3600 s long obtained by linking (after detrending) the ambient vibration signals collected in the reference positions A9/B9 and A14/B14 during the execution of the setups.

- VB modes are generally excited during train passages. Quasi-antisymmetrical modes at girder level (such as the mode VB<sub>1</sub>) generally shift their frequency peak at a lower value due to the effect of the train mass;
- TO modes are not clearly excited during a train passages as expected in a structure hosting a single-track rail line.

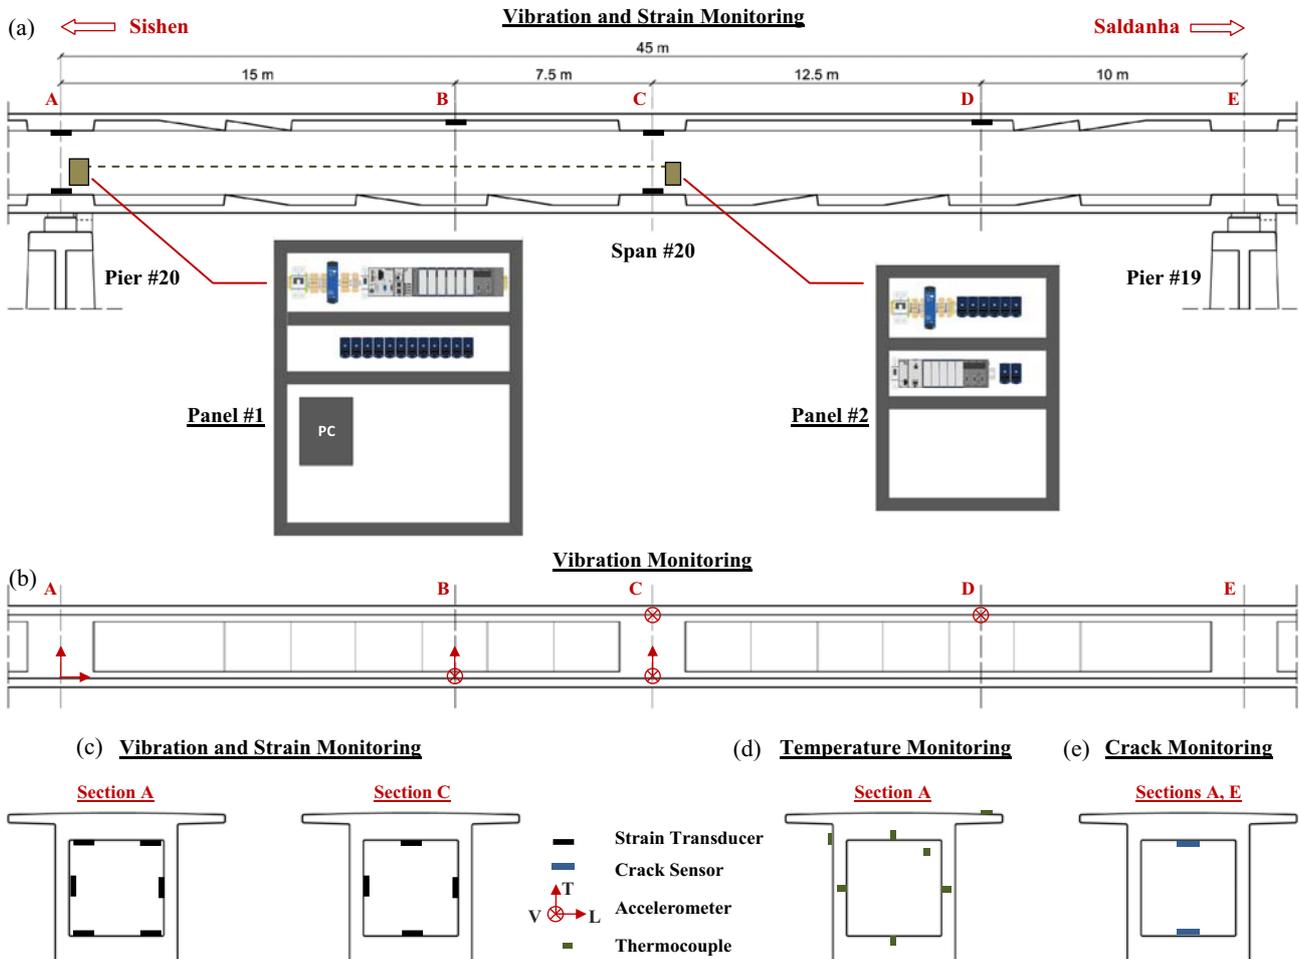
**Figure 12.** Schematic of the monitoring system and placement of: (a) longitudinal strain transducers and electric panels; (b) accelerometers; (c) transversal strain transducers; (d) thermocouples, and (e) crack sensors.

A monitoring system, based on a limited number of sensors, has been designed and developed by the Concrete Materials and Structural Integrity Research Unit (CoMSIRU) of the University of Cape Town. Preliminary versions of the system were presented in [8, 16]. The monitoring system consists of 36 sensors (8 accelerometers, 16 strain transducers, 4 crack sensors and 8 thermocouples) distributed along a single span of the viaduct as shown in Fig. 12. Data acquisition (DAQ) and synchronization of the 36 sensors are managed by a NI C-RIO device and an expansion chassis both equipped with NI C Series DAQ modules. The entire hardware is arranged in two panels each other connected, with the NI C-RIO and chassis hosted in Panel #1 and #2, respectively (Fig. 12). The Panel #1 also hosts a small industrial PC to manage the data transferring by the Internet. Panels and LabVIEW [14] DAQ software running in the C-RIO have been developed in cooperation with KAIROS [15]. At present, the installation of the system has been planned in early September 2015 on span #20 being observed the occurrence of cracking phenomena at both the supports on piers #19-20 and vibration modes generally well defined in that span. However, a further comprehensive vibration test will be performed to select the optimal span.

- a) Vibration monitoring i.e. monitoring of the natural frequencies of the girder (Sishen side) and the response induced by the RDP train by both using accelerometers and strain transducers;
- b) Strain monitoring i.e. monitoring of the variation of strains (and stresses) in the concrete material at positions close to the major cracks. In addition, monitoring of the curvature will be performed by the longitudinal strain transducers;
- c) Crack monitoring i.e. monitoring of the width of the most significant cracking phenomena;
- d) Temperature monitoring to investigate the variation of the temperature in the cross-section at the pier #19 and the possible thermal influence on cracks width, natural frequencies and in general on the structural response.
