## Vibration-based SHM for cultural heritage preservation: the case of the S. Pietro bell-tower in Perugia

**Abstract.** In the present work, multivariate statistical analysis techniques are newly applied in the field of condition assessment of cultural heritage structures. More specifically, the paper presents the design and the implementation of an SHM system for the bell-tower of the Basilica of San Pietro, one of the most relevant monuments of the city of Perugia, Italy. The system comprises three high-sensitivity accelerometers permanently installed on top of the tower and a remote server that automatically processes the data so as to acquire modal parameters and to use such information for novelty analysis and health assessment. In the paper, after a brief description of the permanent monitoring system installed on the structure and of the adopted SHM strategy, the results of the first months of continuous monitoring are presented. Later on, the potential capability of the aforementioned statistical techniques in damage detection is verified by using the continuously identified eigenfrequencies of the bell tower.

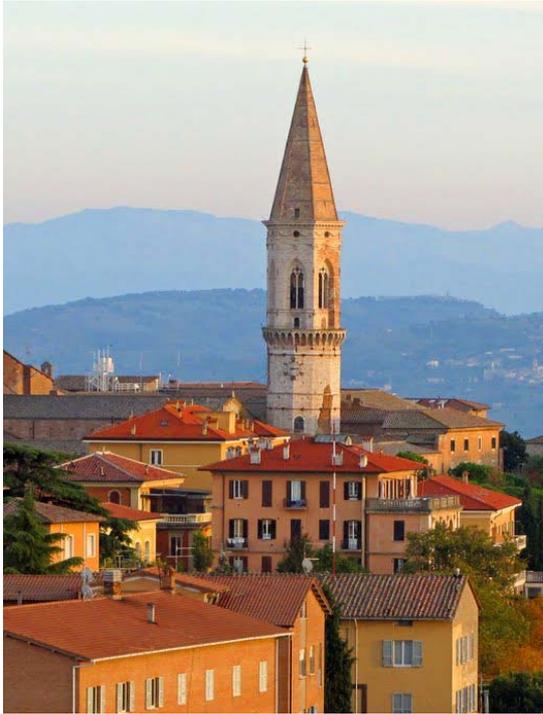
Figure 1. The San Pietro Bell-Tower.

The Basilica of San Pietro in Perugia is located in the southern part of the City. The abbey was erected in 996 while the first erection of the bell-tower (Figure 1) dates back to the 13th century.

The bell tower is constituted by a dodecagonal shaft in the first 26 m, a belfry with hexagonal cross section reaching an height of about 41 m and a cusp at the top.

The shaft is made of stone masonry, with large external portions realized in brick masonry as structural rehabilitation measures due to the occurrence of several damages. The belfry and the cusp are made of brick masonry, but the former is characterized by an external curtain of stones. Moreover the belfry exhibits high mullioned windows in each of the six sides, thus resulting in a significant slenderness degree in the upper part of the structure.

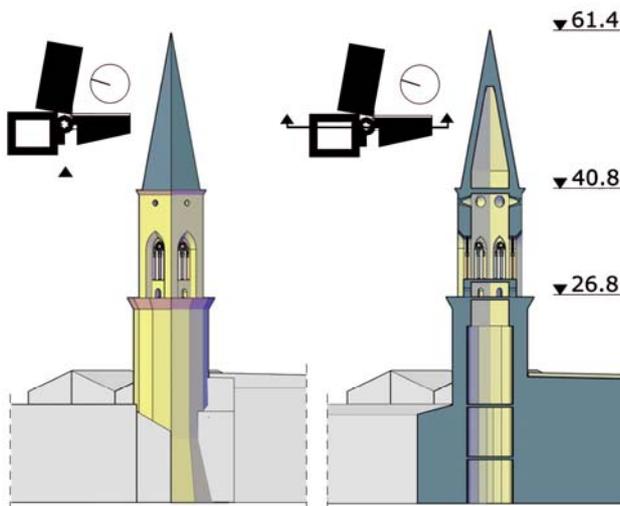
Figure 2. Solid CAD model of the bell-tower.

The Benedictine abbey consists of several architectural volumes, including the basilica, the convent and today other local institutions, arranged around three main cloisters. In this context, the bell tower stands out between the basilica and other branches of the abbey, with a total height of about 61.4 m. In the first 17 m the structure is restrained by the bordering buildings, so that the tower is free to move only in the last 45 m (Figure 2).

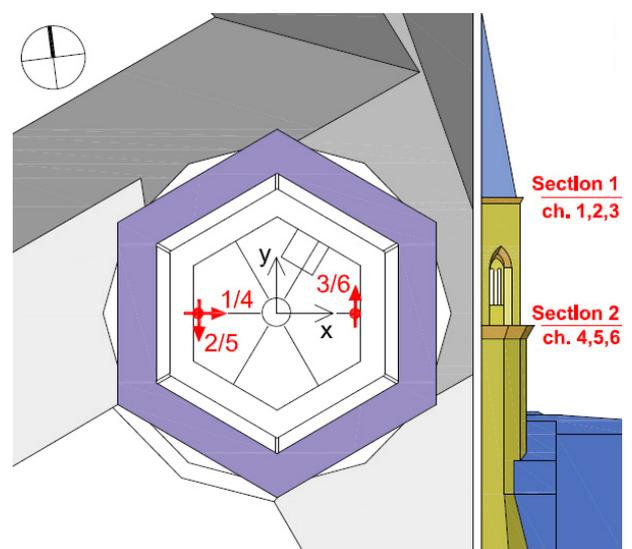
Figure 3. Sensors' layout in AVT.

AVT and OMA of the bell-tower were performed on February 16th 2015 when a fairly strong wind was blowing. The AVT was carried out by using high sensitivity accelerometers located in two sections of the bell-tower (Figure 3): at the base of the cusp (40.8 m) and at the base of the belfry (29.1 m). Uni-axial accelerometers model PCB 393B12 (10 V/g sensitivity) were used and data were recorded by using a 24-channel system, carrier model cDAQ-9188 with NI 9234 data acquisition modules (24-bit resolution, 102 dB dynamic range and anti-aliasing filters). The data were down-sampled at 100 Hz for storage purpose.

Table 1 summarizes the values of identified natural frequencies and corresponding modal damping ratios, where mode types are referred to the reference axes depicted in Figure 3. Identified mode shapes are shown in Figure 4.

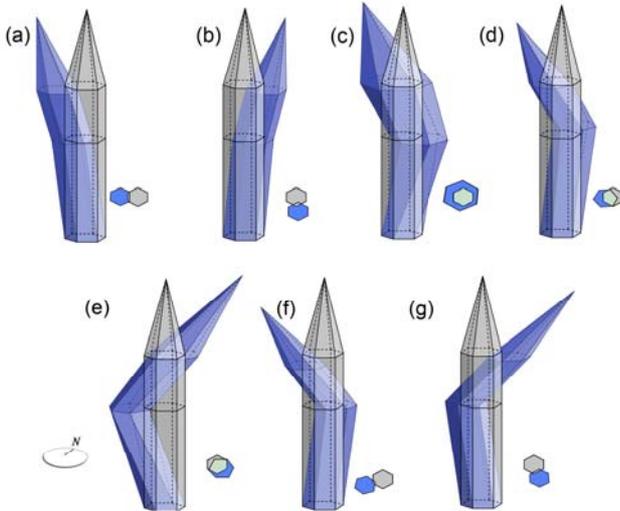
Figure 4. Identified mode shapes of the bell-tower.

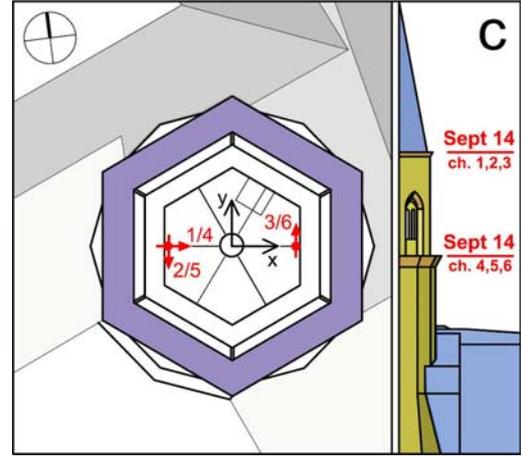
Figure 5. Sensors' layout of the monitoring system.

The continuous monitoring system comprises three high sensitivity uni-axial piezoelectric accelerometers (10 V/g sensitivity) installed at the base of the cusp, with the configuration depicted in Figure 5.

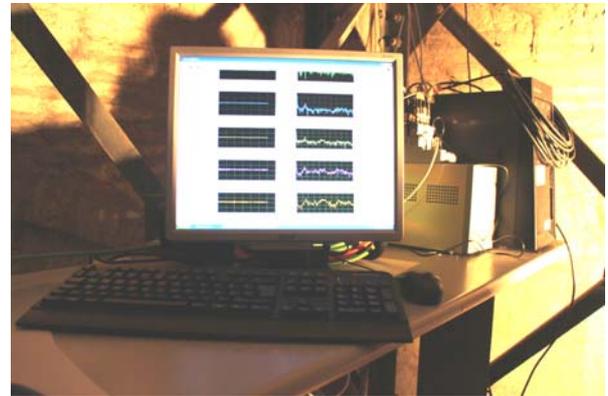
Figure 6. In-field data acquisition system.

The continuous monitoring data are recorded using the same data acquisition system used in the AVT, connected to a host PC located on site (Figure 6). Data are recorded at about 1600 Hz, down-sampled at 100 Hz and stored in separate files of 30 recording minutes. The recorded data are then sent through the internet to a remote server located in the Laboratory of Structural Dynamics of the Department of Civil and Environmental Engineering of University of Perugia, where they are processed through an ad-hoc developed MatLab code. Figure 7 shows the location of the bell-tower and its network connection to the laboratory. Figure 8 shows remote access for quality control of the acquired data during monitoring.

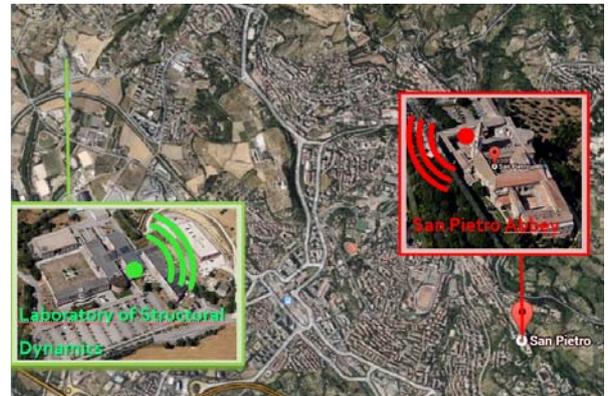
Figure 7. Remote data transmission.

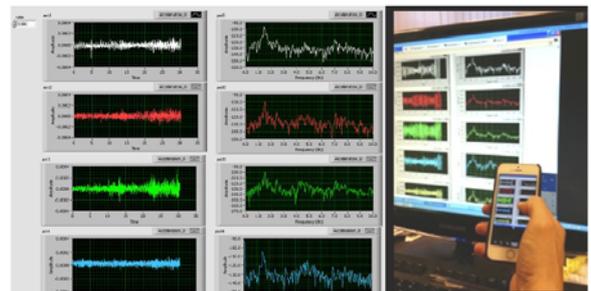
Figure 8. Remote access to monitoring data.

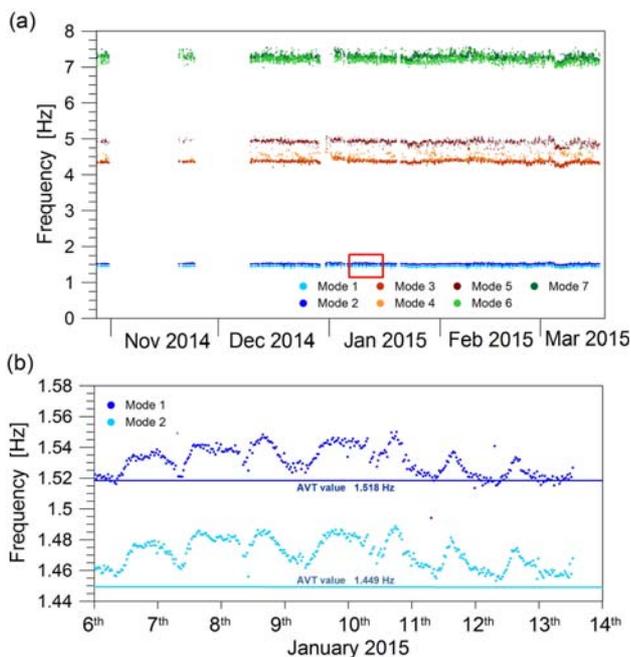
**Figure 9.** Time histories of the first seven modal frequencies identified from the permanent monitoring of the San Pietro bell tower (a) and detailed view highlighting daily fluctuations of the frequencies of the first two modes (b).

Figure 9 (a) shows time histories of identified natural frequencies of the bell-tower during about four months of monitoring. As shown from these results, the frequencies of all seven modes identified in the AVT are also consistently identified during monitoring, with the only exception of the fourth mode which is quite elusive, conceivably due to an insufficient level of excitation of this mode in operational conditions.

A detailed view of the time evolution of the first two eigenfrequencies, shown in the plot of Figure 9 (b), clearly highlights daily fluctuations of the natural frequencies, which are conceivably due to changes in environmental conditions, primarily air temperature. This has been checked by looking at correlations between natural frequencies and temperature of the air measured from the weather station located nearby the tower. The results, shown in Figure 10, clearly demonstrate frequency-temperature correlations, where frequencies are seen to increase with increasing temperature, because of micro-cracks closing in the masonry driven by thermal expansion. It should be noticed that correlation coefficients between frequencies and temperature could be higher than those observed in Figure 10, if temperature of masonry instead of air temperature would be considered.

Frequency shifts equal to those computed in Figure 15 have been artificially imposed to the time histories of the identified eigenfrequencies (Figure 9) starting from the 87<sup>th</sup> day of monitoring. The frequencies identified in the first 80 days have been used for building the statistical models (MLR and PCA), as described in Section 3.3. The MLR model has been built by considering Rms amplitudes of the three measurement channels and the damping ratios of the first two modes as predictors, while three PCs have been retained in PCA.

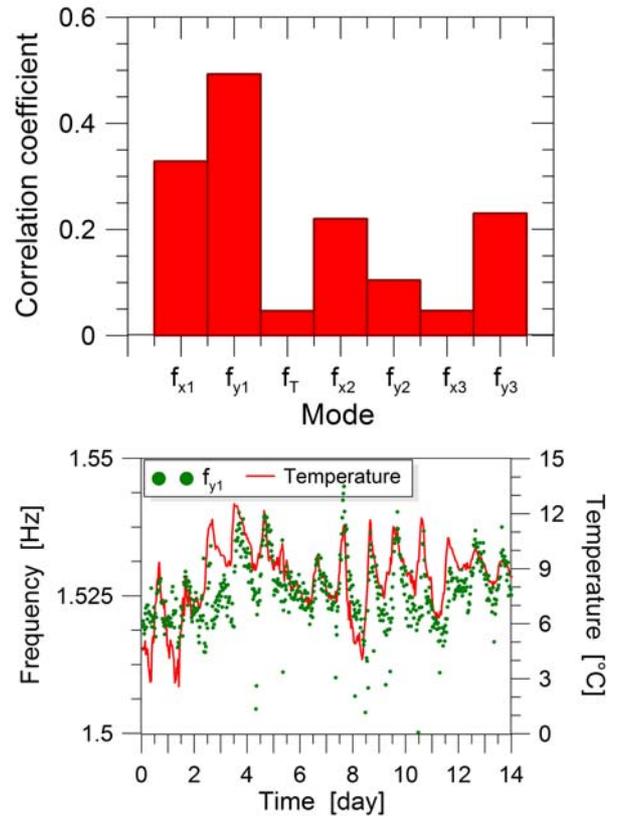
**Figure 10.** Correlation coefficients between identified frequencies and air temperature (top) and detailed view of the time histories of air temperature and first modal frequency (bottom)

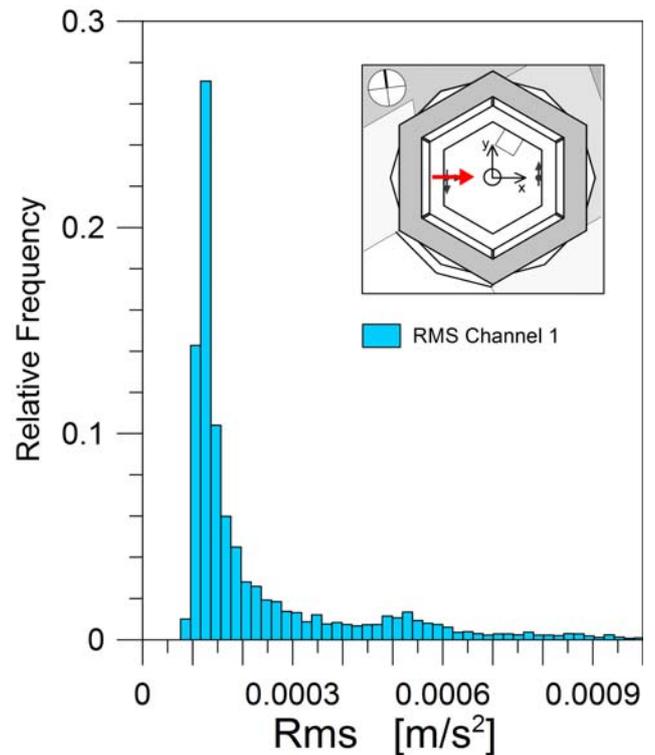
**Figure 11.** Histogram of root mean square (Rms) values of accelerations recorded by sensor number 1 during monitoring

Figure 11 shows the root mean square values of the accelerations recorded by the first sensor. The small levels of vibration are especially noteworthy, which is a consequence of the high stiffness of the structure which is slightly excited by wind. A little higher responses are observed when the excitation is provided by swinging bells, as shown in Figure 12.

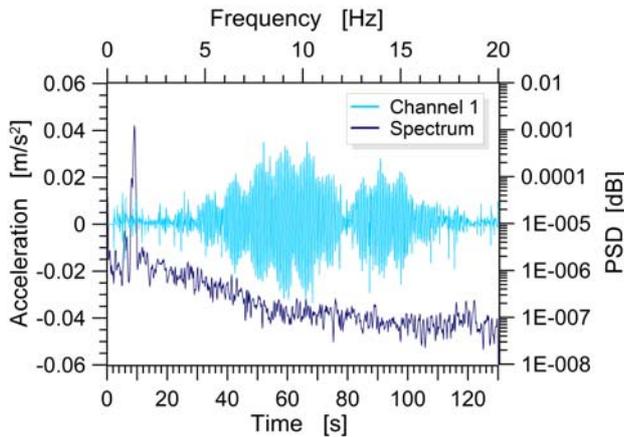
**Figure 12.** Dynamic response of the structure to a single swinging bell

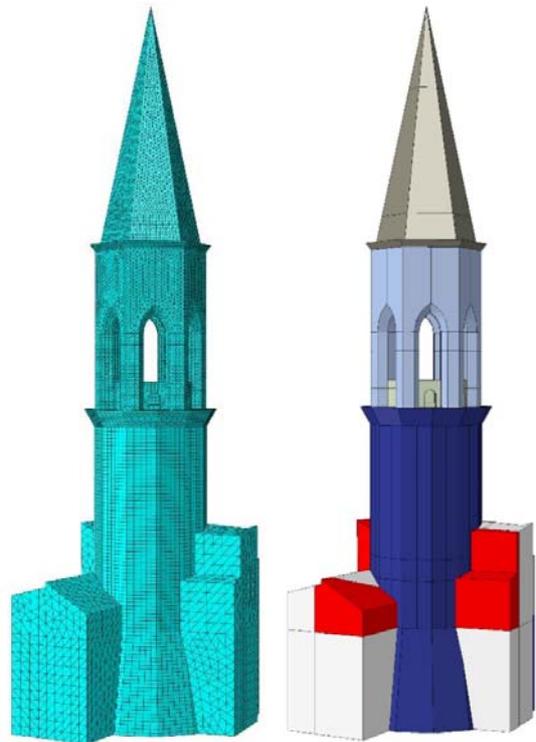
**Figure 13.** Finite element model (left) and topology of materials (right).

With the purpose of investigating seismic vulnerability of the bell-tower, as well as frequency sensitivities to damage, a numerical finite element model of the structure has been constructed. The model, whose graphical sketch is depicted in Figure 13, is a linear elastic representation of the structure in its actual conditions, using three-dimensional finite elements with orthotropic constitutive behaviour.

After some modal sensitivity analysis, not reported here for the sake of brevity, the numerical model has been manually tuned in order to match the experimentally identified modal properties. The main elastic properties of the materials constituting the tower, as estimated after such a tuning, are summarized in Table 2. In general, obtained results are very similar to what suggested in codes and in the literature for regular stone masonry (shaft) and for mixed stone-brick masonry in the remaining parts of the tower.

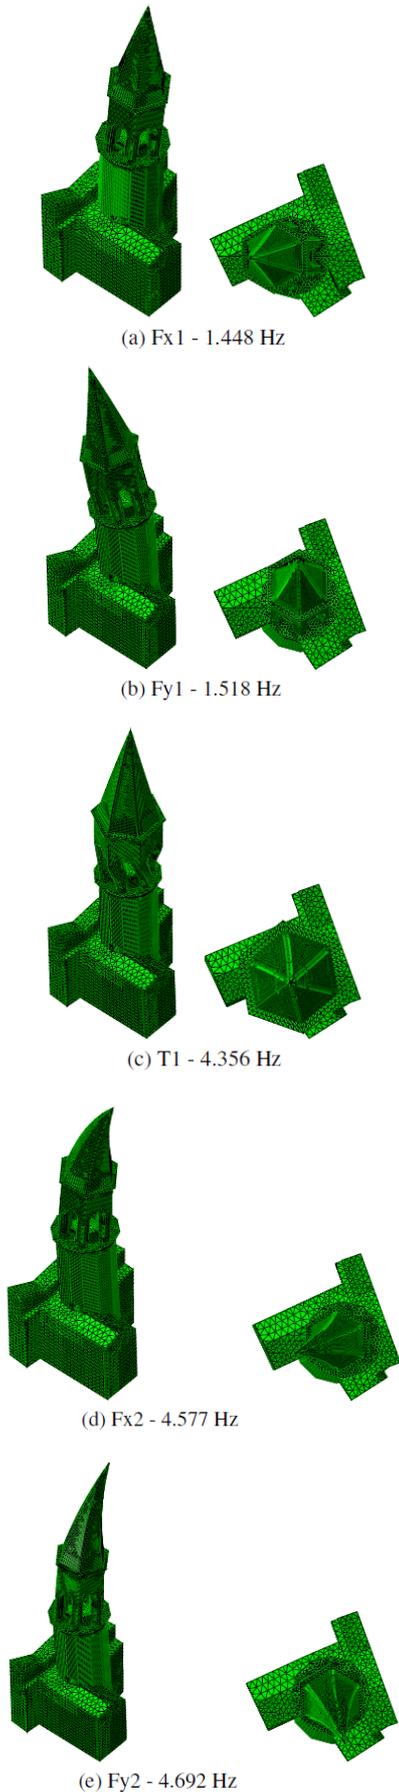
**Figure 14.** Flexural (F) and torsional (T) modal shapes obtained by the FE model

Table 3 summarizes identified and computed natural frequencies after manual tuning. These results highlight a good agreement between experimental results and numerical predictions, allowing to use the numerical model with some confidence. Mode shapes computed from the FE model are shown in Figure 14.

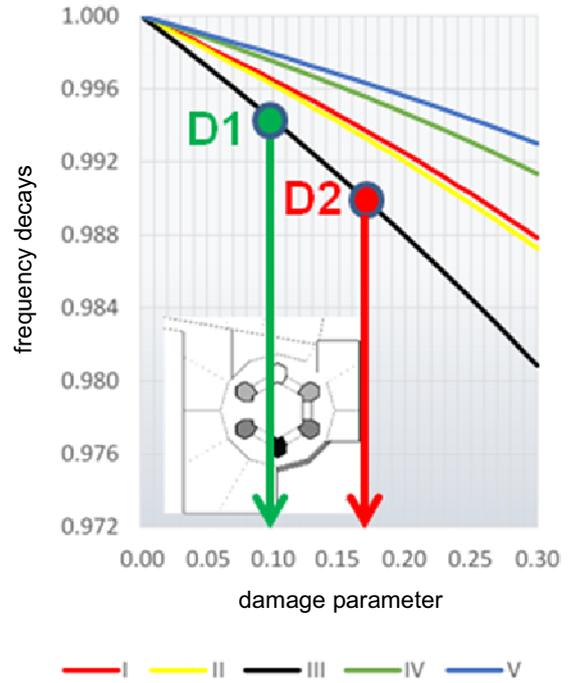
**Figure 15.** Decay of eigenfrequencies with damage parameter

The results of the damage sensitivity analysis of eigenfrequencies are shown in Figure 14. These results show that the most damage-sensitive frequency is the one of the third, torsional, mode. Progressively less sensitive are the frequencies of remaining modes.

Two damage scenarios are considered in particular. The first one, called D1, represents the damage condition producing a relative variation in the most sensitive frequency equal to 0.5%, while the second one, called D2, corresponds to a 1.0% reduction in the frequency of the most sensitive mode. As shown in Figure 15, these damage conditions correspond to values of the damage parameter equal to 0.08 and 0.18, respectively, corresponding to 8% and 18% localized reductions in stiffness in the critical regions of the most severely damaged column.

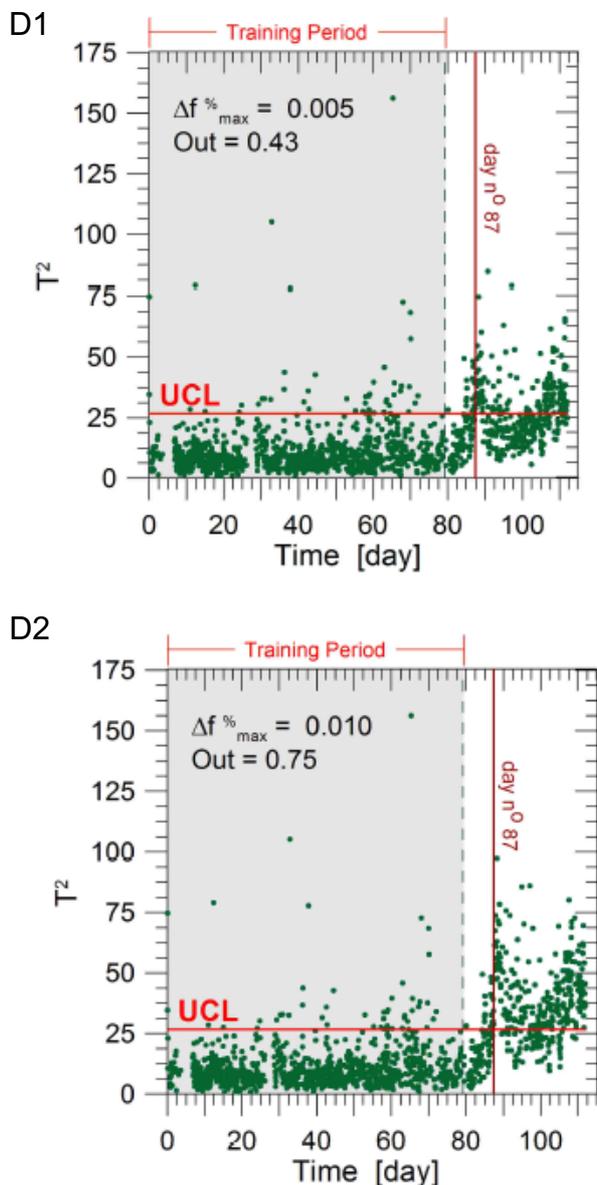
**Figure 16.** Control charts for automated damage detection (Out denotes the outliers' percentage after introducing the damage)

Figure 16 presents the control charts, in terms of the  $T^2$  statistics, obtained for the two considered damage patterns. As shown in these plots, a significant increase in the number of outliers after the occurrence of the damage is observed in both D1 and D2 cases, where the percentage of outliers increases as expected with increasing damage severity. It is concluded, therefore, that the proposed SHM system enables rapid assessment of post-earthquake damages of the monitored bell-tower. It should be noticed that these results have been obtained with a training period of only 80 days, which does not allow to fully characterize fluctuations in natural frequencies of the bell-tower associated with seasonal changes in environmental conditions. It is expected, therefore, that increasing the number of available data sets will reduce the minimum level of damage that is detectable by the proposed SHM system.
