Vibration based structural assessment of the rehabilitation intervention in r.c. segmental bridge

Abstract. A vibration based structural assessment campaign was carried out on a r.c. segmental bridge in North East Italy. The bridge has a cantilever static scheme, fixed at the top of the piers and with a hinge at the centre of the span. The particular configuration of the hinge consists in a couple of steel elements, each one composed by a tongue and groove joint. Since the year 1960, the hinge was subjected to consumption and degradation, that caused a malfunctioning of the device. An intervention of rehabilitation of the bridge led to a reinforcement of the existing hinges with the coupling of new metallic devices: new tongue and groove hinges were applied, that by one side allow the horizontal displacements and rotation, by the other side strongly reduce the relative vertical displacements of the two parts of the bridge. A dynamic test campaign was set up in order to assess the effectiveness of the intervention. The principal dynamic parameters were calculated and analysed with respect to the intervention that was realized. The tests clearly showed the effectiveness of the inter

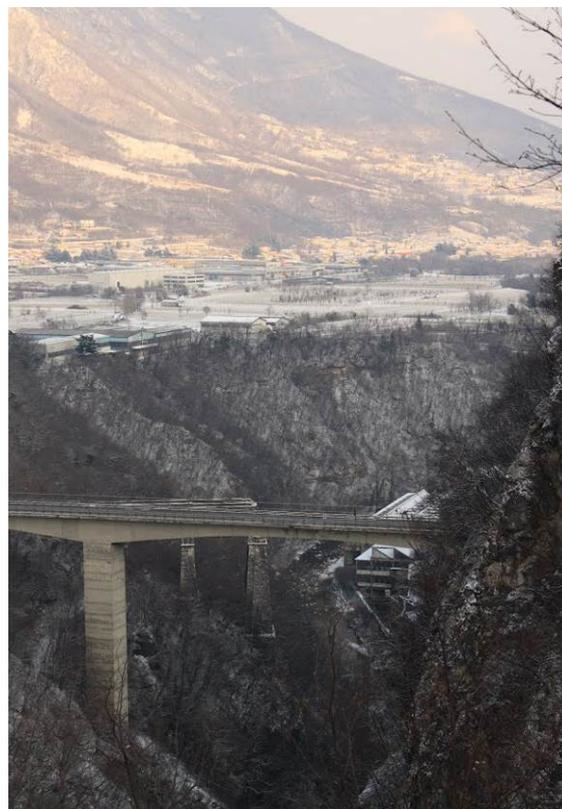
Figure 1. View of the bridge (Copyright by Luca Dalla Riva)

S. Agata bridge is a r.c. segmental bridge in North East Italy. The bridge is 180 m long, with a central span of 83 m, and two piers with a height of 50 m. The piers and the deck are composed by a box girder made by precast segments of post-tensioned reinforced concrete.

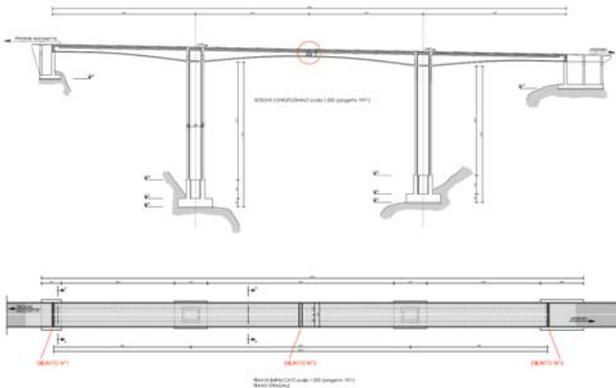
Figure 2. Scheme of the bridge

The bridge has a cantilever static scheme, fixed at the top of the piers and with a hinge at the centre of the span. The particular configuration of the hinge consists in a couple of steel elements, each one composed by a tongue and groove joint.

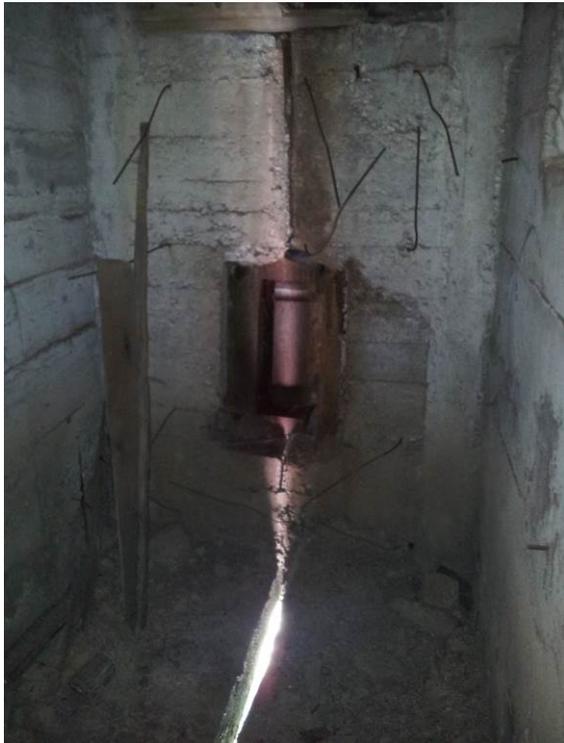
Figure 3. Tongue and Groove Joint at the middle of the deck

Since the year 1960, when the bridge was built, during the huge amount of cycles of rotation and horizontal displacements, the hinge was subjected to consumption and degradation, which caused a malfunctioning of the device. In particular the transit of heavy trucks on the bridge was causing large oscillation and hammering between the two parts of the structures, with consequent structural damage.

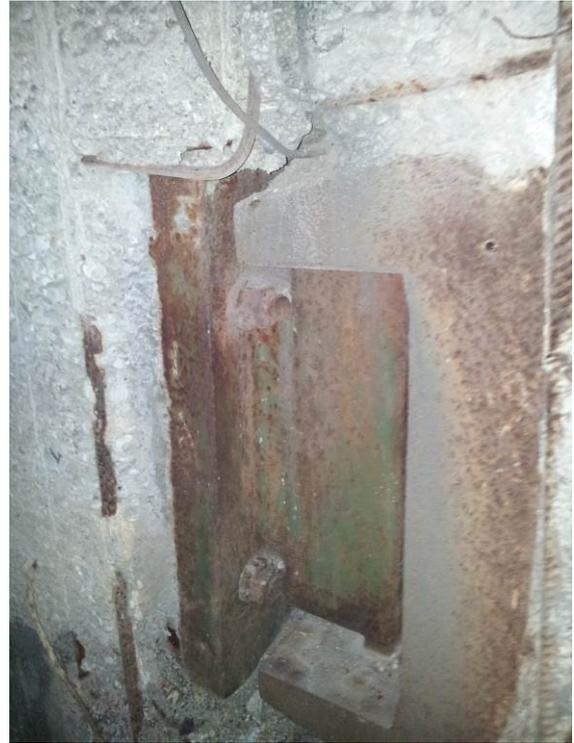
Figure 4. Tongue and Groove Joint at the middle of the deck - detail

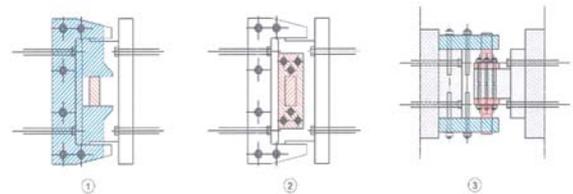
Figure 5. Scheme of the New Tongue and Groove Joint

For these reasons the intervention led to a reinforcement of the existing hinges with the coupling of new metallic devices. The intervention was rapid and didn't involve large demolitions; new tongue and groove hinges were applied at the sides of the old hinges. The intervention allowed to maintain the traffic on the bridge always open, even though one direction at a time.

These new hinges had the purpose to avoid relative displacements between the two sides of the bridge, bringing the hinge to the original behaviour: transmitting only vertical solicitation (shear) without restraining bending moment (rotation) and axial deformation (for example due to temperature variation).

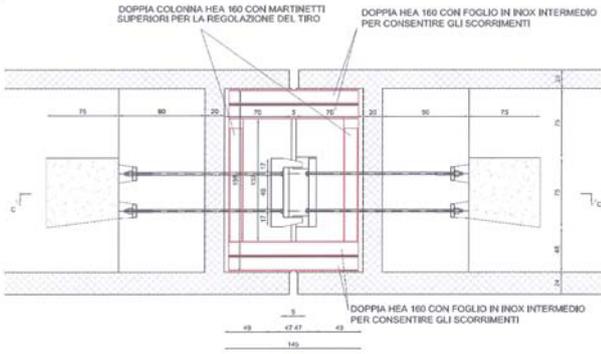
Figure 6. Scheme of the provisional reinforcement system for the installation of the New Tongue and Groove Joint

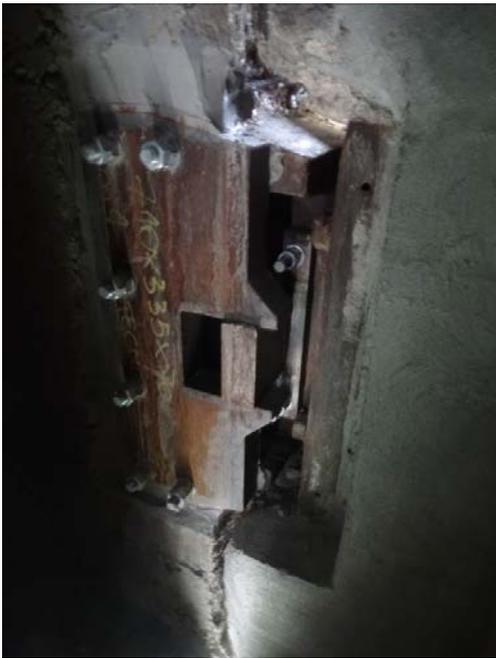
Figure 7. New Tongue and Groove Joint

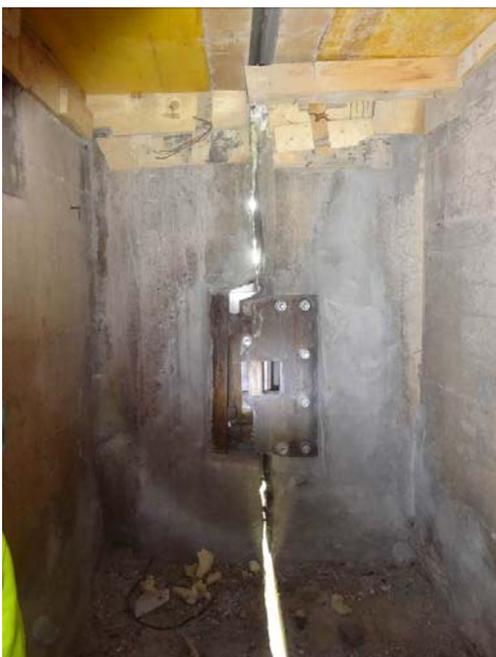
Figure 8. New Tongue and Groove Joint

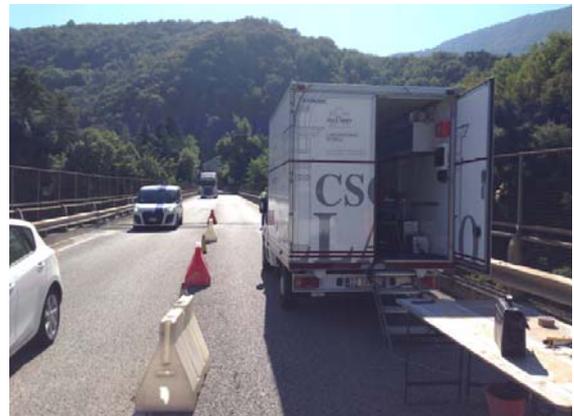
Figure 9. Sensor layout

Eight accelerometers were applied to the structure in order to identify most of the principal mode shapes of the structure.

Five accelerometers were applied to the structure, in order to identify at least a couple of vertical modes and the principal torsional mode. Moreover, two accelerometers were disposed in longitudinal direction, and one in transversal direction.

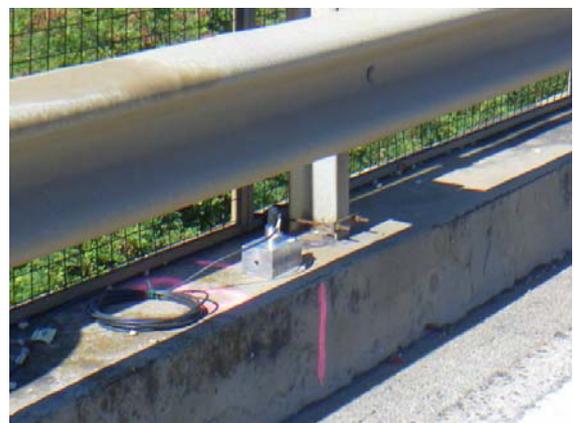
Figure 10. Execution of dynamic test

The excitation of the structure was applied through ambient vibration, mostly caused by the transit of vehicles and trucks.

In particular, some tests were made with the transit of a single truck, measuring also the damped vibration of the bridge after the transit.

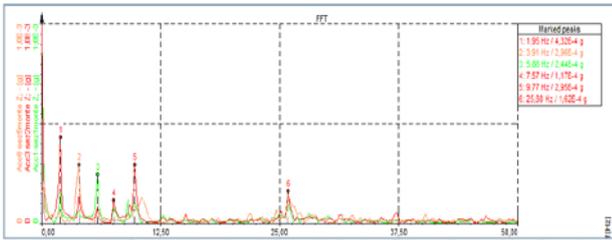
Figure 11. Principal vertical frequencies

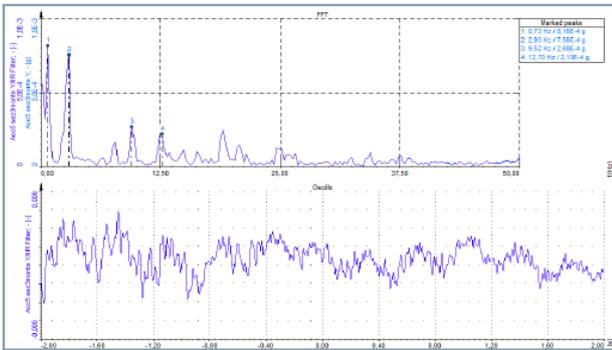
Figure 12. Principal transversal frequencies

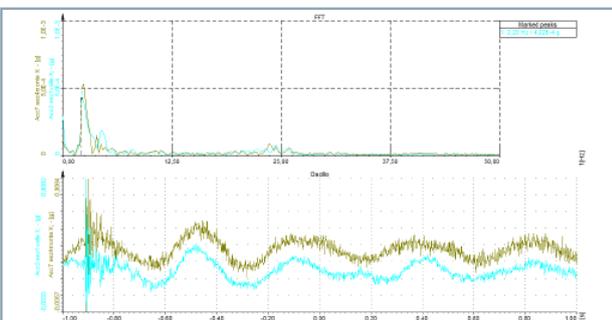
Figure 13. Principal longitudinal frequencies

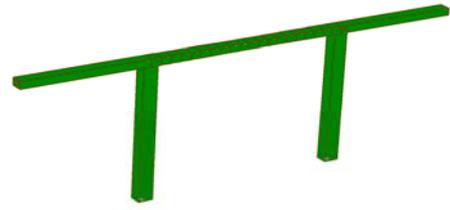
Figure 14. FE model

The results were compared with the FE model built on the basis of the original project.

The FE model, after the model updating procedure, results in a good correspondence with the experimental values. The model updating procedure showed that the elastic modulus of the material is higher than standard concrete, with a general good behaviour of the whole structure.

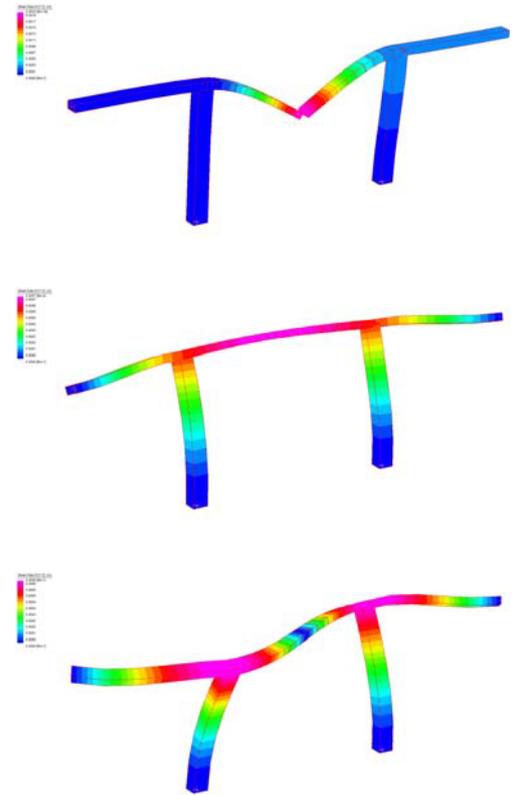
Figure 15. First mode shapes: vertical, transversal and torsional

Mode	Experimental frequency (Hz)	Theoretical frequency (Hz)
Transversal	0.75	0.79
1 st vertical	1.95	1.75
2 nd vertical	3.95	4.27
Torsional	9.75	8.0

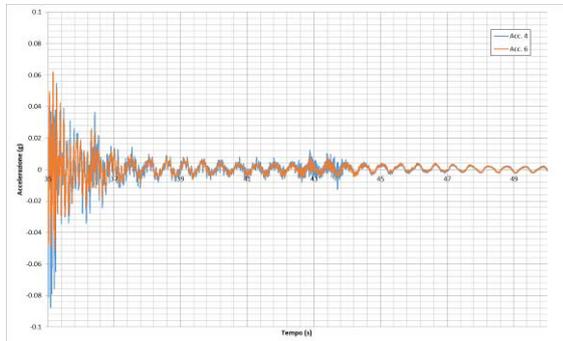
By comparing the time history response of the two sensors at the two sides of the bridge it was verified if the new hinges at the centre would create an effective shear connection between the two halves of the structure.

Figure 16. Comparison of the vibration of the sensors at the two sides of the hinge: time history and frequency.

The tests clearly showed the effectiveness of the intervention, and helped the designer to have a better understanding of the structural behaviour of the bridge.

The tests clearly showed the effectiveness of the intervention, with a coupling of the behaviour of the two sensors at the sides of the hinge, without differential vibration frequencies.
