Investigation of cutting-induced damage in CMC bend bars

Abstract. Ceramic matrix composites (“CMC”) with a strong fibre-matrix interface can be made damage-tolerant by introducing a highly porous matrix. Such composites typically have only a low interlaminar shear strength, which can potentially promote damage when preparing specimens or components by cutting. In order to investigate the damage induced by different cutting methods, waterjet cutting with and without abrasives, laser-cutting, wire eroding and cutoff grinding were used to cut plates of two different CMCs with a matrix porosity up to 35 vol.-%. For each combination of cutting method and composite, the flexural and interlaminar shear strength of the resulting specimens was determined. Additionally, the integrity of the regions near the cut surfaces was investigated by high-resolution x-ray computer tomography. It could be shown that the geometrical quality of the cut is strongly affected by the cutting method employed. Laser cut and waterjet cut specimens showed damage and delaminations near the cut surface leading to a reduced interlaminar shear strength of short bend bars in extreme cases.

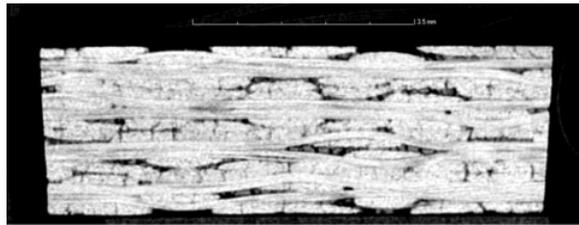
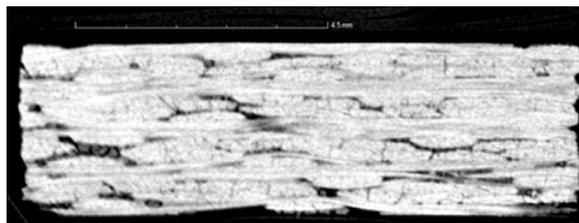
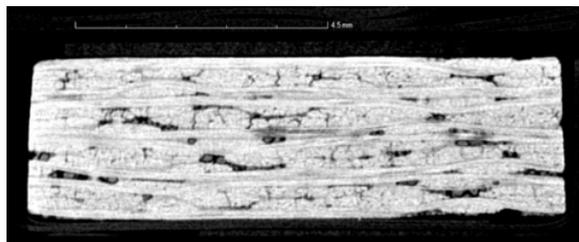
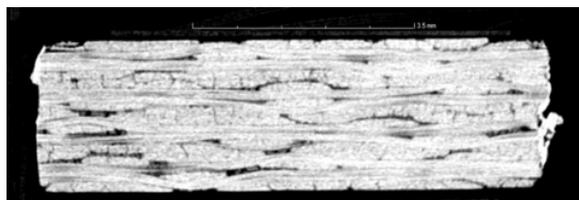
a) cutoff grinding (CG)

b) waterjet cutting (WJ)

c) abrasive waterjet cutting (AWJ)

d) laser cutting (LC)

Figure 1. μ -CT Cross section of Schunk FU2998/1 specimens cut with different methods. The cut surfaces are on the left and right of the image.

μ -CT images of cross sections of a cut bend bar are shown in Fig. 1. 3D views of the cut surfaces are shown in Fig. 2. It is obvious that the used cutting methods produce cuts of different quality. The

side surfaces of cutoff-ground specimens are smooth (Figs. 1a and 2a), but the cut was sometimes not perfectly perpendicular to the specimen top surface (an example is shown Fig. 1a, the observed flank angle varied somewhat from specimen to specimen). Waterjet cut specimens had a more irregular surface (Figs. 1b and 2b). In some places, slightly delaminated top layers could be observed near the exit surface (encircled areas in Fig. 2b). Waterjet cutting with particle addition resulted in a smoother cut surface (Figs. 1c, 2c) with slightly rounded edges near the exit surface of the waterjet (edges at the top of Fig. 1c). Again, slightly delaminated top layers could be observed near the exit surface (encircled areas in Fig. 2c). Laser-cutting resulted in evident surface defects with molten regions on the cut surface (bright areas in Fig. 1d). Superficial cracks were also visible on the cut surfaces. The heat affected zone was very brittle and material could be easily removed by slight mechanical contact leading to a very irregular surface (Fig. 2d).

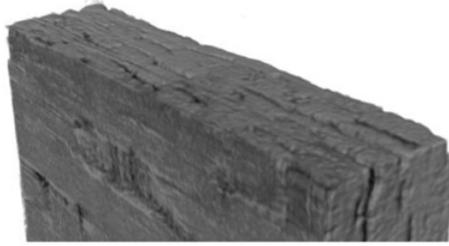
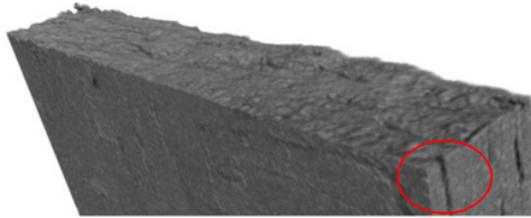
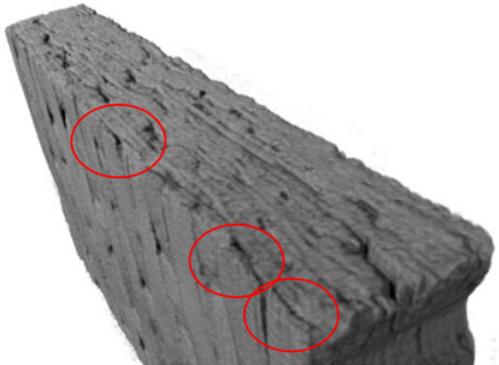
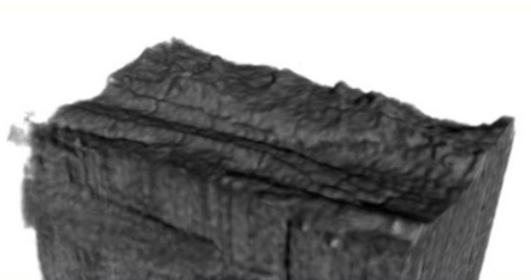
a) cutoff grinding (CG)

b) waterjet cutting (WJ)

c) abrasive waterjet cutting (AWJ)

d) laser cutting (LC)

Figure 2. 3D-view of the surface morphology of Schunk FU2998/1 specimens cut with different methods. The cut surface is facing up, the exit surface of the waterjet beam is on the left.

variation within one specimen should not exceed ± 0.2 mm (EN 658 part 3) and ± 0.1 mm, respectively (EN 658 part 5). Looking at the specimen surfaces (Figs. 2 and 5) and Tables 2 and 3 it is clear that these requirements are not met by all employed cutting methods. Both, material damage and geometry deviations exceeding the limits are observed. The observations concerning the different cutting methods are summarized in Table 4. No distinction is made between the results of the two studied materials as they showed similar behaviour with respect to cutting quality achieved – the differences in measured flank angles (Tables 2 and 3) are not significant due to the variability from specimen to specimen. The

Looking at Figs. 2 and 6, it is clear that waterjet cutting (with or without particle addition) can induce small delaminated zones near the specimen edge of weak matrix composites. However, no clear evidence for delamination damage in the central zone of the cut surface was found. In short bending tests, the maximum shear stresses occur in the centre of the specimen and in a valid test, failure must occur in this region. It is therefore likely that, for the two composites studied, the damage caused by waterjet cutting was not detrimental for the determination of interlaminar shear strength.

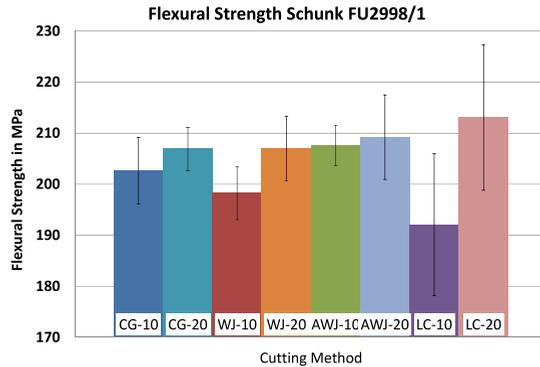
Figure 3. Flexural strength (3-point-bending) of Schunk FU2998/1 specimens cut with different methods: cutoff grinding (CG), waterjet cutting (WJ, with particles AWJ) and laser cutting (LC). The number after the cutting method indicates the width of the specimens (10 – narrow, 20 wide specimens). The error bars indicate 90% confidence intervals.

The flexural strength of Schunk FU2998/1 specimens cut by different methods is shown in Fig. 3. Within experimental uncertainty, no significant difference in the determined three-point bending strength could be determined for the eight specimen groups. It is interesting to note that the determined average bending strength of the wider specimens was slightly higher for all cutting methods. Although the differences were not statistically significant, this may be a hint that the non-ideal surface topography can lead to a lower evaluated strength. Compared to the other groups, the laser cut specimens showed a large strength scatter (standard deviation) resulting in the largest uncertainty in the determined average value.

When looking at Figs. 3 and 7, it is obvious that the different surface quality did not have a significant effect on the determined flexural strength of the tested ceramic matrix composites due to their inherent damage tolerance. It is particularly instructive to compare the strength for identical cutting methods, but different specimen width. If fibre damage induced by cutting would be relevant for flexural strength, one would expect that wider specimens would be less affected as only fibres near the cut surface would be damaged.

For Schunk FU2998/1 (Fig. 3), there is no significant difference in flexural strength between the specimen groups with approx. 10 mm and 20 mm width for any of the cutting methods. Even for laser cut specimens, the average value of the flexural strength does not differ from specimen groups cut by other methods despite the molten zones observed at the cut surface. However, the strength scatter (standard deviation) is significantly larger for this specimen group. It is believed that the larger scatter in strength is mainly due to difficulties in determining the width of the specimens precisely – the surface is irregular and the measured specimen width also shows a larger scatter compared to the other specimen groups.

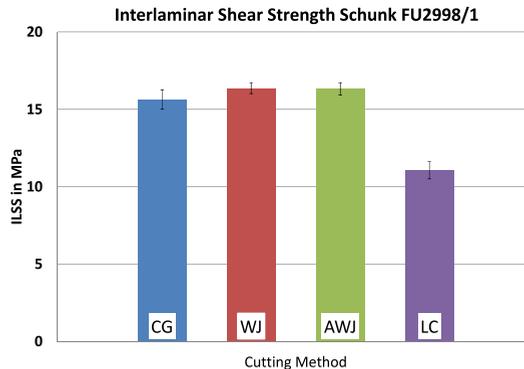
Figure 4. Interlaminar shear strength of Schunk FU2998/1 specimens cut with different methods as determined in short bending: cutoff grinding (CG), waterjet cutting (WJ, with particles AWJ) and laser cutting (LC). The bars on the columns indicate 90% confidence intervals.

The interlaminar shear strength (ILSS) of Schunk FU2998/1 specimens cut with different methods is shown in Fig. 4. WJ and AWJ specimens were taken from one composite plate, CG and LC specimens from another plate with a slightly thinner matrix between the fibre layers. Nevertheless, within experimental error, the ILSS of cutoff-ground and the waterjet cut specimen groups were almost identical, and the laser-cut specimens had significantly lower interlaminar shear strength.

Indeed, for Schunk FU2998/1 there is a significant difference in flexural strength between the laser cut and the other specimen groups (Fig. 4). Obviously, interlaminar cracks easily initiate in the rough surface with molten zones and lead to the lower observed interlaminar shear strength of these specimen group. There is also a small difference in interlaminar shear strength between the CG group on the one side and the WJ and AWJ group on the other side. Inspection of the AWJ and WJ specimens showed that they originated from a plate with a slightly thicker matrix layer between the fibre fabrics which explains the small difference in interlaminar shear strength.

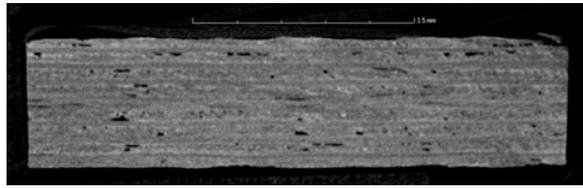
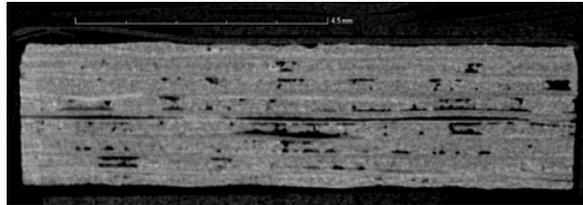
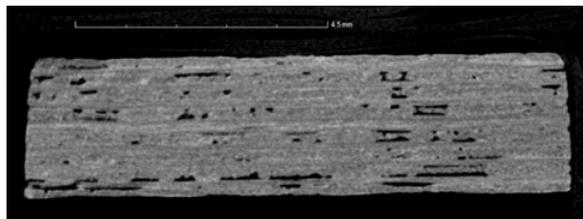
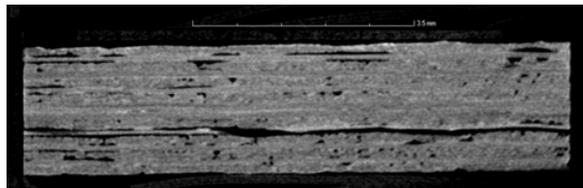
a) cutoff grinding (CG)

b) waterjet cutting (WJ)

c) abrasive waterjet cutting (AWJ)

d) wire eroding (WE)

Figure 5. μ -CT Cross section of SiCARBON™ specimens cut with different methods. The cut surfaces are on the left and right of the image.

μ -CT images of cross sections of cut SiCARBON™ bend bars are shown in Figs. 5 and 6. Again, the employed cutting methods produce cuts of different quality. The side surfaces of cutoff-ground specimens (Figs. 5a, 6a) are smooth, but in some cases the cut was not perfectly perpendicular to the specimen top surface. Waterjet cut specimens had a more uneven surface (Figs. 5b, 6b) with slightly

rounded edges near the exit surface of the waterjet (Fig. 5b). In some locations (encircled in Fig. 6b) delamination could be detected near the exit surface. The observations for waterjet cutting with particle addition (Figs. 5c, 6c) are nearly identical to those without particle addition. Wire eroding resulted in almost perfectly perpendicular side surfaces (Fig. 5d). Grooves parallel to the fibre layers could be observed (Fig. 6d). Close inspection by high-resolution μ -CT showed that the grooves were caused by missing fibres – it is believed that these superficial fibres were burnt away during eroding by the discharge.

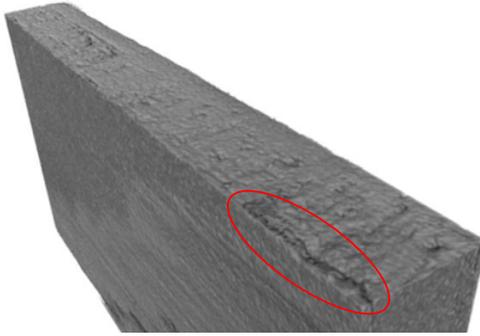
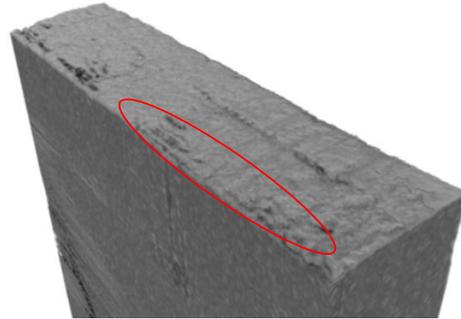
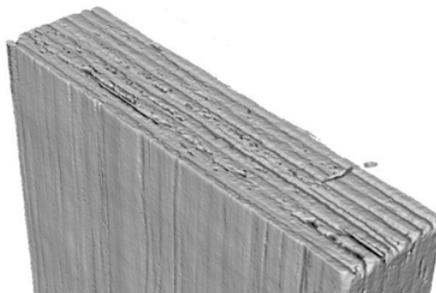
a) cutoff grinding (CG)

b) waterjet cutting (WJ)

c) abrasive waterjet cutting (AWJ)

d) wire erosion (WE)

Figure 6. 3D-view of the surface morphology of SiCARBON™ specimens cut with different methods. The cut surface is facing up, the exit surface of the waterjet beam is on the left.

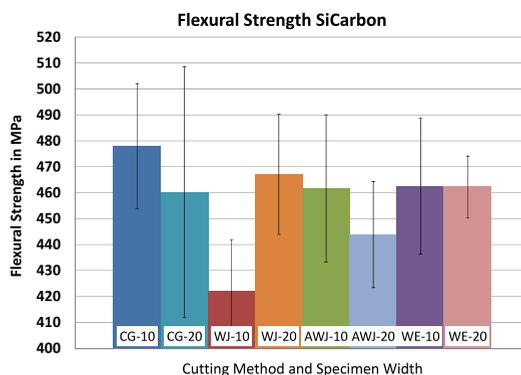
Figure 7. Flexural strength (3-point-bending) of SiCARBON™ specimens cut with different methods: cutoff grinding (CG), waterjet cutting (WJ, with particles AWJ) and wire erosion (WE). The number after the cutting method indicates the width of the specimens (10 – narrow, 20 wide specimens). The error bars indicate 90% confidence intervals.

Results for the flexural strength of SiCARBON™ specimens cut by different methods are shown in Fig. 7. The average three-point bending strength was about 460 MPa. With the exception of WJ-10

(narrow water jet cut specimens), the 90% confidence interval of all specimen groups overlapped. The waterjet cut specimens were also the only group showing a dependence of the flexural strength on the specimen width. The strength scatter was higher than for Schunk FU2998/1 and did not show significant differences between the specimen groups.

For SiCARBON™ (Fig. 7), the only significant difference is observed for the specimen groups WJ-10 and WJ-20 (421 MPa vs. 467 MPa). Inspection of the strength data of individual specimens

showed that the relatively low strength of the specimen group is mainly caused by five specimens which were cut from adjacent locations in the composite plate. It is therefore believed that the lower strength of this group is caused by a local fluctuation in material properties rather than being a result of cutting damage. This is further supported by the fact that the groups AWJ-10 and AWJ-20 had both a flexural strength similar to WJ-20 (namely 462 MPa and 444 MPa) despite showing similar cutting damage. It can be concluded that waterjet cutting can induce local delamination in weak matrix composites, but the small delaminated zones near the specimen edge do not have an effect on flexural strength.

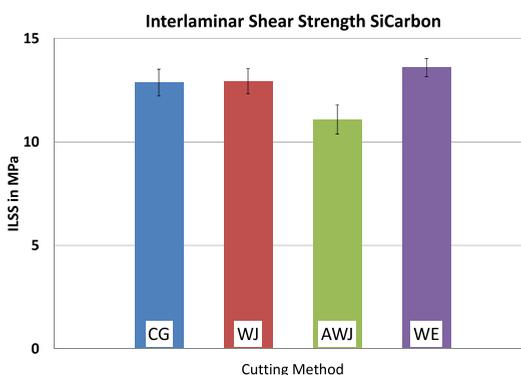
Figure 8. Interlaminar shear strength of SiCARBON™ specimens cut with different methods as determined in short bending: cutoff grinding (CG), waterjet cutting (WJ, with particles AWJ) and laser cutting (WE). The bars on the columns indicate 90% confidence intervals.

The ILSS of SiCARBON™ specimens cut with different methods is shown in Fig. 8. The specimens prepared by abrasive waterjet cutting showed somewhat lower interlaminar shear strength (11.1 MPa) when compared to the other groups (12.9–13.6 MPa).

For SiCARBON™ the only significant deviation in interlaminar shear strength is observed for the specimen group AWJ. Inspection of the strength data of individual specimens showed that the relatively low strength of the specimen group is mainly caused by three specimens. Two of them were cut from directly adjacent locations and all three originated from the same area and plate as the low strength WJ-10 bending specimens. Due to the fact that delaminated zones were visible already before testing in this material, typically several delamination cracks were observed after the short bend test which made it difficult to safely assess the validity of the test (namely observation of shear failure in the central part of the specimen). It is therefore possible that the lower strength of the AWJ group is caused by pre-existing delaminated regions which may or may not be caused or enlarged by the waterjet cutting process.
