Experimental research on mechanical properties of high voltage transmission lines after the simulated wildfires

Abstract. In order to determine whether the mechanical performance after the fires of high voltage transmission lines meets the requirements of normal use, this article simulates the wildfire, and does the mechanical performance experiment of high voltage transmission lines (HVT lines) after the simulated wildfires. The experiment studied the breaking force and elongation of each layer of 500kV HVT lines after the simulated wildfire. Experimental results show that, after fires, each layer of single aluminum wires of 500kV HVT lines have low breaking force which can be decreased obviously to half of that of new lines. For the steel core, decrease of breaking force is not obvious than aluminum wires, and with the increasing degree of wildfires, it increases gradually to a maximum of 35% of new steel lines' breaking force. After wildfires, aluminum lines' resistance ability of deformation decreases significantly, and its plastic deformation increases obviously during uniaxial tension. The steel core has little plastic deformation, and layers of aluminum become fluffy after

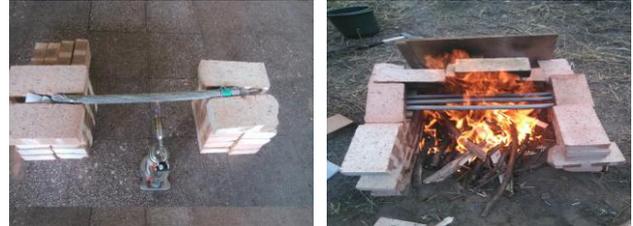
Figure 2. The picture of blowtorch and firewood

Experimental Equipment. As shown in Figure 1, tensile test of materials are tested in 10t universal testing machine. The experiment uses a constant displacement loading mode, and applying test specimen to fracture with speed of 15mm/min. The experiment adopts flat chuck for fixing. The experimental results are collected by computer automatically. The experimental temperature is 20°C. The blowtorch and firewood used for simulating wildfires are shown in Figure 2.

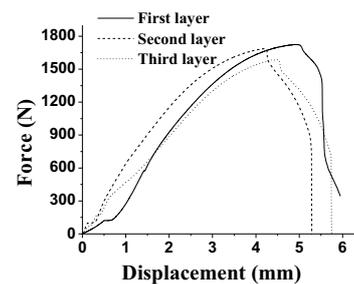
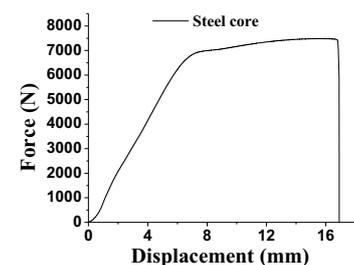
In the course of the experiment, we found that tensile curves of all aluminum lines have no obvious yield stage and reinforcement service stage, and the plastic deformation is very small. The tensile curves of steel core have obvious yield stage and reinforcement service stage. Figure 3 show the tensile curves.

Figure 3. Tensile curves of new signal lines of every layer

Experimental results are shown in Table 1. It is consistent with the said of that tension stress increases gradually from the outer layer to the inner layer in document [7].

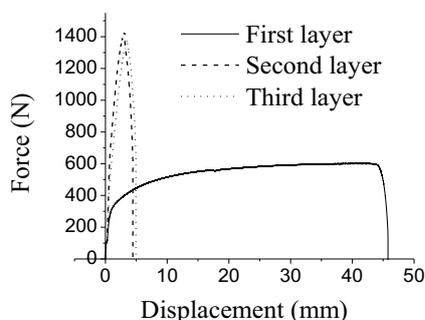
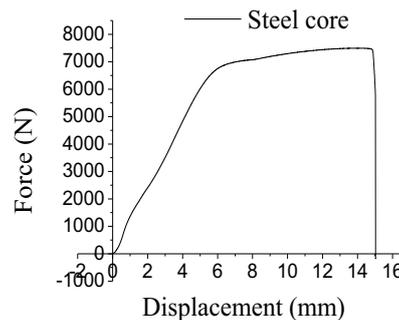
Experimental results of the HVT lines burned by wildfires. As shown in Figure 4, the HVT lines retrieved from the scene of wildfires had been completely blackened in the outer layer, and the inner layers had been partly blackened. The tensile curve of the outermost aluminum layer has a long reinforcement service stage, but similar to new lines, the tensile curve of the second and third layers of aluminum lines has no obvious yield stage and reinforcement service stage. The tensile curves of steel core have obvious yield stage and reinforcement service stage. Figure 5 show the tensile curves.

Figure 5. Tensile curves of signal lines burned by wildfires of every layer

Experimental results are shown in Table 2. The average tensile force of the outermost aluminum layer is smallest, and the elongation of it is high. The average tensile force of the second and third layers of aluminum lines is closer, and it is much higher than the outermost aluminum layer, and the elongation of them is low. The average tensile force of the steel core is much higher than the aluminum lines.

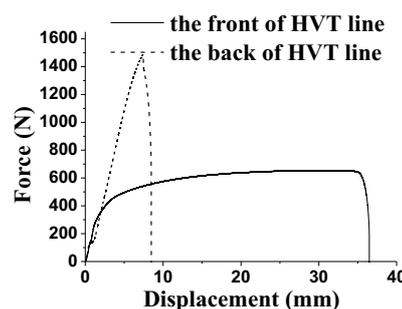
Experiment tested the tensile force of the front and the back of the HVT lines burned by blowtorch, and found: The tensile force of the front of the outermost layer of single aluminum lines decreases significantly; The tensile force of the back of the outermost layer of single aluminum lines decreases less. Experimental results are shown in Figure 6.

Fig.6 The tensile force of the outermost layer of aluminum lines burned by blowtorch

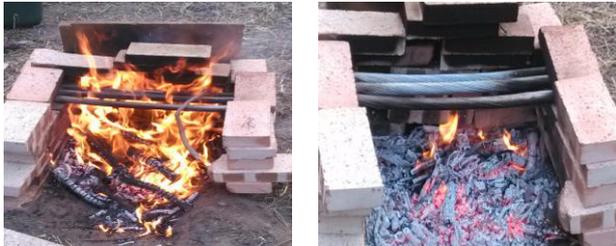
Experimental results of the HVT lines burned by firewood. Experiment was carried out with different burning degree of firewood on three HVT lines, in the course of the experiment we found: In the early burning stage of firewood, this three HVT lines are gradually blackened from the inside to the outside, In the later burning stage of firewood, the blackened layer of two

internal HVT lines disappears, and the blackened degree of the outermost HVT lines increases. And all of the outermost layer of three HVT lines appear loose strands. Experimental results are shown in Figure 7.(The outermost root is the first, the middle root is the second, the innermost root is the third.) Experimental results are shown in Table 3.

Figure 7. Process of HVT lines burned by firewood

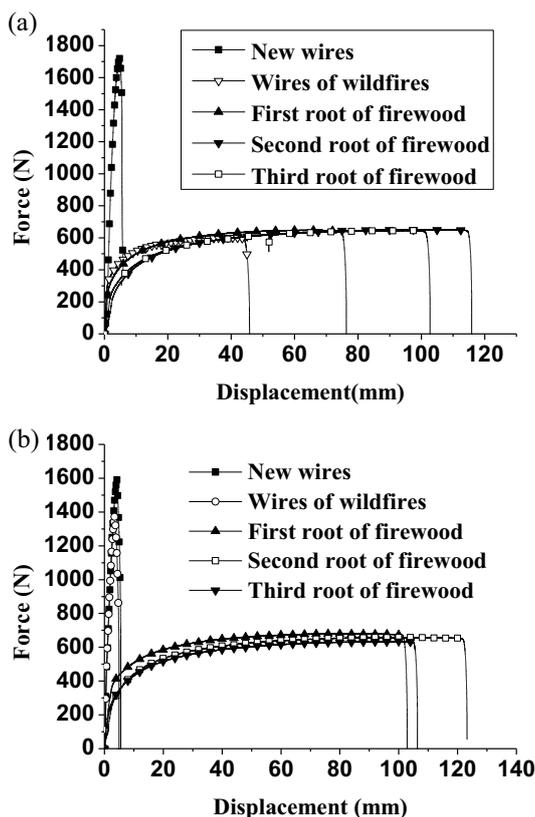
The tensile curve of the second and third layers of aluminum lines under different burning circumstances, are shown in Figure 8. The shapes of tensile curve of the second and third layers of aluminum lines burned by wildfires are similar, and the tensile force has little difference. The shapes of tensile curve of the second and third layers of aluminum lines burned by firewood are obviously different from the shapes of tensile curve of the second and third layers of aluminum lines burned by wildfires. It shows that the different burning degrees have a great influence on the second and third layers of aluminum lines, and the simulation results can not reflect the real wildfire results. But estimation of the overall tensile force,based on the tensile force of aluminum lines burned by firewood, is on the safe side.

Figure 8. The tensile curve of the second(a) and third(b) layer of aluminum lines under different burning circumstances

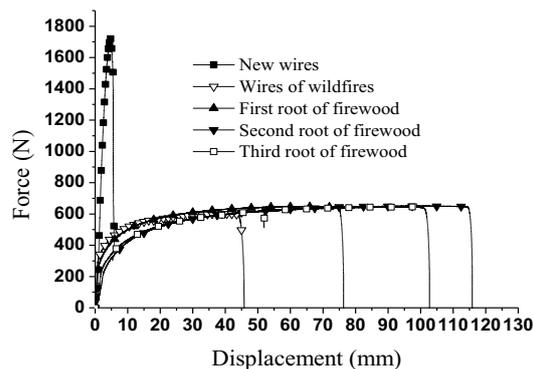
The tensile curve of the outermost layer of aluminum lines under different burning circumstances, are shown in Figure 9. The tensile force of the outermost layer of aluminum lines of the four HVT lines is similar basically, while the tensile force of the first HVT lines burned by firewood is most close to the result of wildfires. For elongation, the elongation of HVT lines burned by wildfires is smaller, while the elongation of HVT lines burned by firewood increases with the the increase of the degree of burning.

Figure 9. The tensile curve of the outermost layer of aluminum lines under different burning circumstances
