# Influence of fire barriers on fire performance of facades with combustible insulation

**Abstract.** In today's modern society sustainability has become a key driver for innovation. Sustainability in buildings is, or at least it should be, strongly interconnected with energy efficiency and fire safety. Unfortunately, cases of fires in buildings all over the world are a wakeup call to start thinking of fire safety as an inevitable part of energy efficiency in buildings. Thermally enhanced building envelopes, due to materials used, can represent significantly increased fire load on façades. To determine their fire performance, it is necessary to move on from material level to the whole building level, i.e. full scale tests. This paper presents findings from comprehensive research on influence of fire barrier on fire performance of External Thermal Insulation Composite System – ETICS with combustible thermal insulation. To confirm findings, tests on identical ETICS systems were conducted in March 2014 and May 2014.

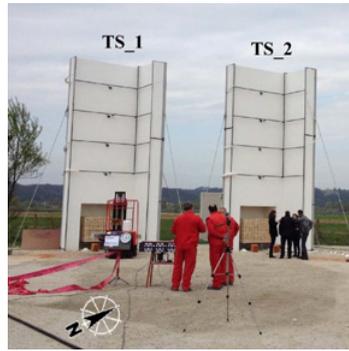
Both test specimens were L-shaped, 8 m high, with one leg 2.6 m long forming the main test wall (main face) and the other leg 1.5 m long forming the return wall (wing) as shown in Fig. 1. The L-shape of the specimen represents an internal corner of a building. The only difference between test specimens was the fire barrier made of non-combustible stone wool (SW) thermal insulation that was constructed above the opening of one test specimen. Composition of test specimens and their classification according to the reaction to fire classification as declared by the manufacturer [3, 4] is shown in Table 1.

**Figure 1.** Test specimens before the test start.

Since the tests were performed outside, the weather conditions, i.e. wind speed, wind direction and air temperature, were monitored in order to be able to take into account their possible influence on testing and obtained results. During the Test 1, the air temperature at the start of the test was within the range 11.2–12.3°C. The air velocity was 1.8 m/s at the start of the tests, while during the test air velocity was measured up to 5.4 m/s in N–E direction. Air temperature during the Test 2 was within the range of 20.5–22.2°C and the air velocity was within the range of 2.2–4.5 m/s in N, N–W direction. Direction of north is shown in Fig. 1.

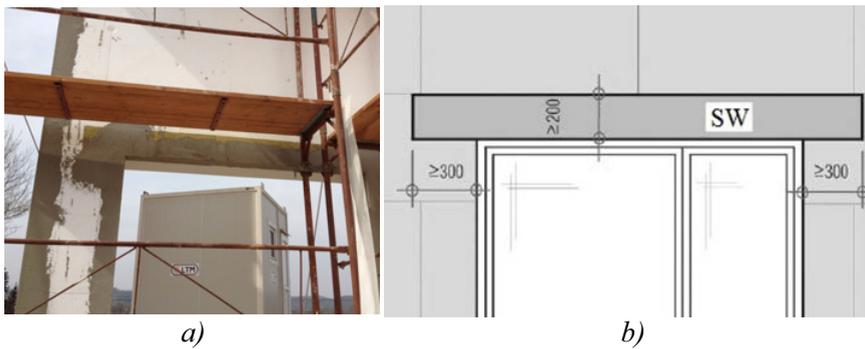
Fire barrier in the test specimen TS\_2 was positioned directly above the combustion chamber which simulates an opening in a building, Fig. 2a. Lintel protection above each opening prevents fire penetration in the thermal insulation layer. A schematic drawing of the lintel protection above the opening on test specimen TS\_2 is shown in Figure 2b. It was constructed with respect to the best rules of practice. According to literature [5], this is one of the possible ways of constructive “fire protection”, i.e. passive fire protection in ETICS systems with combustible thermal insulation.

**Figure 2.** Lintel protection: a) Applied on test specimen TS\_2, b) General scheme [5].

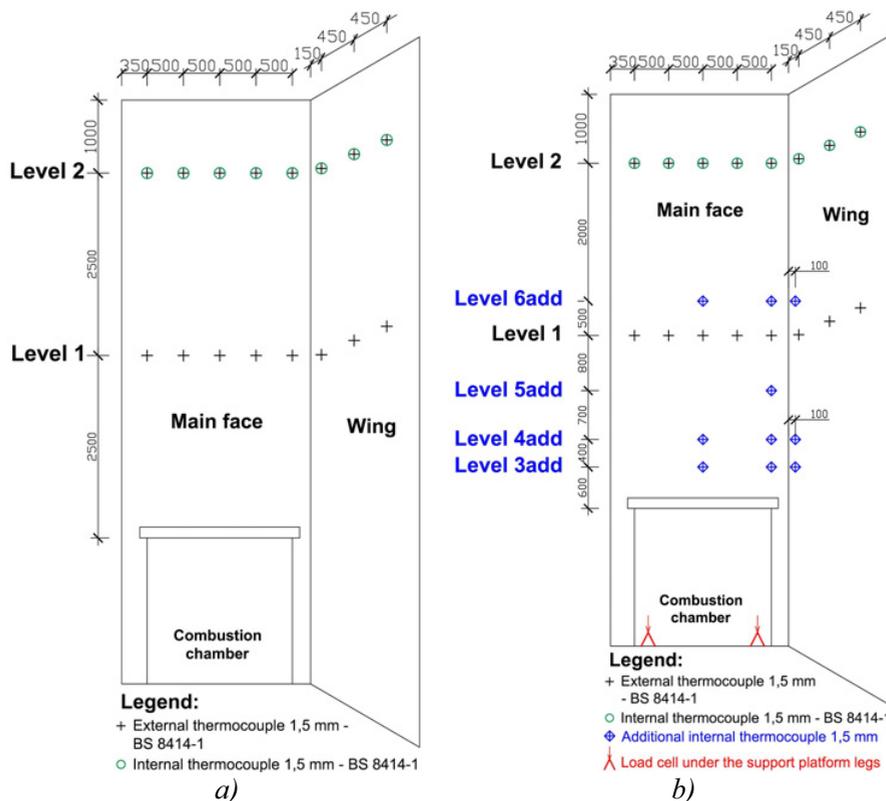
External thermocouples were positioned on the main face of the façade and on the wing, both at Level 1 and Level 2 (Fig. 3a) in accordance with BS 8414-1. Internal thermocouples required by BS 8414-1 were positioned at Level 2, on the main face of the façade and on the wing.

Table 2 shows the additional measurements done during the tests with Fig. 3b showing the position of the additional internal thermocouples and load cells. The results of these are part of the analysis in this paper.

**Figure 3.** Positioning scheme of: a) thermocouples required by BS 8414-1 [2]; b) load cells and additional internal thermocouples.

Additional measurements of temperature within thermal insulation layer were conducted only during Test 2 (Fig. 7). Additional levels marked in Fig. 3b were defined to gain an insight into the vertical fire spread within combustible insulation, with and without fire barrier. The results show that the fire barrier in specimen TS\_2, caused the temperatures within thermal insulation layer up to Level 6 add (6.0 m above the combustion chamber) to stay below 300°C. However, this indicate that EPS in specimen TS\_2 has melted away at least 6 m above the combustion chamber, as EPS starts to melt at temperatures

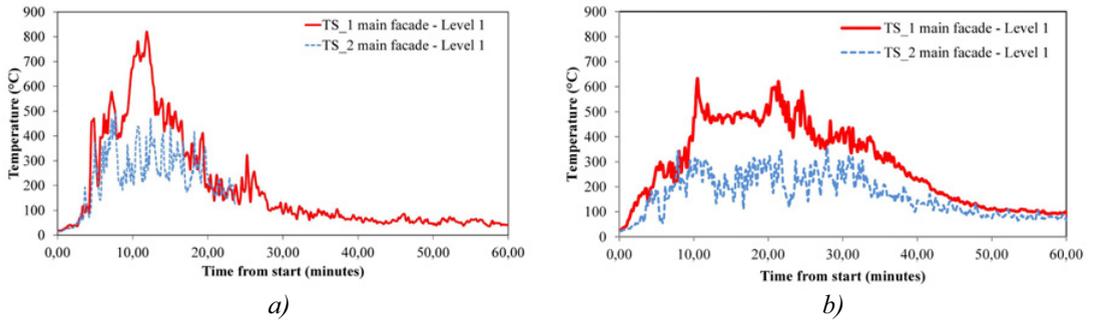
**Figure 4.** Average surface temperature at Level 1 on main facade: a) Test 1, b) Test 2.

Figure 4 and Fig. 5 are presenting temperature profiles based on average temperatures measured according to the standard [2] with external thermocouples on test specimens at Level 1 and Level 2, respectively. Figure 6 presents the average temperature measured within the thermal insulation layer at Level 2, according to the standard. Average temperatures imply an average of several thermocouples at the same level.

Development of surface temperatures on test specimens TS\_1 and TS\_2 in Test 1 is comparable and has practically the same increase rate and values up to 8 min from the test start (Fig. 4a and Fig. 5a). After those 8 min average surface temperatures on test specimen TS\_1 are considerably higher compared to the test specimen TS\_2. In case of Test 2, such a correspondence of temperatures in first

few minutes from test start is not present (Fig. 4b and Fig. 5b). Although, surface temperatures on test specimen TS\_1 during the Test 2 were higher compared to test specimen TS\_2, thus confirming the behavior from Test 1. As it can be observed in Fig. 4 and Fig. 5, temperature profiles of test specimen TS\_1 are characterized with stronger peaks, while the temperature profiles of test specimen TS\_2 are characterized with a multitude of oscillations and significant peaks cannot be recognized. Temperature profiles of both test specimens, i.e. TS\_1 and TS\_2, follow form of the fire development curve, but the fire development curve of TS\_2 has quite lower amplitude, i.e. the stages corresponding to the flashover and fully developed stage are mitigated due to presence of SW fire barrier.

When results from Test 1 and Test 2 are being compared, the differences in developed temperatures in each test can be noticed on both test specimens. Differences in surface temperatures on test specimen TS\_1 reach up to 200°C at Level 1 (Fig. 4a and Fig. 4b) and up to 150°C at Level 2 (Fig. 5a and Fig. 5b). On test specimen TS\_2, when Test 1 and Test 2 are being compared, differences in surface temperatures reach up to 150°C at Level 1 (Fig. 4a and Fig. 4b), while at Level 2 temperatures remain practically the same (Fig. 5a and Fig. 5b). It can be assumed that the differences are caused by changes in weather conditions and different burning rate of fire sources, which will be further discussed in this paper.

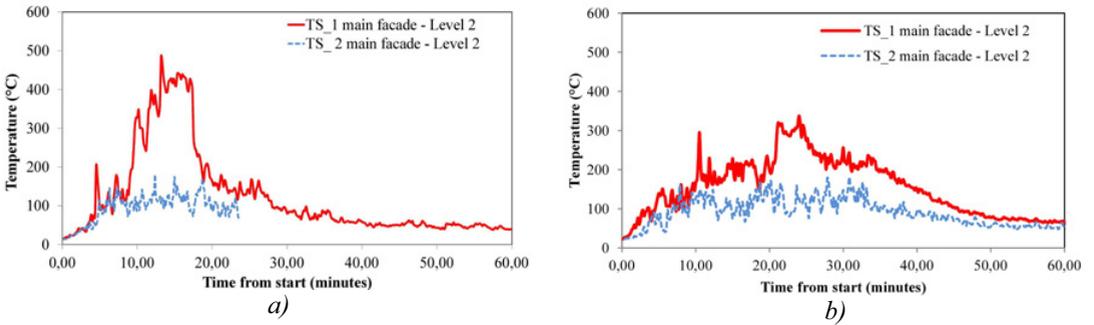
**Figure 5.** Average surface temperature at Level 2 on main facade: a) Test 1, b) Test 2.

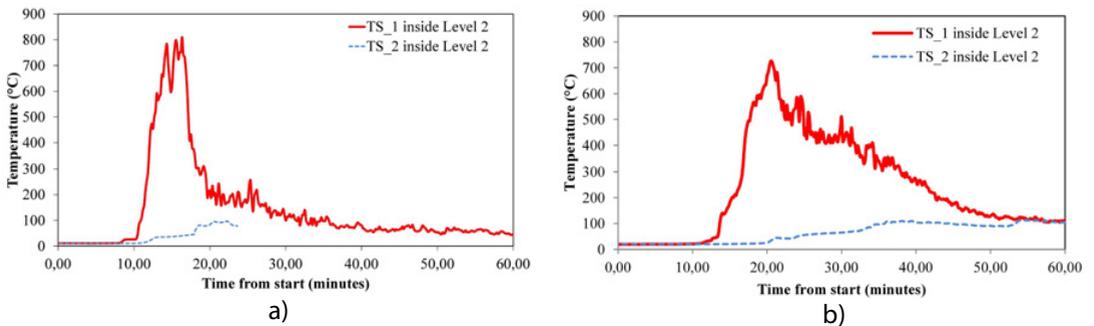
**Figure 6.** Average temperature within thermal insulation layer at Level 2 on main facade: a) Test 1, b) Test 2.

Analysis of average temperatures within the thermal insulation layer shows that test specimen TS\_2 has considerably lower temperatures compared to test specimen TS\_1. Obviously, fire barrier has limited the fire development within the insulation in test specimen TS\_2 and temperatures remained below or around 100°C at Level 2 (both Test 1 and Test 2). The adverse effect occurred on TS\_1, i.e. the thermal insulation in test specimen TS\_1 caught fire and peak temperatures reached around 800°C in Test 1 and around 720°C in Test 2 at Level 2 (Fig. 6a and Fig. 6b). The first peak in test specimen TS\_1 appeared around 14 min from the start in Test 1 (Fig. 6a), while in Test 2 it appeared around 20 min from the start (Fig. 6b). Possible explanation for this occurrence of peak's time shift could be change in weather conditions and different burning rate of fire source.

Analogously to the above presented tendencies of average surface temperatures, the average temperatures within the thermal insulation layer are constant and have the same value in both test specimens up to the first 8 min from the start in Test 1 (Fig. 6a) and up to the first 10 min from the start in Test 2 (Fig. 6b).

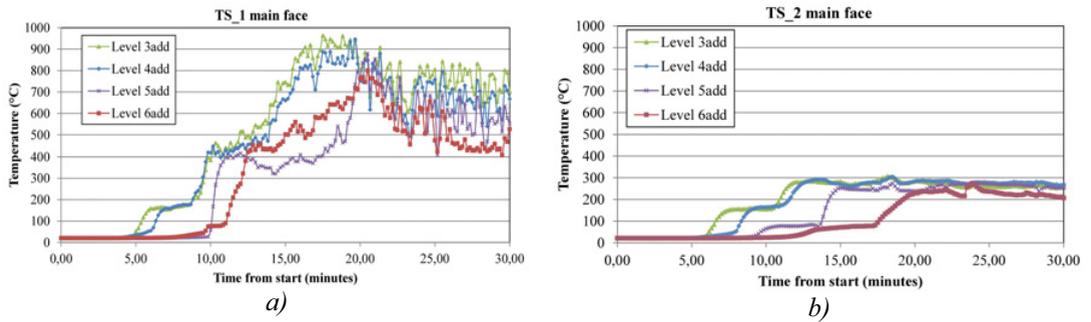
**Figure 7.** Average temperature within thermal insulation layer at additional levels on main façade from Test 2: a) specimen TS\_1, b) specimen TS\_2.

above 80°C [6–8]. EPS melting vertically underneath uncracked render is confirmation of accelerating internal fire spread because of the occurring stack effect.

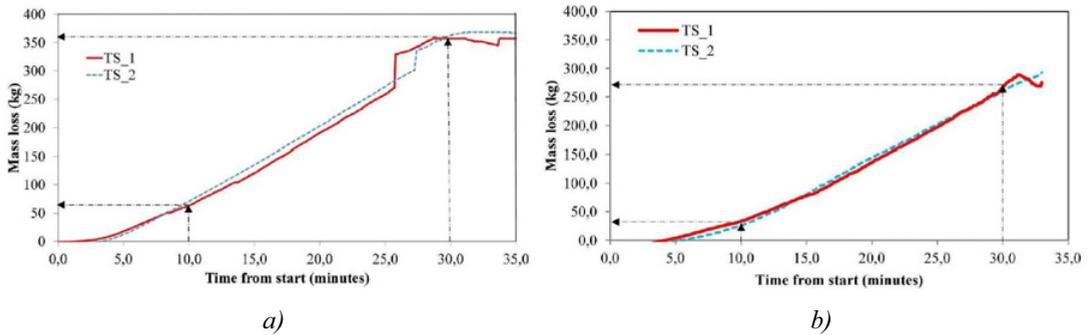
**Figure 8.** Mass loss of wood crib: a) Test 1, b) Test 2.

As expected the fire barrier has no influence on burning rate of the fire source, i.e. the mass loss of wood crib was practically the same for test specimens TS\_1 and TS\_2. That finding from Test 1 was confirmed in Test 2 (Fig. 8a and Fig. 8b). On the other hand, there is a noticeable difference in mass loss measured in Test 1 and the one measured in Test 2. In Test 2 the burning rate is decreased (Fig. 8b) compared to that in Test 1 (Fig. 8a). It should be noted that the standard [2] only defines to “nominal” volume of wood crib used as a fire source. For the same geometry of wood crib and the same type of softwood used (fir), in Test 2 the initial mass of wood crib was approximately 100 kg heavier for TS\_1 and approximately 80 kg heavier for TS\_2, compared with the mass of wood cribs in Test 1. Even for the same type of softwood, its density can vary and thus affect the mass of wood crib. Also, different moisture content in the wood will affect the mass of the crib. Variation in density of softwood and its moisture content, together with changes in weather conditions, resulted with wood cribs in Test 2 that were burning more slowly, i.e. the mass loss was lower compared to the mass loss in Test 1 (Fig. 8a and Fig. 8b). Consequently, lower temperatures were developed on the surface of the test specimens and within the thermal insulation layers in Test 2 compared with temperatures developed in Test 1 (Figs. 4–6).

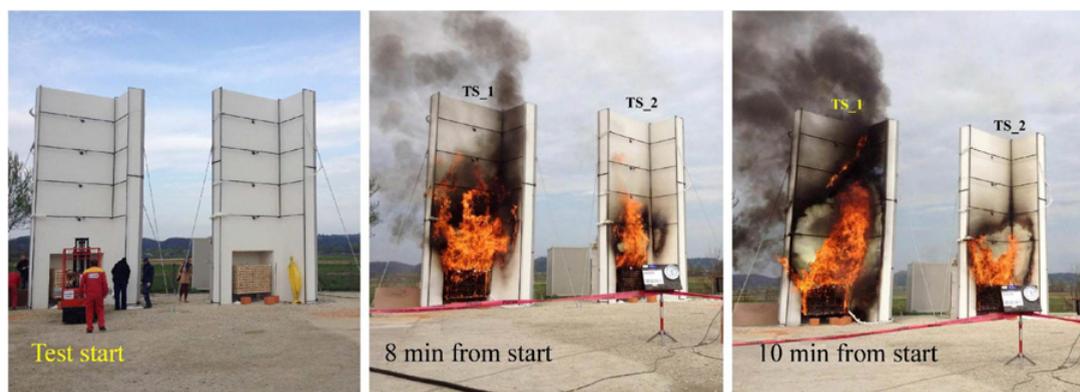
Figures 9–12 shows the development and fire spread on both specimens during Test 1. By visual observation during the test, it has been noted that the fastest fire spread, both vertically and horizontally, was present on the test specimen TS\_1 accompanied with significantly more smoke production compared to specimen TS\_2. On test specimen TS\_2, fire spread was mitigated due to the fire barrier above the combustion chamber, which is also reflected in the temperature profiles (Figs. 4–7). The fire barrier however, did not prevent the fire from consuming the test specimen. The insulation above the fire barrier melted as the temperature passed the melting point and pooled on top of the fire barrier. Here it collected until the render at the lintel level broke and allowed melted material to drip out as burning droplets as well as burning on top of the fire barrier creating a delayed smoke production. The main risk with burning droplets is that they can spread the fire downwards and can also endanger firefighters in real fire cases. Smouldering was present on specimen TS\_2 after the wood crib had burned out. This is assumed to be the residual melted EPS insulation slowly combusting within the fire barrier.

**Figure 9.** Visual observations of test specimens during the first 10 min of testing.

All specific appearances observed during Test 1 (Figs. 9–12) have also occurred during Test 2, but at slightly later times. Nevertheless, a pattern of behaviour in this type of fire scenario can be established for tested ETICS systems as follows:

- 1) ETICS with EPS (TS\_1): As the fire extends from the combustion chamber the organic render ignites and starts to crack. This is followed by the render opening up allowing the EPS underneath to ignite. As the EPS starts to burn the smoke emissions increase until a thick black smoke is observed, and it is followed by occurrence of pool fire and burning droplets. All the EPS in the specimen is consumed by the fire before the wood crib is burned out.

- 2) ETICS with EPS and fire barrier (TS\_2): As with TS\_1 the fire extends from the combustion chamber and ignites the organic render. The fire is “localized” on the façade above the opening. The EPS above the fire barrier starts to melt. The fire spreads up the façade in part due to melted EPS igniting and starting to burn at the level of the fire barrier. This causes a delayed smoke production as well as significant amount of burning droplets as the fire barrier can no longer contain the melted EPS. The EPS is melted only partially along the specimen height.

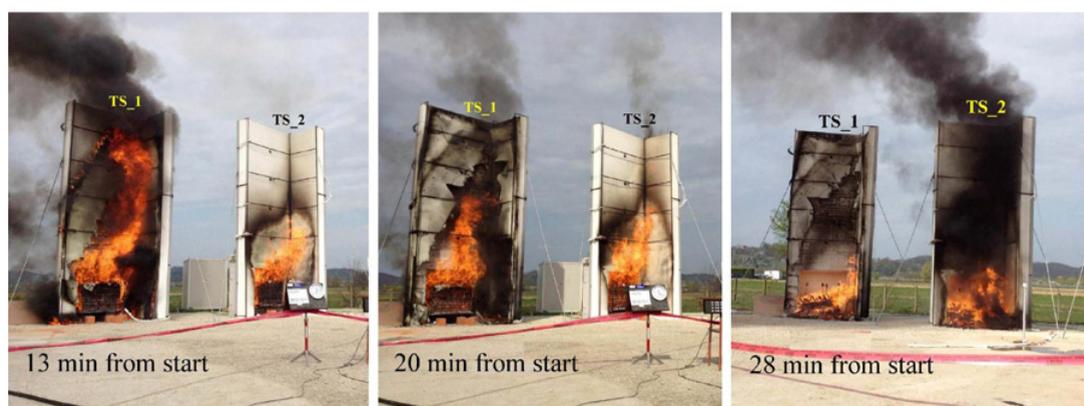
**Figure 10.** Visual observations of test specimens from 13 min to 28 min from the test start.

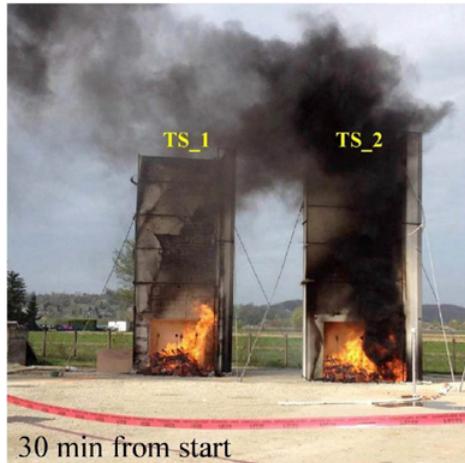
**Figure 11.** Visual observations of test specimens 30 min from the test start.

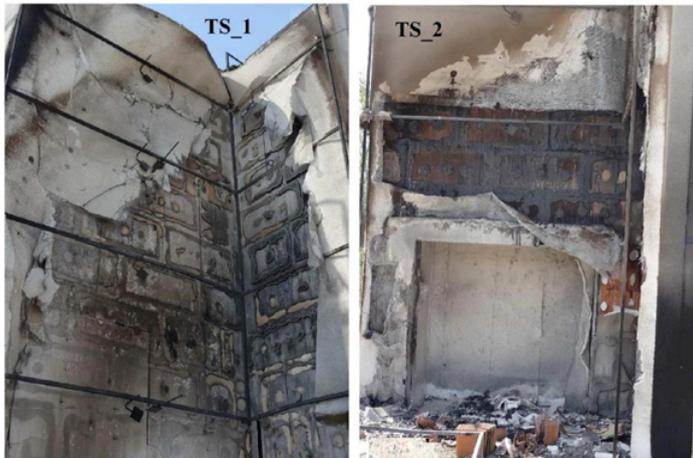
render has left, while all the EPS thermal insulation had burned out, Fig. 12. On test specimen TS\_2 the EPS thermal insulation had melted only partially, Fig. 12.

**Figure 12.** Test specimens TS\_1 and TS\_2 at the end of testing.

- *EPS burned out completely if no fire barrier was present, while it was melted under the render and pool fire occurred on the ground near specimen when a stone wool fire barrier was in place over the window.*
- *The fire barrier delayed the smoke production and burning droplets compared to the sample with no fire barrier.*
- *Temperature profiles show considerably higher surface temperature and temperature within thermal insulation layer on specimen when no fire barrier is used.*
