# Causes of formation of cracks in the outer masonry of multilayer walls in the zone interwindow belts and partition

**Abstract.** This article examines the causes of crack formation in the exterior layer multilayer enclosing structures, on early terms of operation (from 3 to 5 years). The problem is investigated on a concrete example of the existing residential building in St. Petersburg. We explore the cracks in the zone interwindow belts and partition. For this purpose, methods such as: analysis of the experience, visual inspection, the experimental methods in laboratories, numerical modeling in the software package ANSYS. As a result of visual examination of sediment soils are not detected. According to the results of tests of a selected samples bricklaying, compliance of its durability to existing rules - is defined. Identified a number of causes of crack formation. Also, a number of recommendations is developed for the design, to avoid similar problems on early terms of operation.

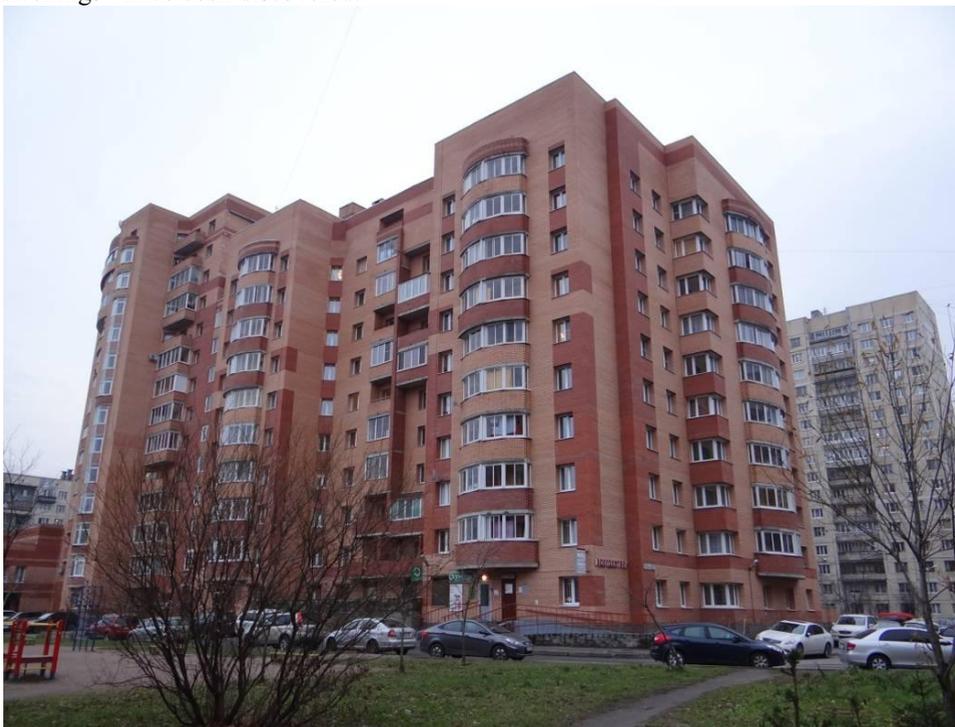
The object of the survey is a residential building (Figure 1), constructed and commissioned in 2009.

**Figure 1.** General view of the building

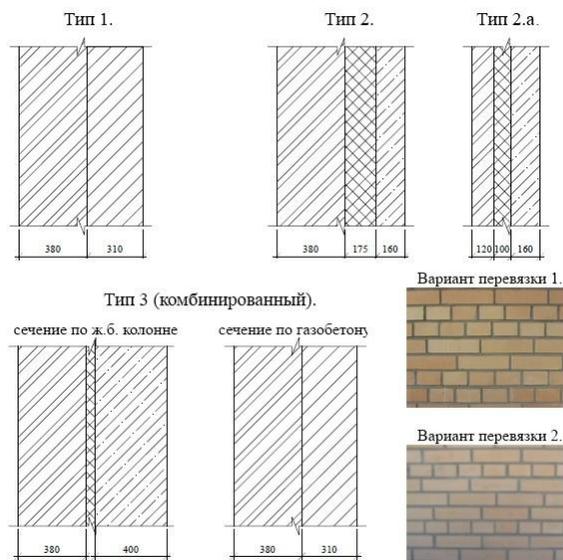
**Figure 2.** The decision on the external walls

There are the following types of external walls (Figure 2), differing primarily on the composition of the inner layer (outer (obverse) layer is made of a single solution for all types of walls):

Type 1. The outer walls of the rectilinear sections, i.e. sections, going along the facades - double layer: inner layer is presented laying of aerated concrete blocks with a thickness 310 mm, external (obverse) - combined masonry thickness of 380 mm (decisions laying of an obverse layer, see below).

Type 2. Outside end walls of Z-and P-shaped sections formed by internal cross-walls - three-ply: the inner layer of reinforced concrete thick wall represented 160 mm, external (obverse) - combined masonry thickness of 380 mm (decisions laying of an obverse layer, see below). Between the internal and obverse layers provides a layer of insulation from min 175 mm mineral wool.

Type 3 or combined. Outside end walls of Z-and P-shaped sections formed by the inner columns - double layer: inner layer is represented by two reinforced concrete columns, forming an end face and the laying from aerated concrete blocks arranged between columns. Between the columns and an obverse layer provides insulation.

- two variants of bandaging of a laying of an obverse layer (Figure 2); and consistency in their application is missing, that provokes concentration of tension in a laying;

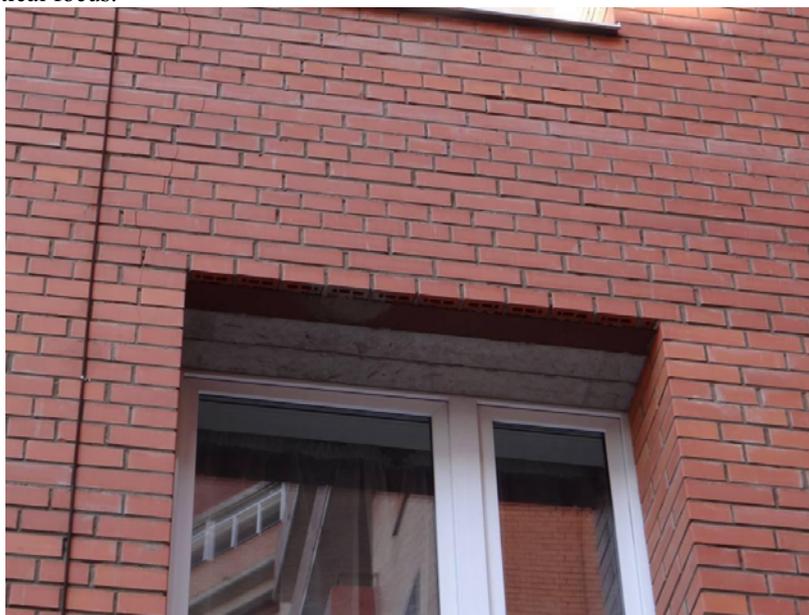
Development of cracks begins in an interwindow belt with the bottom and/or top corner of apertures with a tendency to their merge, including with cracks above - and the below-located interwindow belts, cross-cutting and the trunk (Figure 3).

In bottom corners of apertures of a crack have local sites of an exit to piers; the cracks beginning in the top corners bypassing crossing points, come also to piers. Nevertheless in general, cracks have an obvious vertical focus.

**Figure 3.** Cracks of vertical orientation on border of interwindow belts and piers

The width of cracks not more disclosure 2-3 mm.

However, in this case, it is impossible to call lack of a vertical deformation seam between obverse layers of piers and interwindow belts a background on which these mechanisms prove. Manifestation of mechanisms happens rather against imbalance the rigid of characteristics of communications of interwindow belts and piers concerning deformations of obverse layers. These circumstances caused emergence of vertical cracks on border of interwindow belts and piers.

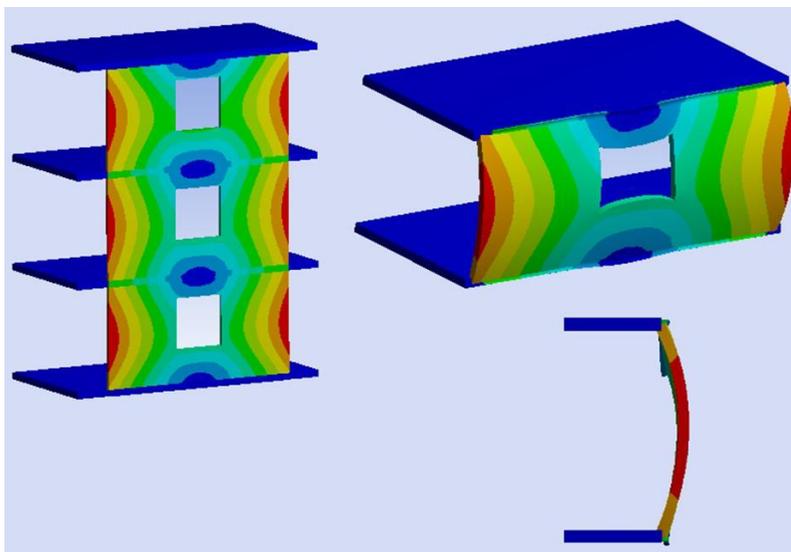
In section 5.2 noted that the value of the given plot height of an obverse layer type 2 hred.2 substantially less value given the height of the plot of an obverse layer type 1 hred.1 (hred.2 << hred.1). An obverse layer pier can also be attributed to the type 2 (with values listed heights respectively hred.1 and hred.2). Considering only the difference of the actual heights of a pier and an interwindow belt, it may be noted that the value of the given height is hred.3 differ from hred.1 и hred.2. Difference given heights (hred.1 – hred.3) and (hred.2 – hred.3) leads to a difference of longitudinal deformation and . Bandaging of layings obverse layer of a pier and interwindow belt constrains noted differences that causes tangent tension , which, given the low resistance of laying shear, leads to warping sections on the boundary layers and cracks (obverse layers are moved relative to each other by their height). Capping model with floor-by-floor support on plates of overlapping in Figure 4, the full height of the building in Figure 5.

**Figure 4.** The device of an obverse layer with a floor-by-floor support on overlapping plates

Lack of a horizontal deformation seam between a plate and a laying of an obverse layer, led to that plates put an obverse layer into the general operation of reinforced concrete building structures. At the same time, the corresponding loadings are transmitted through plates on a laying of an obverse layer (the weight of plates, payloads, the load on the balcony fences and etc.). Also we will note that vertical efforts in a laying can arise as from both its own weight of a laying and weight of the designs leaning on it, and from control of temperature influences that finally provoke emergence of cracks.

3. It should be laid in the expansion project of horizontal seams in places of a floor-by-floor support of an obverse layer. It will promote that there was no tension from not projected loadings and flexural deformations.

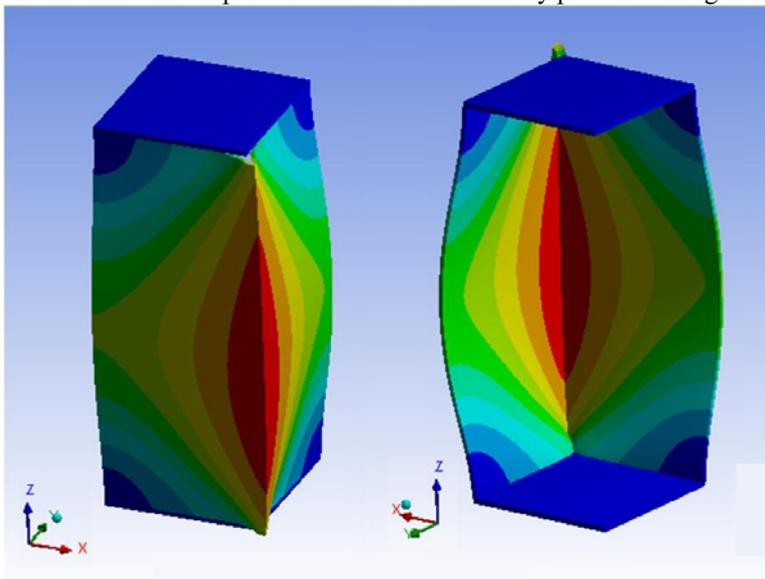
**Figure 5.** The device of an obverse layer on all height of the building

Thus, these mechanisms also describe the shear adjustment layers, caused by the difference of the longitudinal strain.
